NONDESTRUCTIVE TESTING OF CONCRETE BOX GIRDER BRIDGES USING THERMAL IMAGING

A thesis submitted in partial fulfillment of
the requirements for the degree of

WASHINGTON STATE UNIVERSITY
Department of Civil and Environmental Engineering

MAY 2008

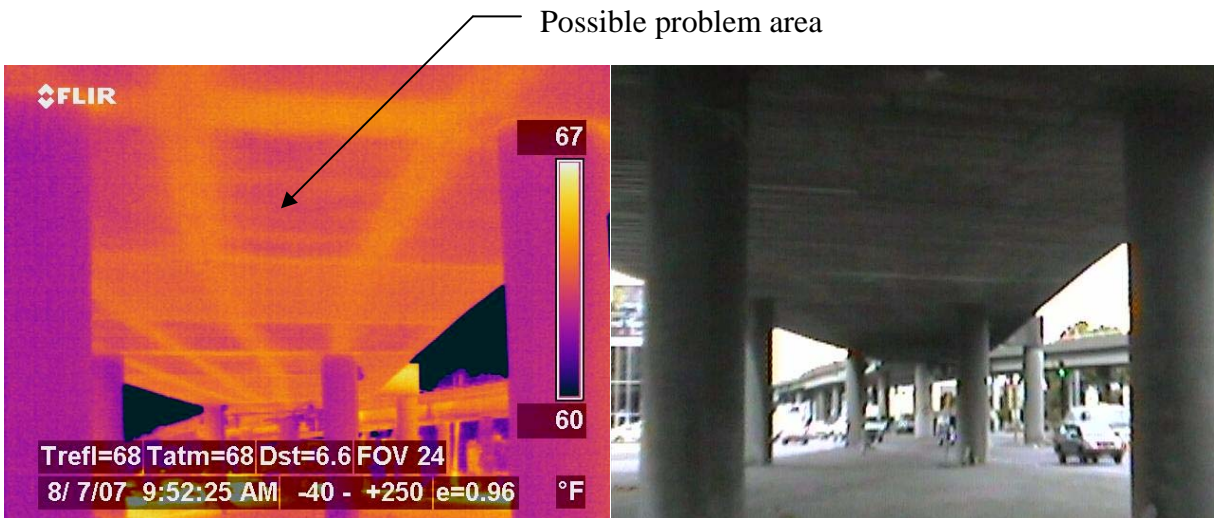
conditions from which a heating location might be determined. The arrow points to a location which should be a solid color inside a rectangle of yellow indicating a uniform temperature distribution. The yellow areas in the image signify locations of interior webs of the box girder. However, a closer look at the image reveals a few areas with higher surface temperatures than the surrounding concrete within the rectangle. This signal of inconsistency may indicate a problem area.

Figure 4.1 – Thermal image and photograph of box girder bridge under ambient conditions

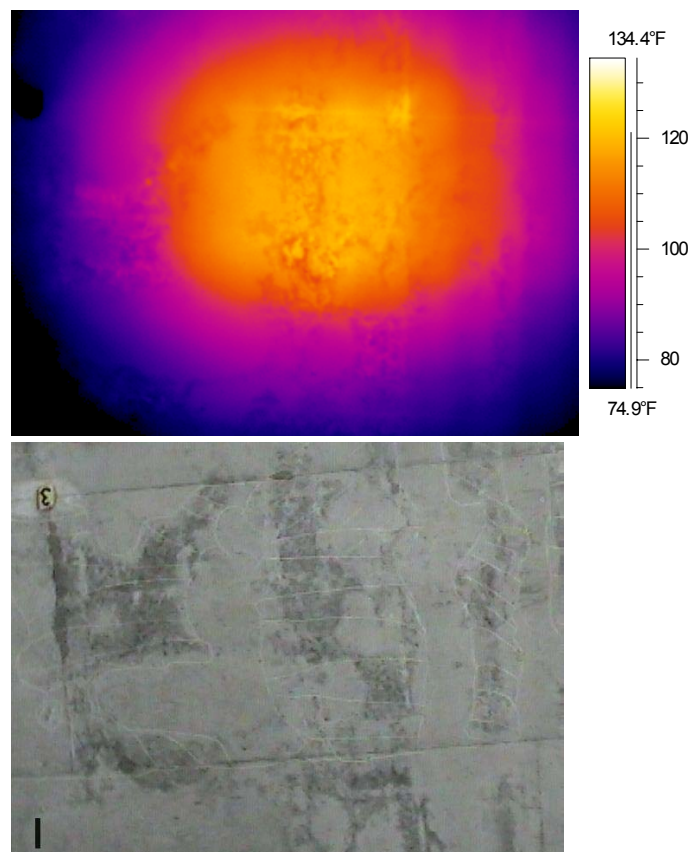
Heating Location # 1 was inspected on August 6th, 2007 using inspection Method 2. The inspection position was in Span 11 between marker # 1 and marker # 3 (markers were attached to the surface during prior WSDOT inspections). The surface was heated for a time span of 1:45 (hh:mm). The top of the heater was placed approximately 76 cm (30 in.) from the heated surface, which was 7.1 m (23.2 ft.) from the ground. This location was chosen because it was an area that had already been inspected by WSDOT, as indicated by the white chalk in Figure 4.3. The objective was to see how the thermal images displayed what was previously discovered. Figure 4.3 shows a thermal image and a corresponding photograph of the heated surface.

Figure 4.3 – Thermal image and photograph of Heating Location # 1

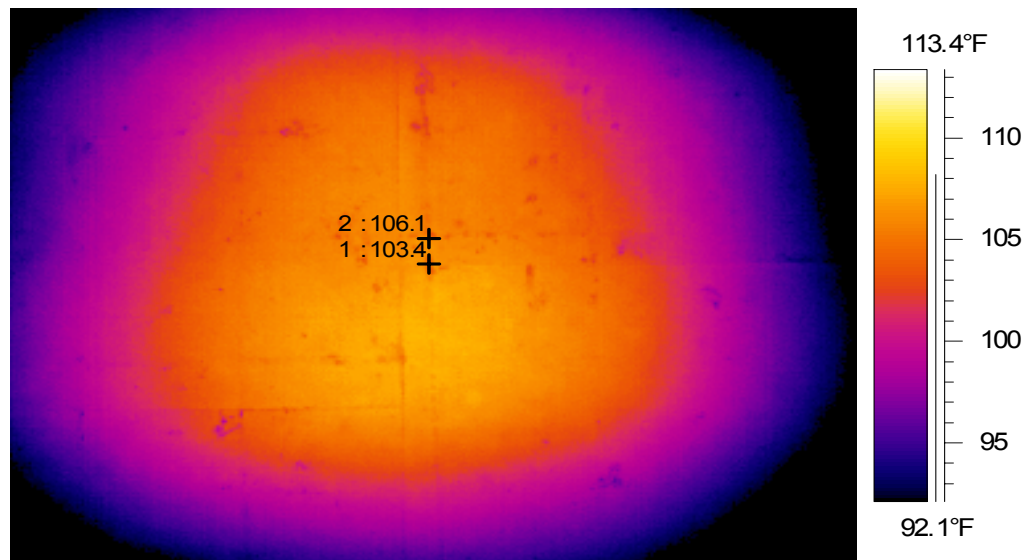
the image with the thermal imaging software, most of the other irregularities were found to be approximately 2 to 3 °F cooler as well. Since the irregularities are not substantially different in terms of temperature, one can conclude that they are just surface marks or areas where a small amount of concrete has spalled off.

Figure 4.7 – Thermal image of Heating Location # 4

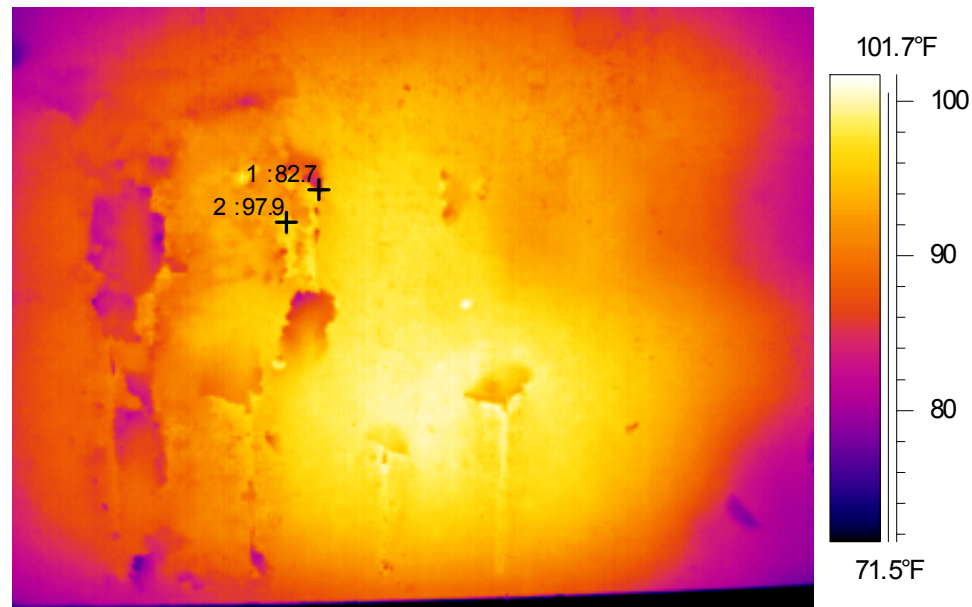
image in Figure 4.8 is filled with a lot of different types of irregularities, as shown by the great differences in color (indicating different temperatures). Irregularities include spalled concrete, delamination, exposed steel reinforcement (rebar), and poorly consolidated concrete. Temperature differences in this image reach approximately 15 °F (like points 1 and 2 shown).

Figure 4.8 – Thermal image of Heating Location # 5

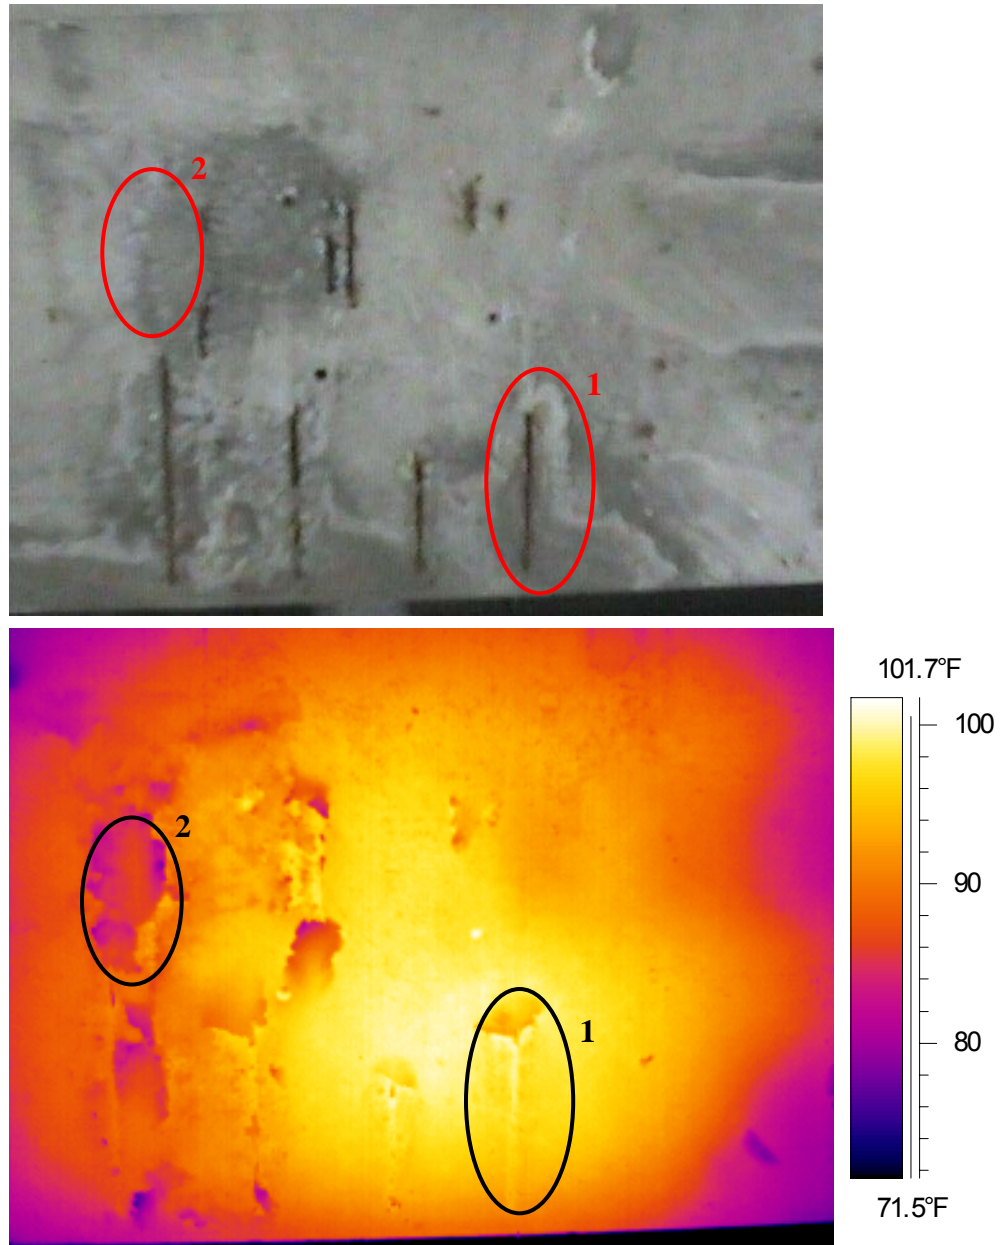
Figure 4.9 –Thermal image and photo of Heating Location # 5

circle. This may be due to delamination, poorly consolidated concrete, or another irregularity, but there is no way to be certain of the specific cause until further tests are completed (either “sounding” with a hammer or chipping out loose concrete). This does, however, reveal that there may be a problem at this location. There are also a few other areas in the Figure 4.9 that exhibit similar temperature anomalies.

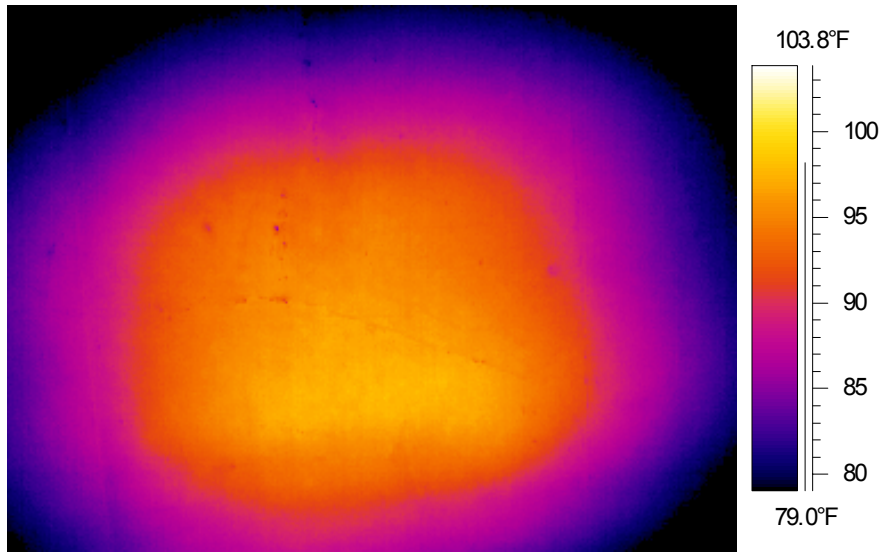
Figure 4.10 shows a thermal image of Heating Location # 6. This inspection did not detect any irregularities. The concrete surface seems to have no flaw. However, the inspection does show some of the surface texture characteristics. In the center of the thermal image, for example, is an area where concrete protrudes a very short distance beyond the flat surface. The surface feature looks like a line with a downward slope. The thermal image also demonstrates how very small surface defects can be detected.

Figure 4.10 – Thermal image of Heating Location # 6

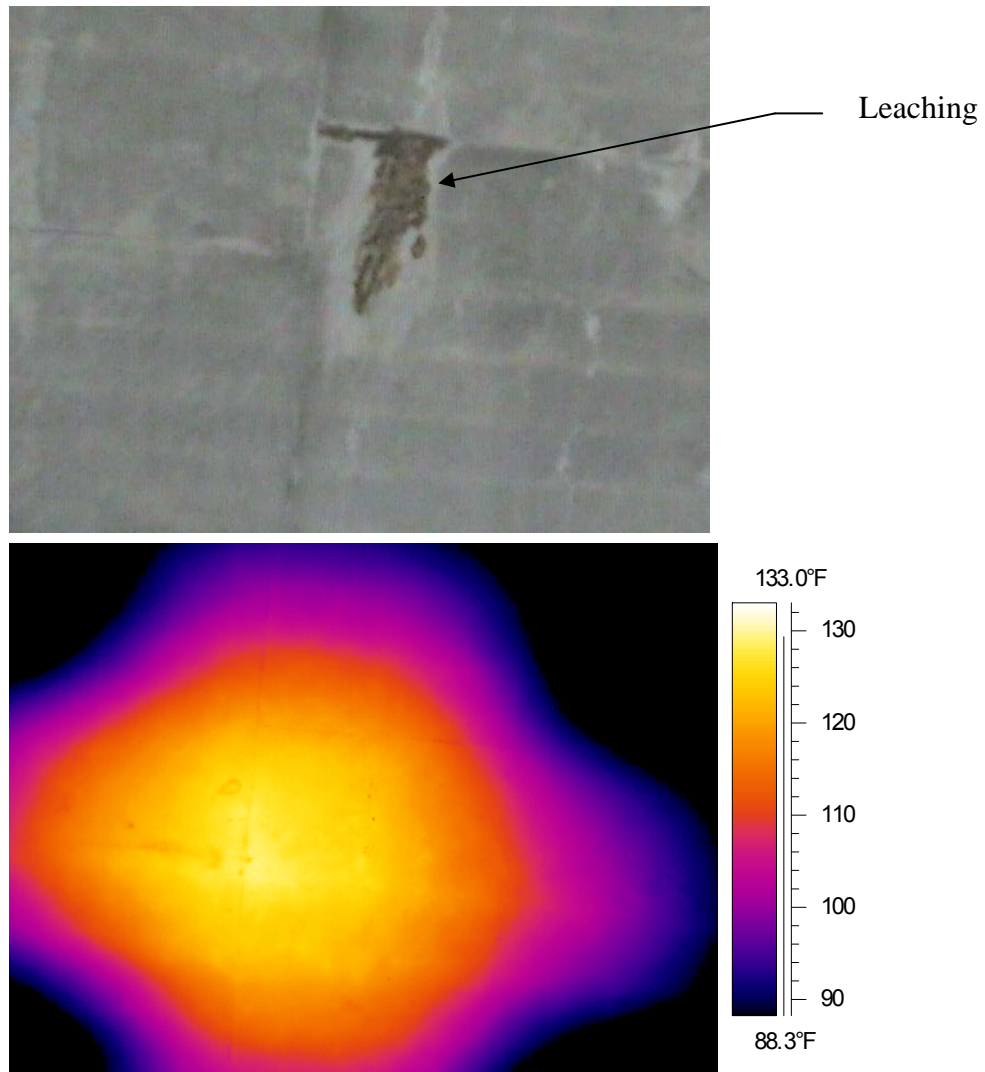
Figure 4.11 shows a thermal image and photo of the unheated surface from Heating Location # 7. This area was chosen because of discoloration due to leaching on the bottom surface of the box girder. The leaching may have been caused by water pooling inside the box girder at this location, and then leaching through. However, the thermal image in Figure 4.11

Figure 4.11 – Thermal image and photo of Heating Location # 7

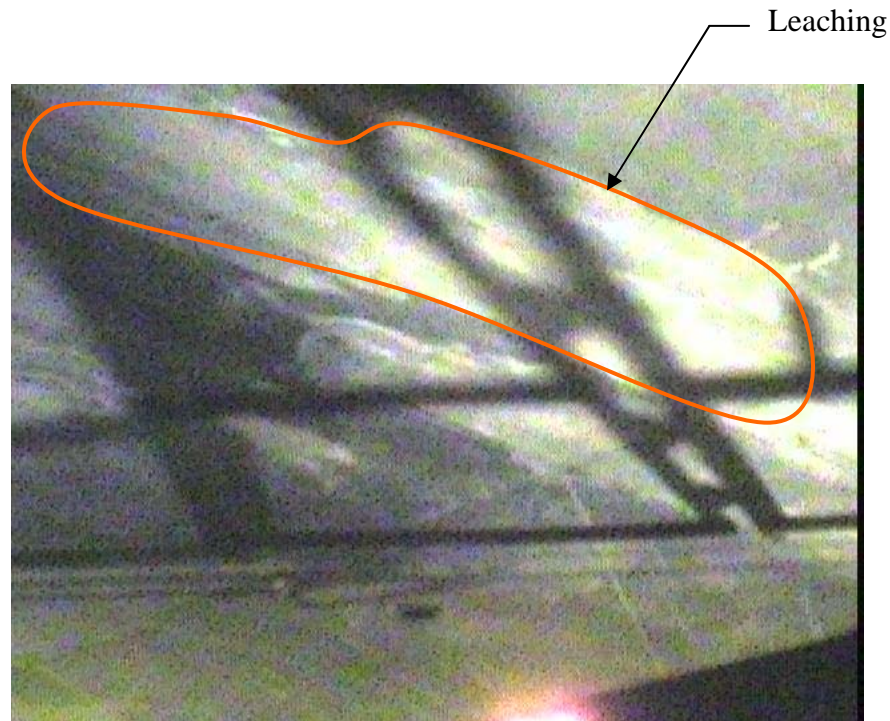
Figure 4.18 – Photo of Heating Location # 1 showing extensive discoloration due to leaching

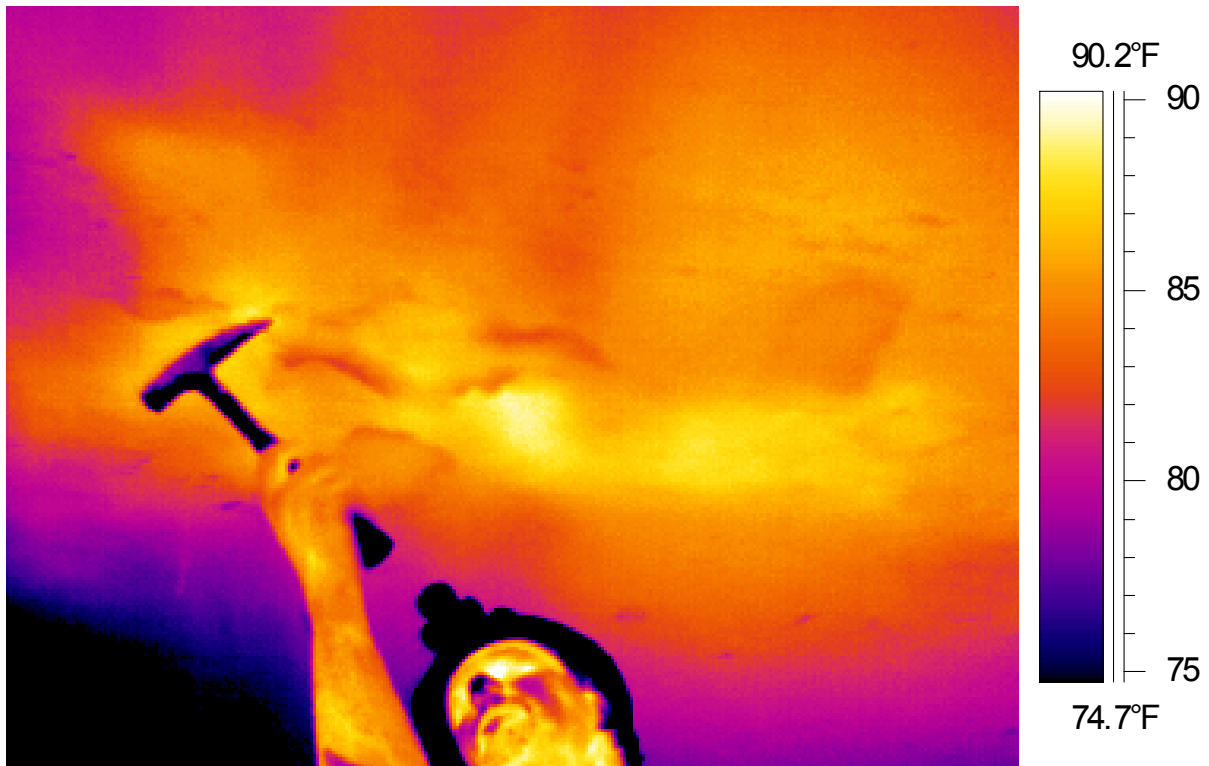
Figure 4.22 – Thermal image of Heating Location # 1: excavating a detected flaw
