EVALUATION OF ISOLATION DETAILS TO ENABLE ROCKING IN
A MASONRY VENEER PANEL

A thesis submitted in partial fulfillment of
the requirements for the degree of

MASTER OF SCIENCE IN CIVIL ENGINEERING

WASHINGTON STATE UNIVERSITY
Department of Civil and Environmental Engineering

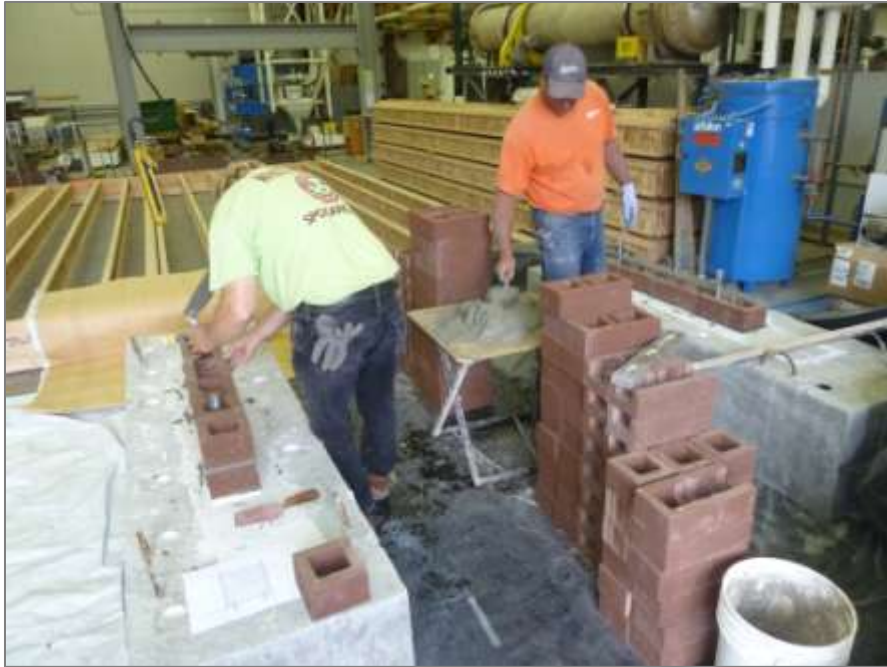
Figure 3.6: Construction Phase 2: Panel Construction

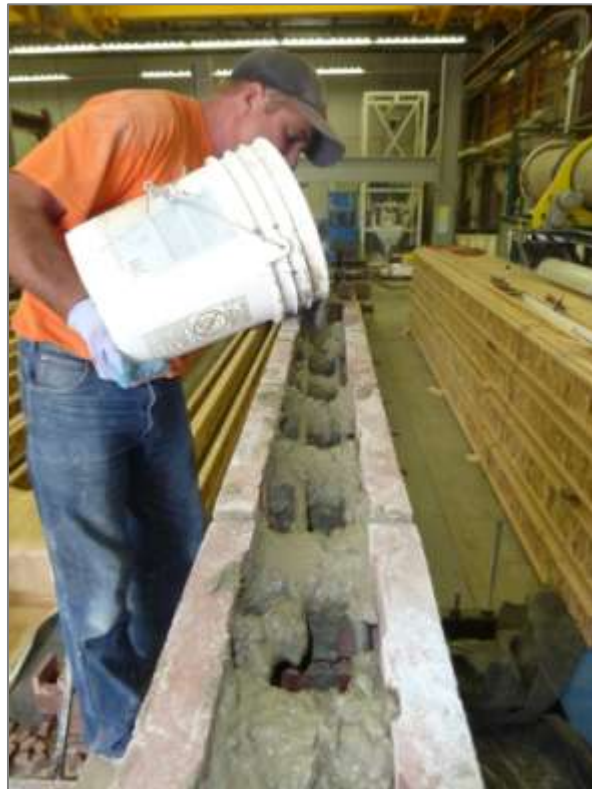
Figure 3.7: Construction Phase 2: Grouting

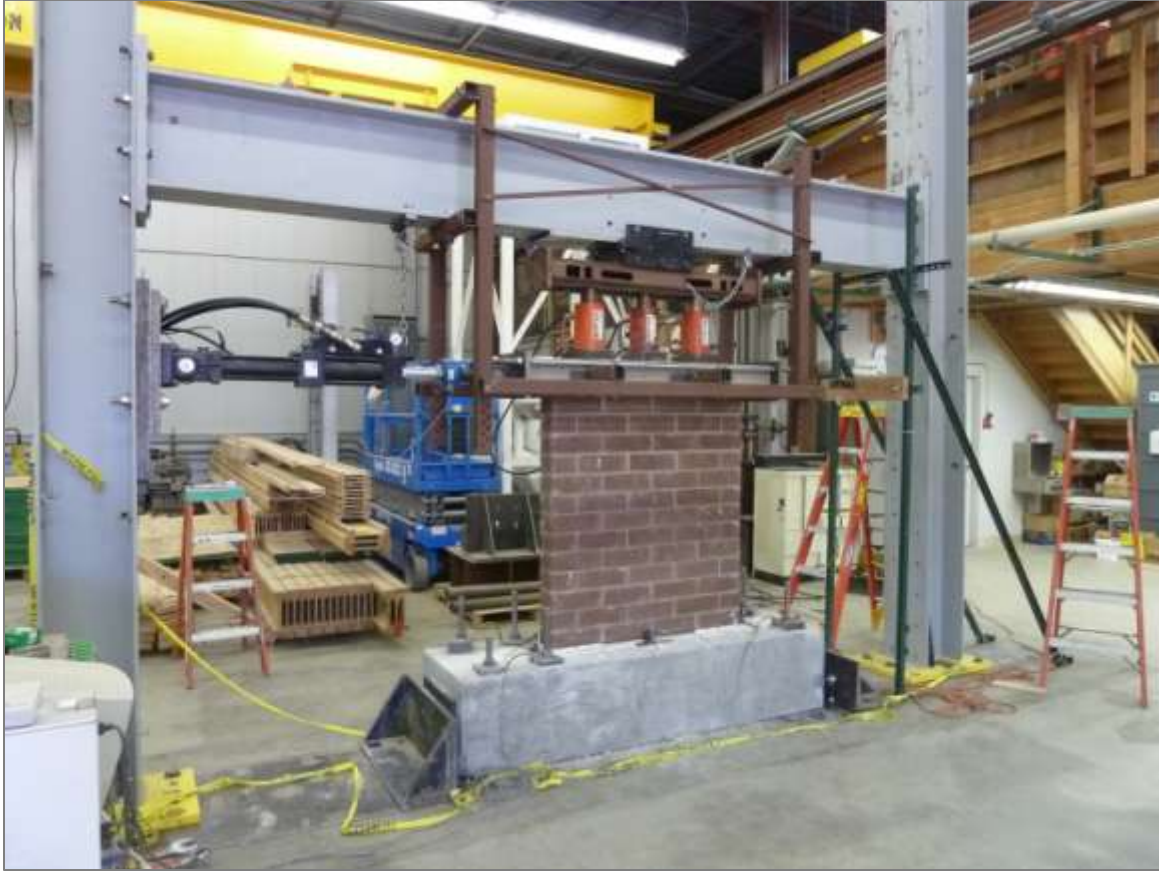
The 22-kip capacity hydraulic actuator was attached to a steel frame on one side and to the loading beam on the other side. Drilled steel plates were placed on the ends of the concrete loading beam and were then tightened with four 1-in. diameter rods. The test setup is shown in Figure 3.8 and Figure 3.9 (North direction on the left).

Figure 3.9: Test Setup

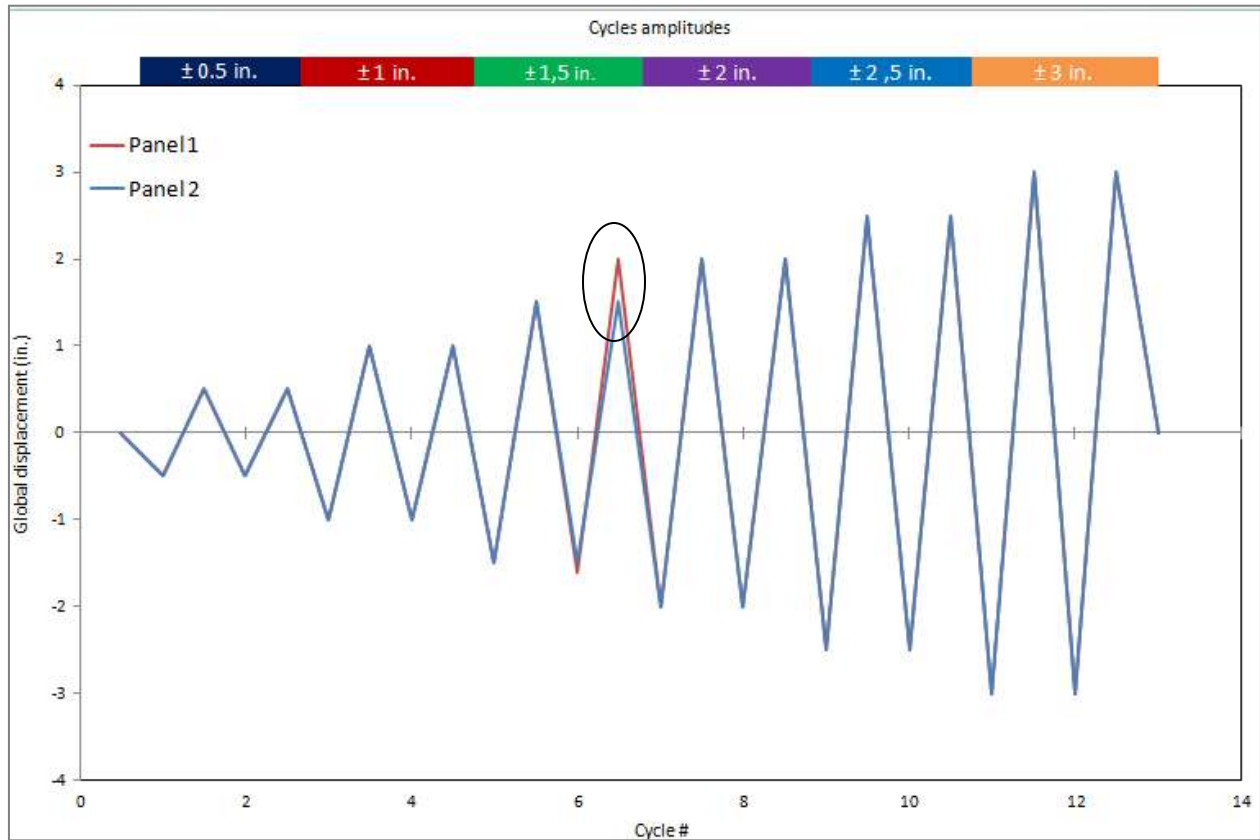
figure represents an error in the intended loading pattern whereby Panel 1 was pushed to 2 in. instead of 1.5 in. As will be evident in the later discussion of results, this error did not significantly impact the behavior of the specimen.

Figure 3.12: Loading Cycles

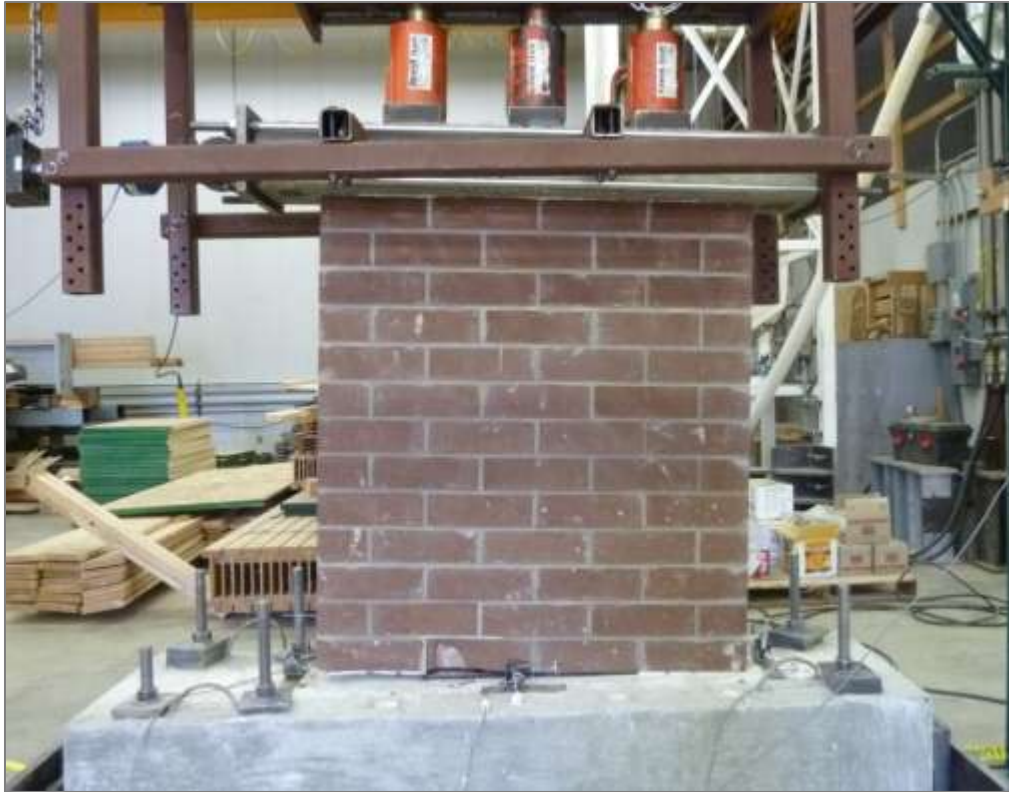
During testing, Panel 1 exhibited rocking behavior with little damage (see Figure 4.1 and Figure 4.2). At the end of testing, some cracks developed in the end of the panel and spalling of the faces of several bricks occurred on the West side as well as at the toes of the panel. Visual observations made during testing are listed in Table 4.1

Figure 4.1: Side View of Panel During Testing Showing Rocking Behavior

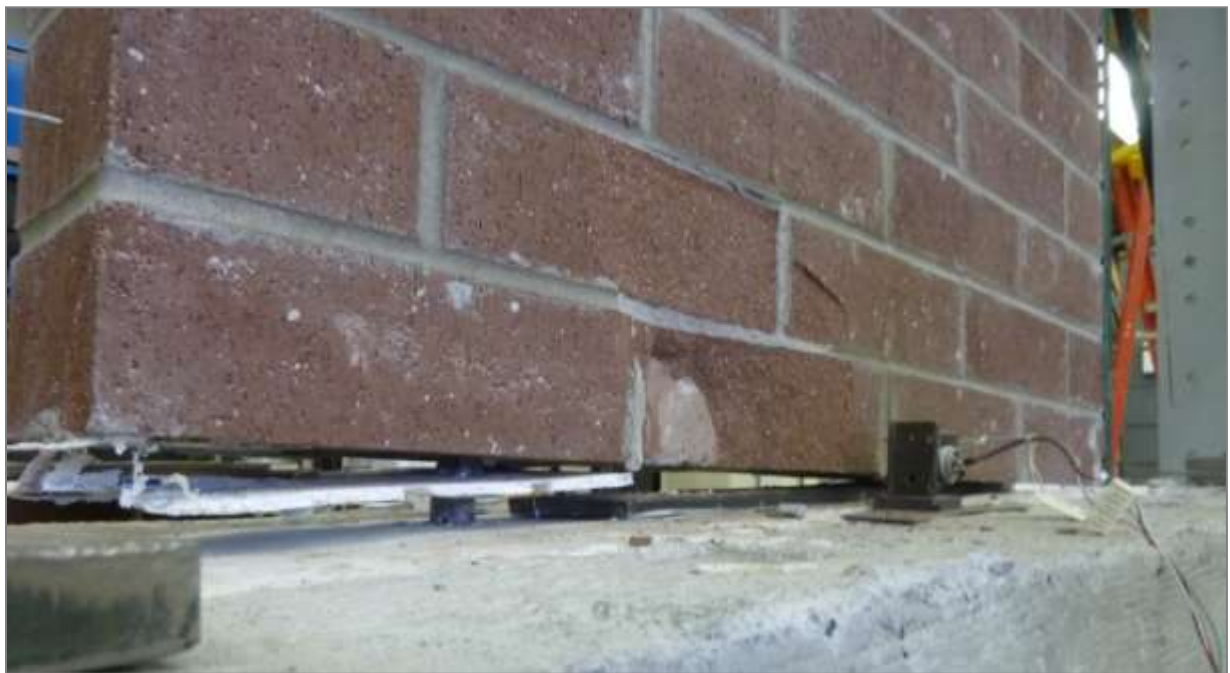
Figure 4.2: Rocking Behavior and Uplift of One End

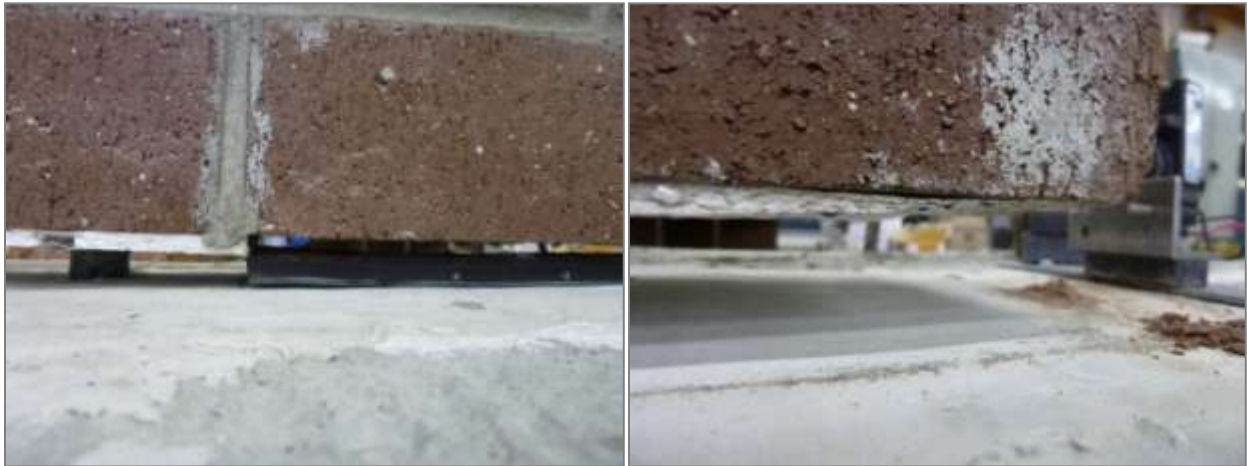
The uplift of the panel characterizing the rocking behavior is shown in Figure 4.3. Complete crushing of the foam is also shown in the figure; however, it can be seen that the foam remained intact.

Figure 4.3: Uplift of the North and South Ends of the Panel

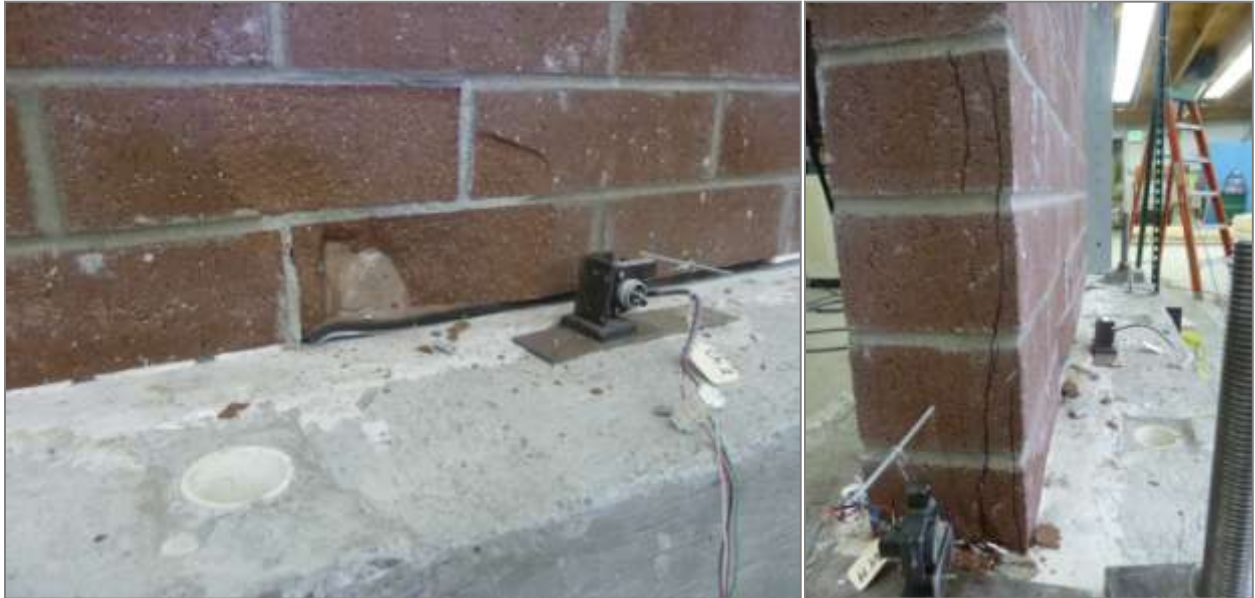
Only minor damage occurred to the panel as a result of inputting the lateral displacements.

Photos showing the observed damage are presented in Figure 4.4.

Figure 4.4: Damage to Panel 1

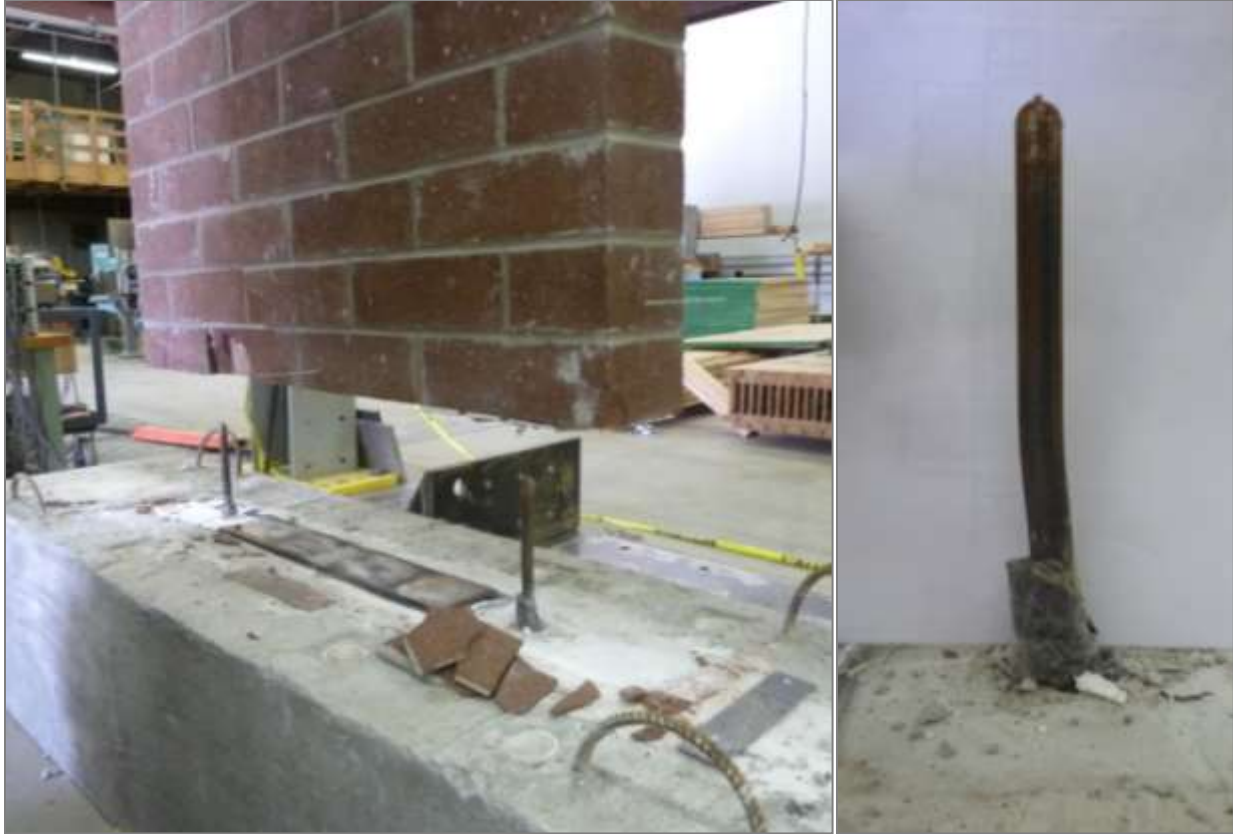
Photos of Panel 1 after completion of the test and removal of the panel from the footing are shown in Figure 4.5. No permanent damage was observed in the neoprene pad, but the steel dowels were bent at their base in a manner indicating shear yielding. The foam strips were compressed to a very thin sheet.

Figure 4.5: Photos showing Panel and Dowels at the End of the Test

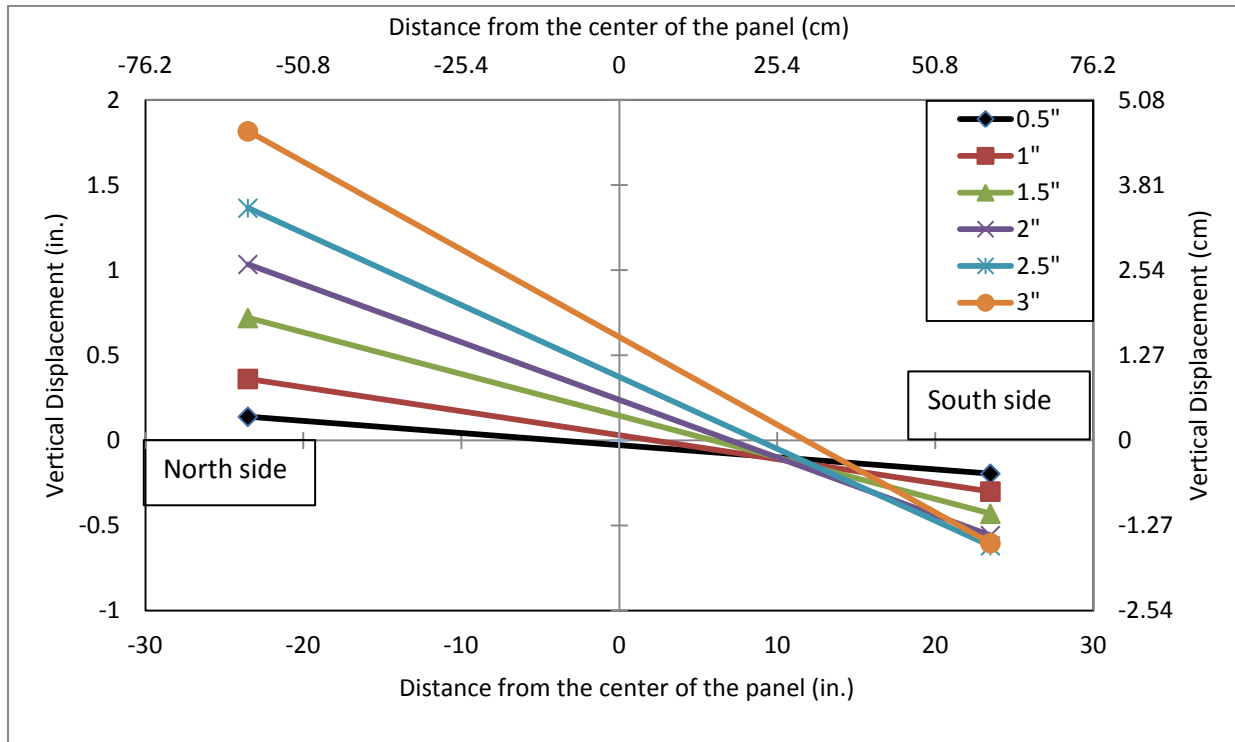
The vertical displacements measured by potentiometers P2 and P3 at the same time for peak displacements of pushing and pulling loading are provided in Figures 4.6 and 4.7. It can be seen in the figures that the center of rotation of the panel is located around 12 in. from the center of the panel (corresponding to $3/4$ of the panel length). This location is approximately at the interface of the neoprene pad and foam strip. It is evident that, when the panel rocks, the compression force on the neoprene is concentrated near the end of the neoprene pad.

Figure 4.6: Measured Vertical Displacements for Pushing

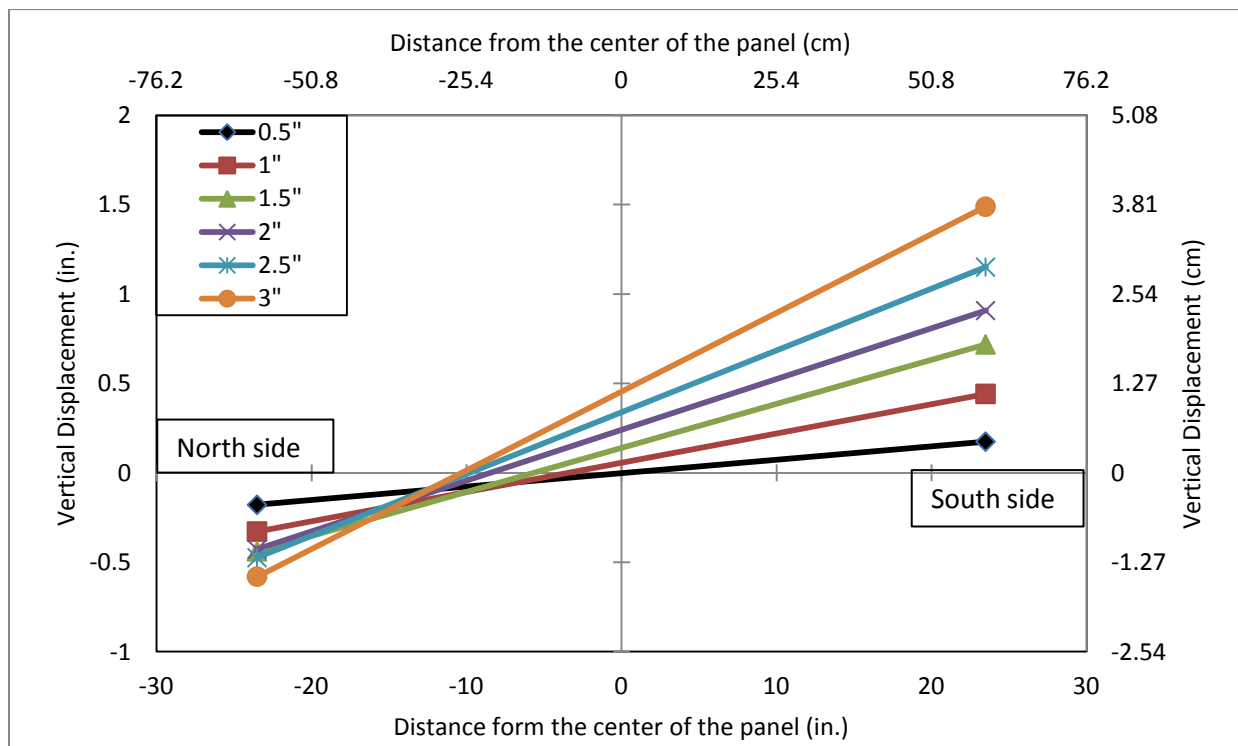
Figure 4.7: Measured Vertical Displacements for Pulling

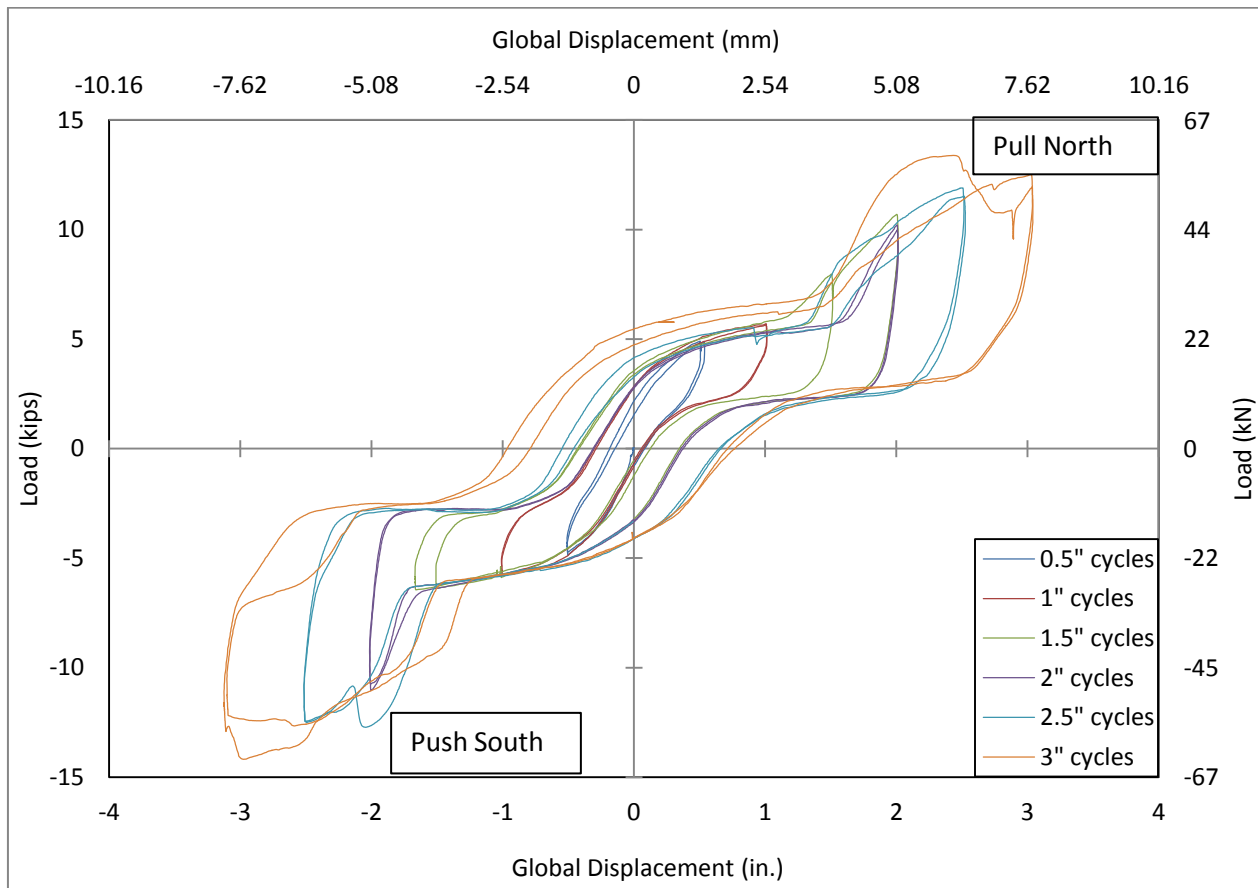
The load-displacement curves based on the global displacements of the panel (from Pot 4) are presented in Figure 4.8. The hysteresis curves are reasonably symmetric and show an approximately bilinear behavior, with a load plateau starting at around ± 0.5 in. (± 5 kips) and continuing until around ± 1.5 in. (± 6 kips). At displacements greater than 1.5 in., the specimen stiffens and the load increases above 6 kips to reach another load plateau around 13 kips. The areas under the curves are relatively small until stiffening of the panel begins.

Figure 4.8: Hysteresis Curve for Panel 1

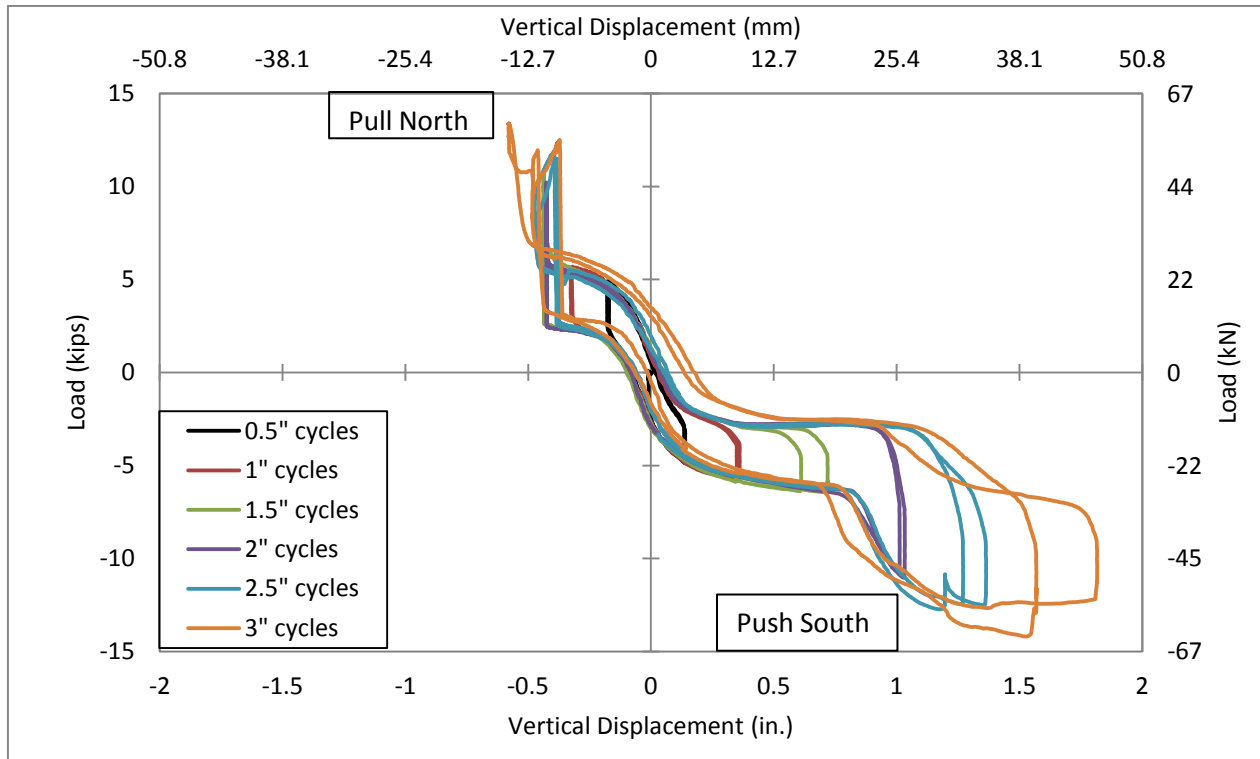
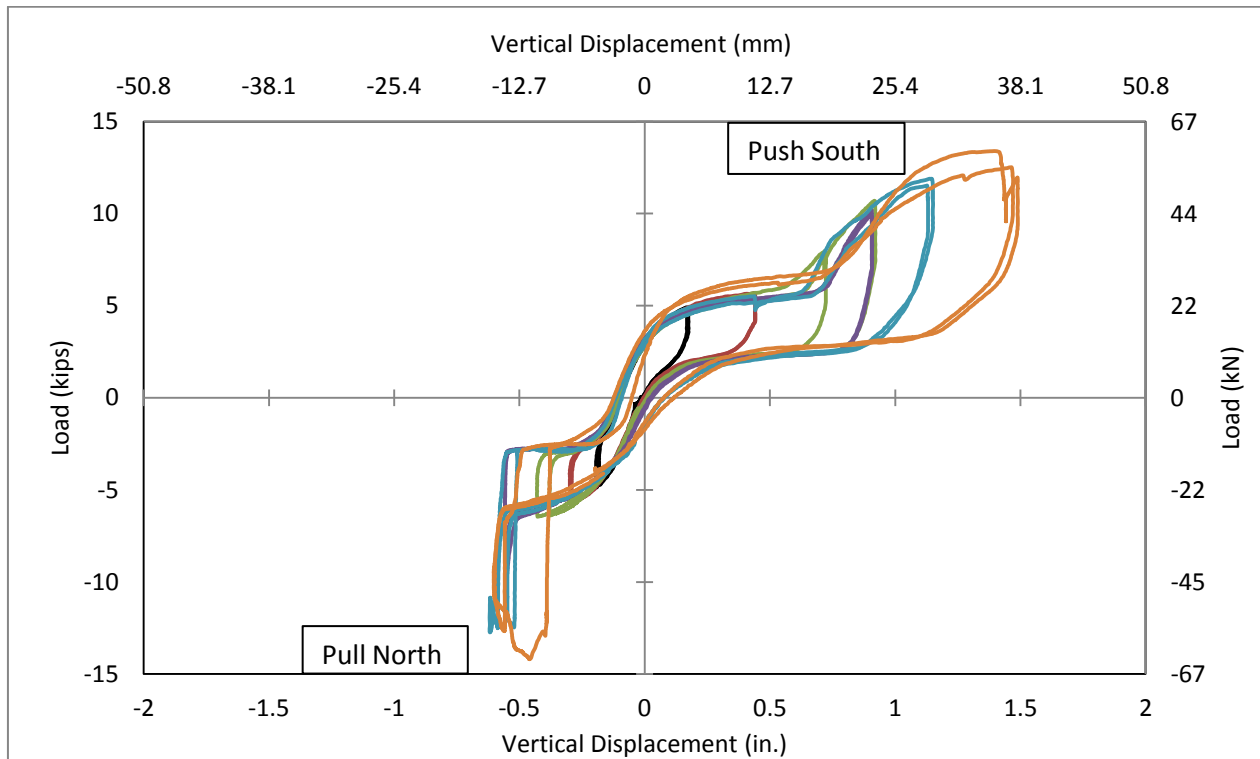
The initial compression displacement due to the engagement of the axial force (20 kips) was small with a value of 0.014 in.

Figure 4.9: Uplifting and Crushing of P2 (top) and P3 (bottom)

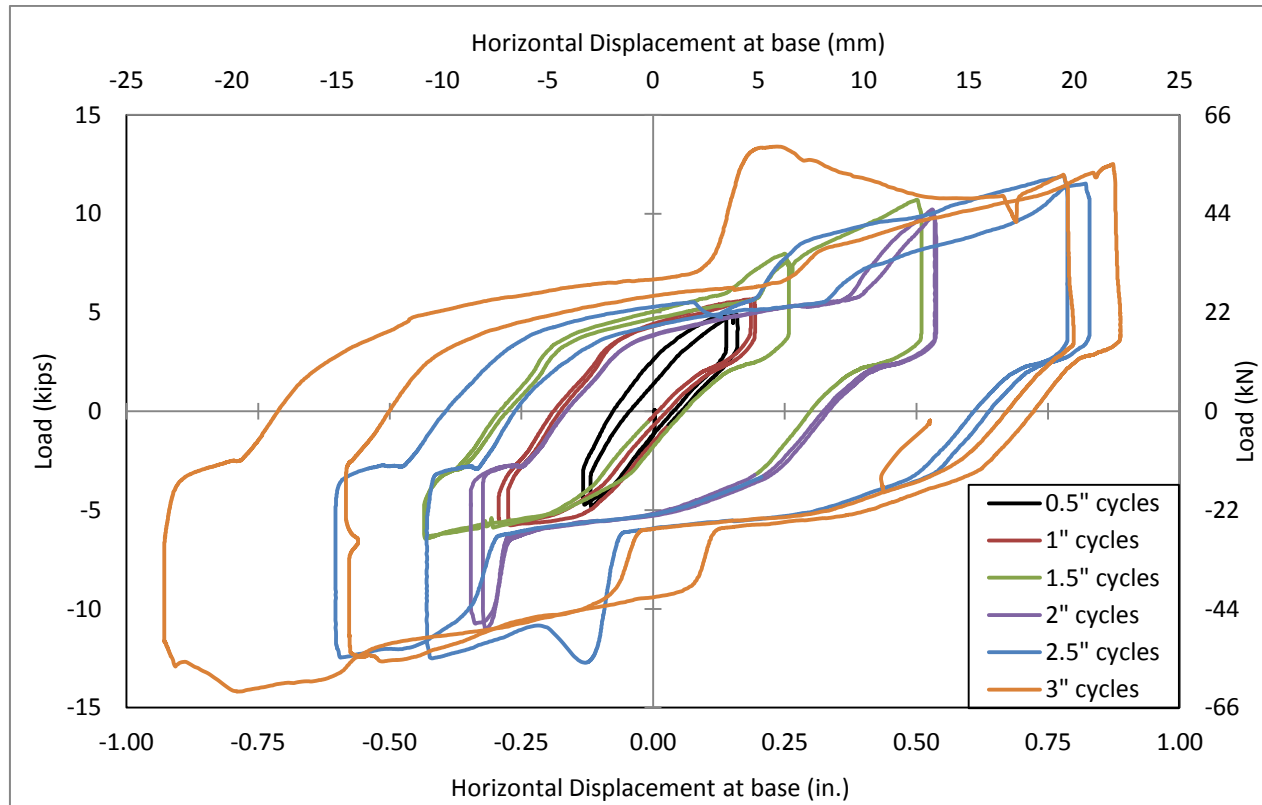
A plot of the measured horizontal displacements (sliding) of the panel vs. the applied horizontal loads is presented in Figure 4.10. The amount of sliding is small for low levels of applied lateral forces, but it becomes more significant as the applied load increases above 5 kips. The curves shown in Figure 4.10 are symmetric in both directions with a significant drop in applied load at the point of reversing the direction of loading. This drop in load is associated with friction between the neoprene pad and the panel as the load is reversed. A residual sliding displacement of about 0.5 in. was present at the end of testing. Note that, as mentioned before, the dowels were encircled with 0.25-in. thick insulation pipe foam, providing a gap between the grout and dowels. This gap needs to be compressed before engaging the dowels, which occurred during the 2.5 in. and 3 in. cycles. Also, when cycling to displacement levels of 2.5 in. and 3 in., an increase in load occurred just prior to 0.25 in. of displacement, followed by a load reduction. A possible explanation for this behavior is that, at larger displacements, the dowels had experienced plastic deformations introducing kinking and momentary locking of the dowels. The subsequent drop in load seen the curves occurs once the dowels begin to again slip vertically.

Figure 4.10: Sliding of Panel 1

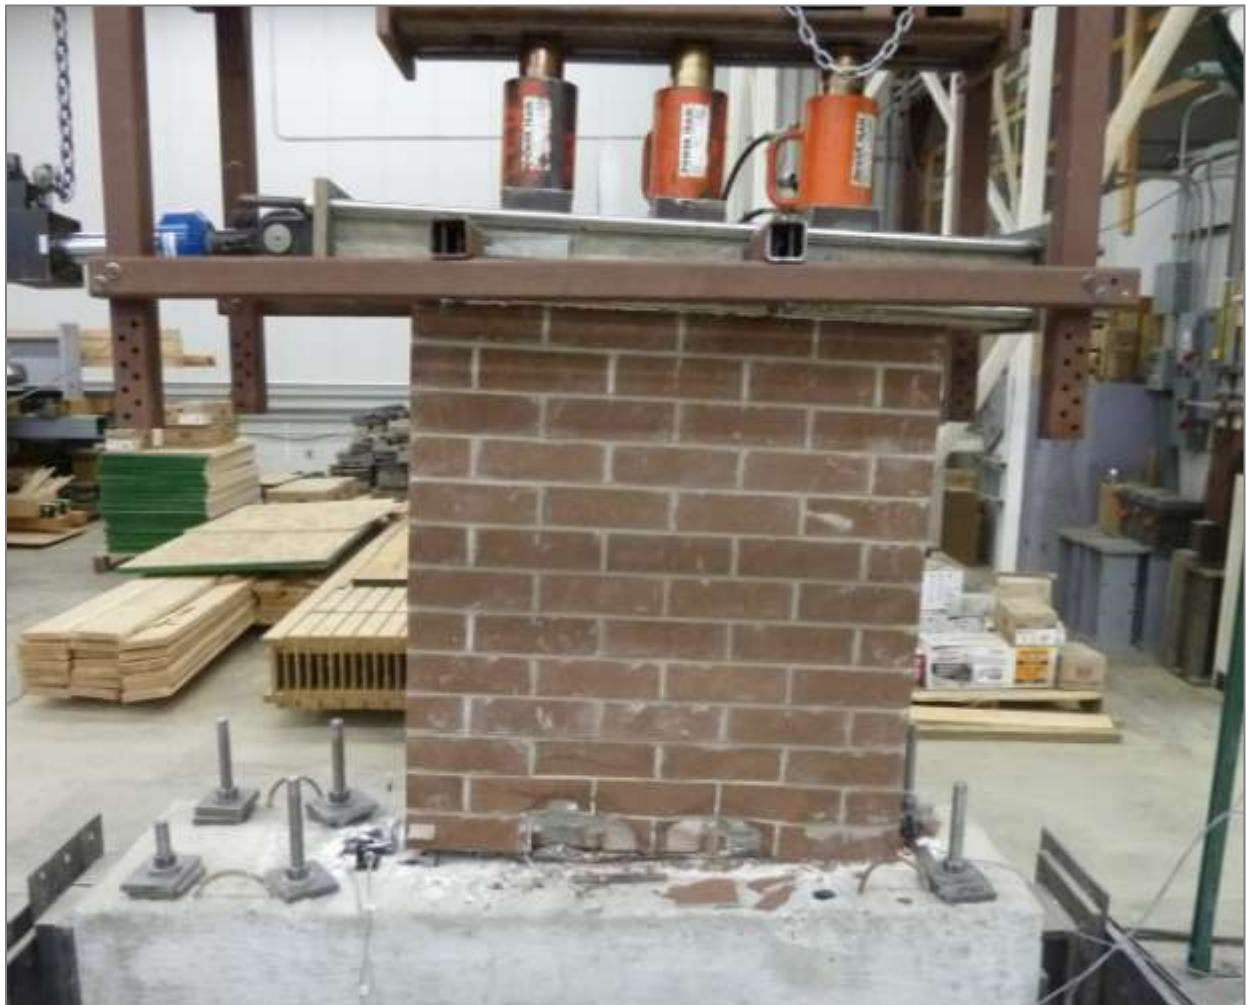
The rocking behavior of the panel at an advanced stage of the test is shown in Figure 4.12.

Figure 4.12: Rocking of Panel 2

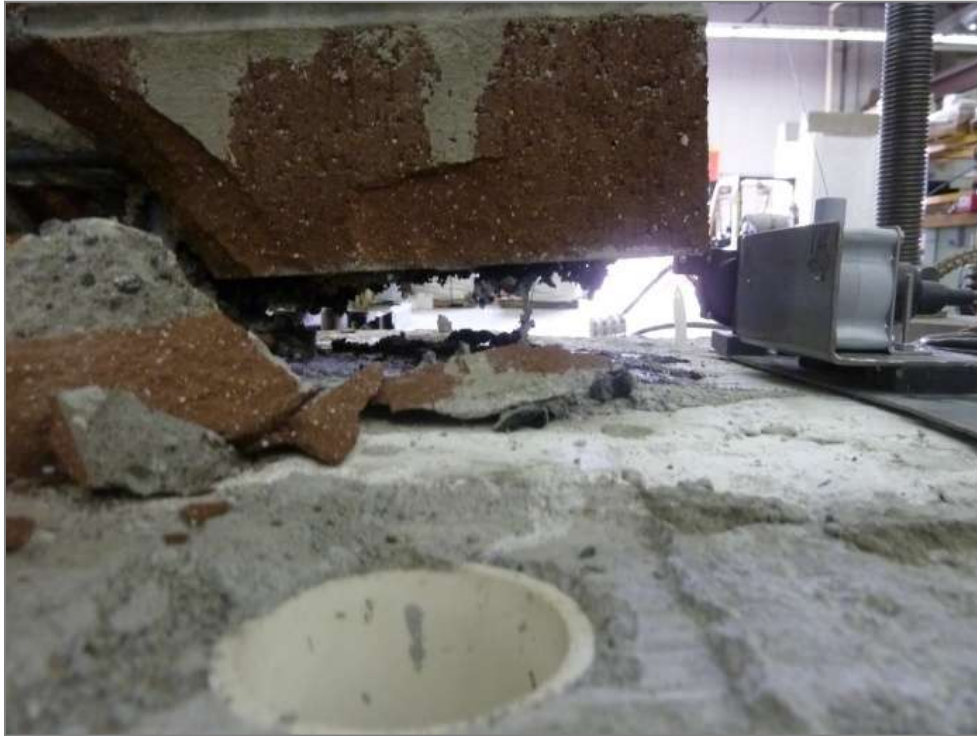
The uplift and damage at the North toe is shown in Figure 4.13. It is clear that the toe is significantly uplifting. In addition, the behavior of the foam strips was different than for the first specimen. While both types of foam were fully compressed, the CCNS broke into pieces.

Figure 4.13: Uplift at North Toe

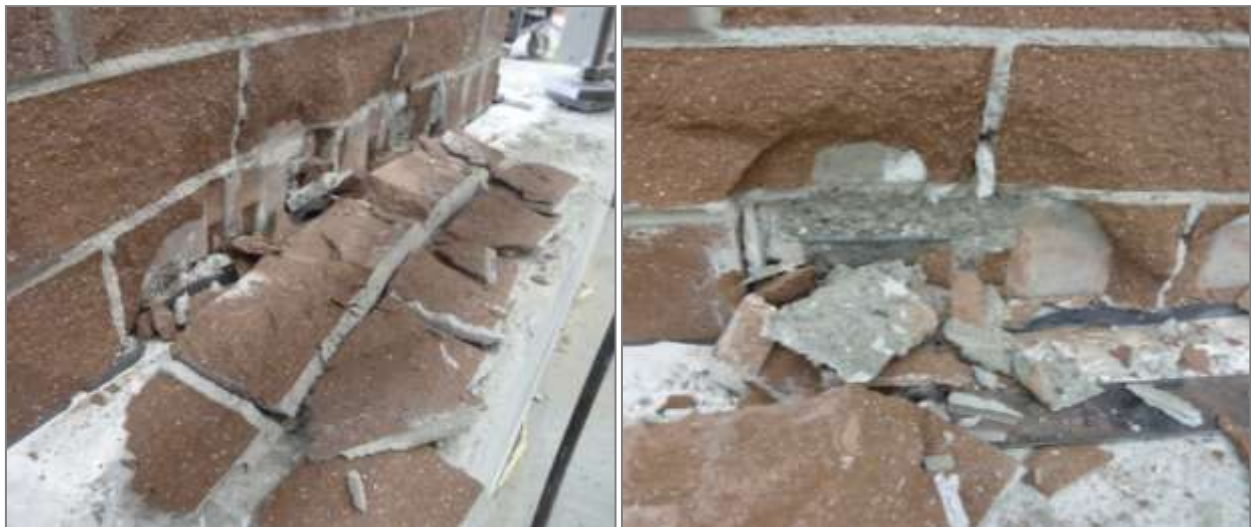
The spalling of the panel at both the East and West sides is shown in Figure 4.14.

Figure 4.14: Spalling on East (left) and West (right)

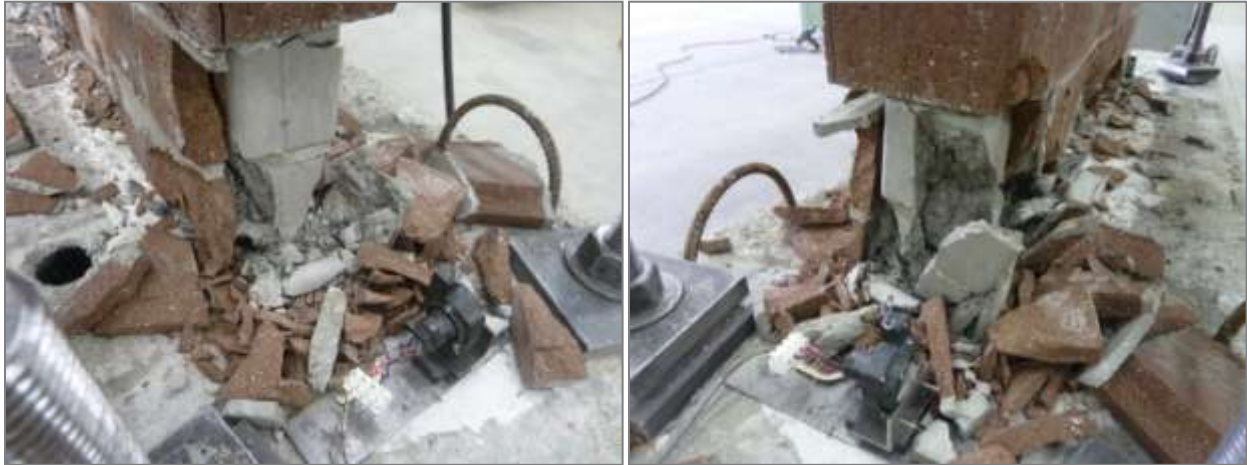
The crushing of the South toe is shown in Figure 4.15. Cracking first occurred in the brick units, followed by spalling of the bricks, and then crushing and spalling of the grout. Large residual vertical and sliding displacements were present in Panel 2 at the end of testing.

Figure 4.15: Toe Crushing at South Toe

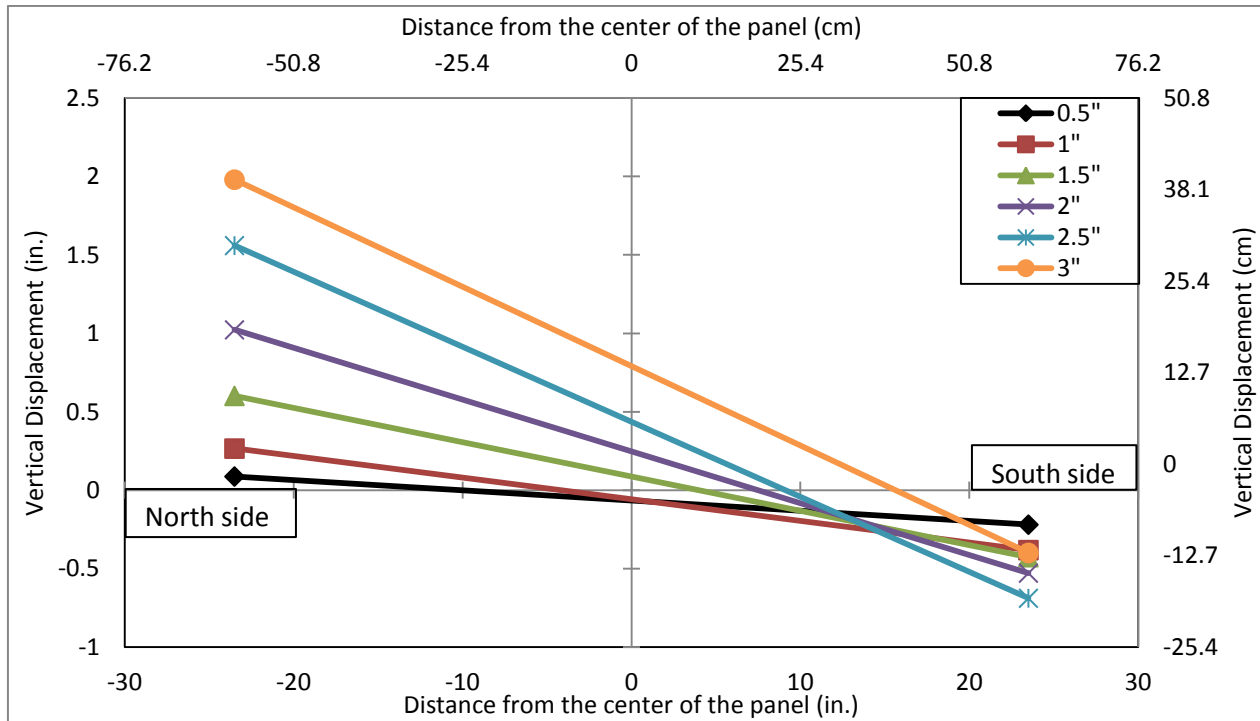
Figure 4.17: Measured Vertical Displacements for Pushing

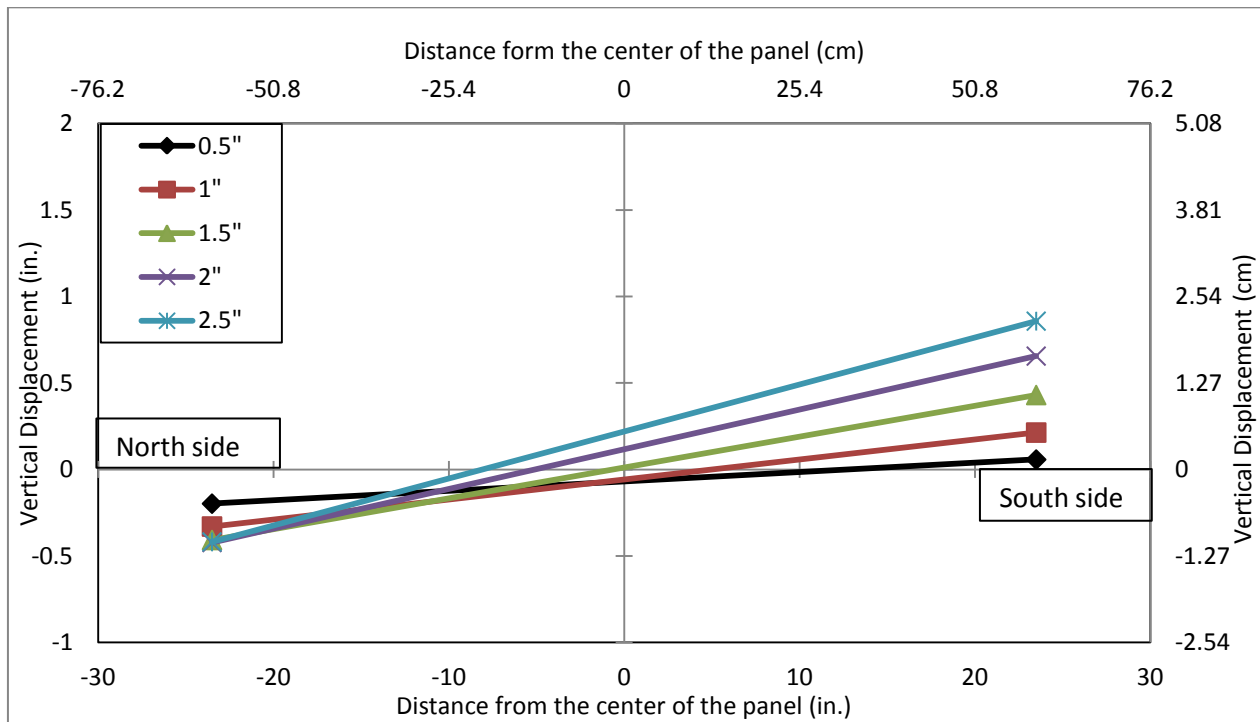
Results for the 3 in. curve are not displayed in Figure 4.18 because of the loss of P3 due to toe crushing. However, it seems that the center of rotation did not move during pulling. It stayed at around 12 in. from the center ($3/4$ of the wall length) because minimal damage was experienced at the North toe.

Figure 4.18: Measured Vertical Displacements for Pulling

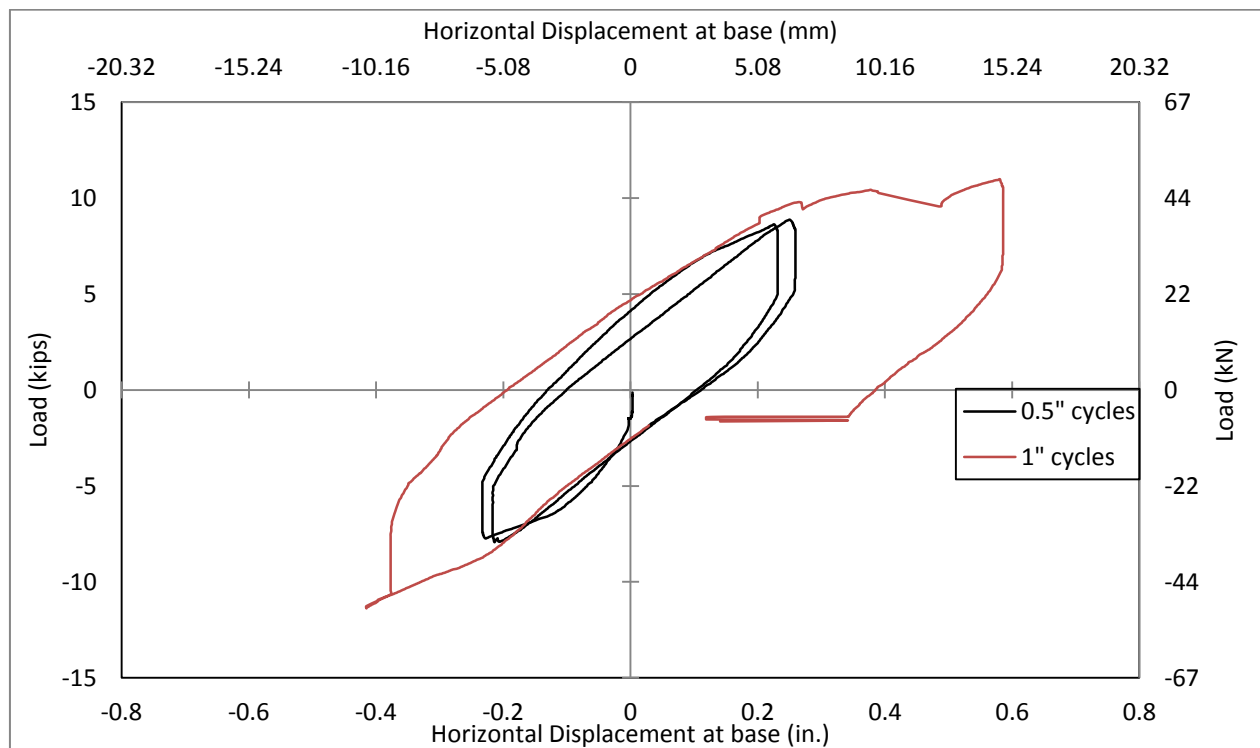
The sliding displacements until the loss of the potentiometer are shown in Figure 4.21. Symmetrical curves are shown for the 0.5 in. displacement cycles. At the half cycle of 1 in. symmetry is lost. This can be seen with the 0.6 in. offset as opposed to the 0.4 in. symmetric offset. Due to damage and sliding, no self-centering is observed after this point.

Figure 4.21: Sliding of Panel 2

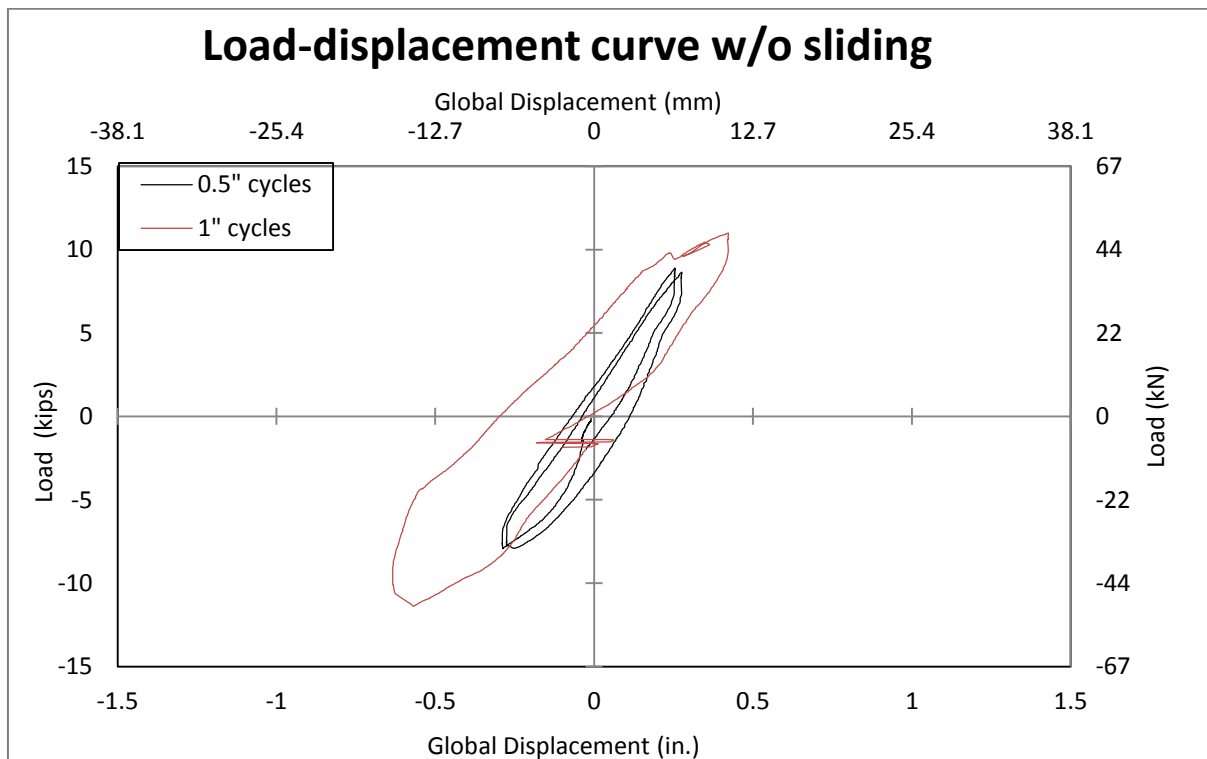
- For the 0.5 in. cycles, peaks are at ± 0.26 in. when sliding is removed
- For the first 1 in. cycle, the extreme values are ± 1 in. with sliding and ± 0.5 in. without sliding corresponding to the compression of the foam around the dowels.

Figure 4.22: Comparison between the Load-Displacement Curves

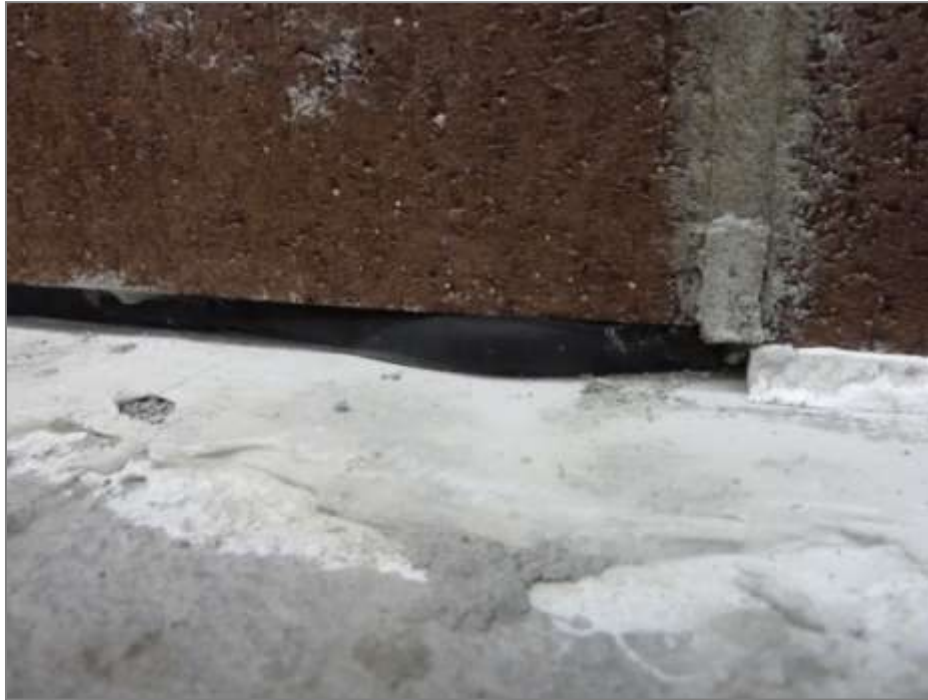
Figure 5.4: Lateral Expansion of Neoprene

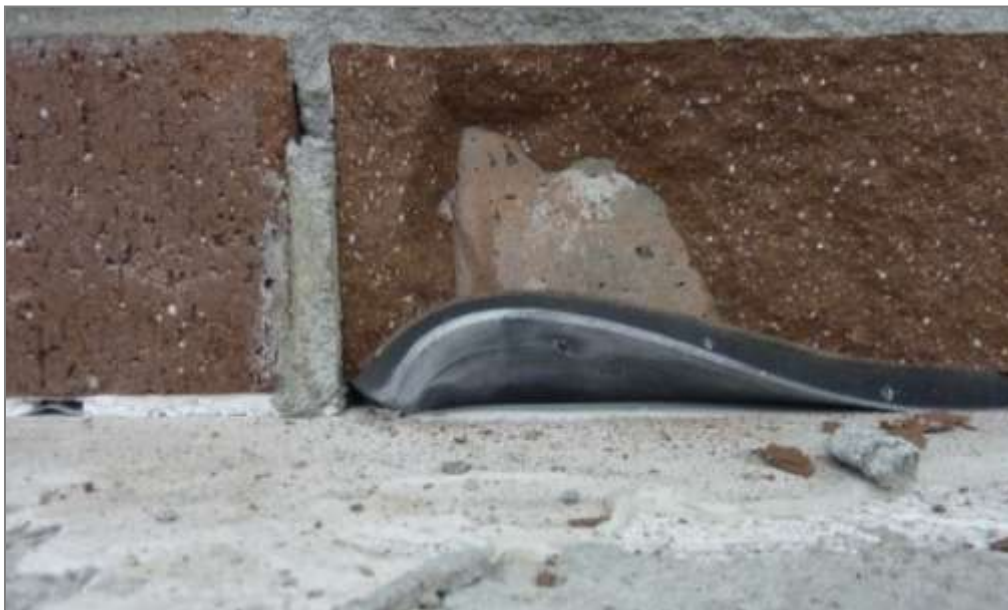
Figure 5.5: Neoprene Deformation in Panel 1
