EVALUATION OF ISOLATION DETAILS TO ENABLE ROCKING IN
A MASONRY VENEER PANEL

A thesis submitted in partial fulfillment of
the requirements for the degree of

MASTER OF SCIENCE IN CIVIL ENGINEERING

WASHINGTON STATE UNIVERSITY
Department of Civil and Environmental Engineering

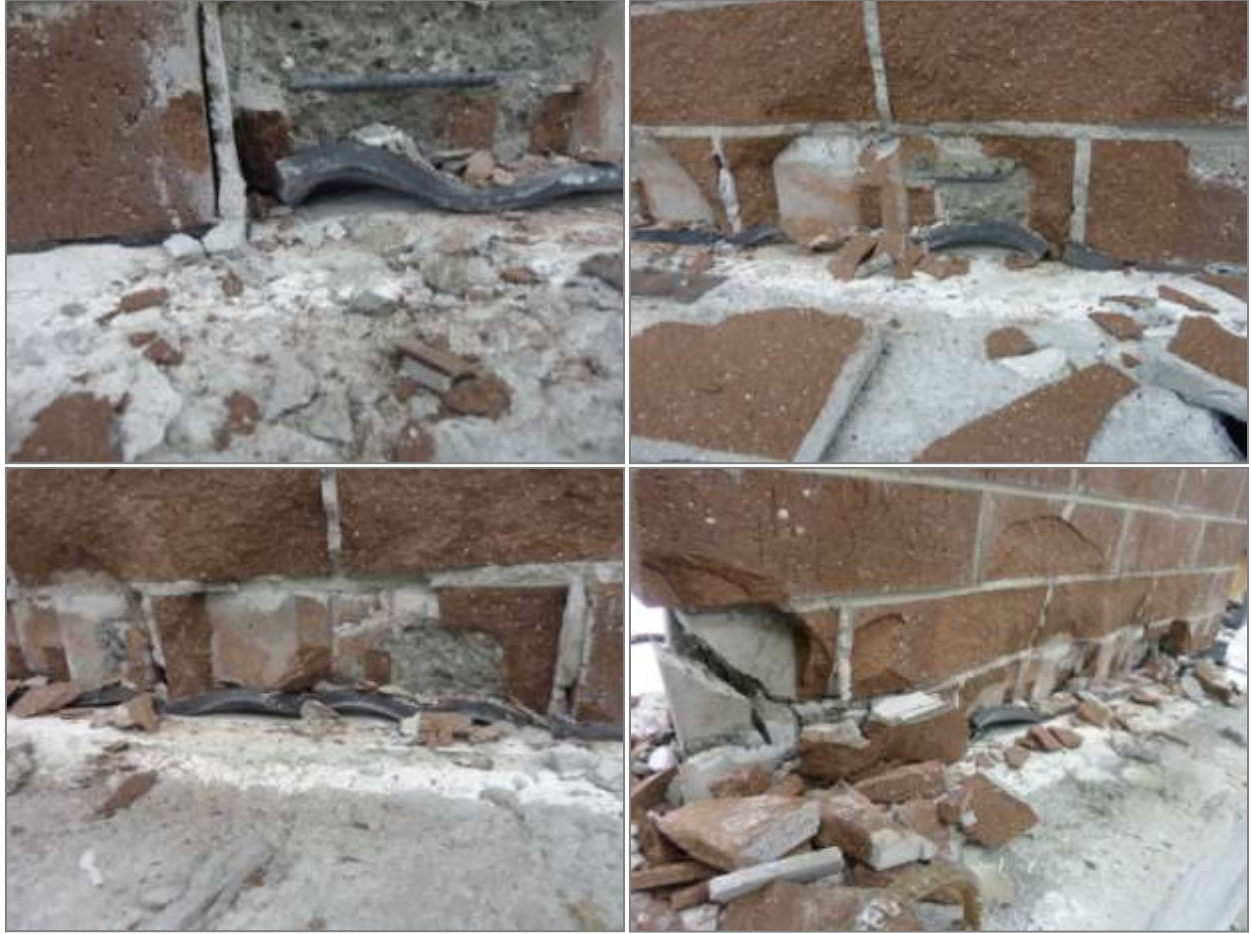
Figure 5.6: Neoprene Friction Reaction in Panel 2
