STRUCTURAL DESIGN AND PERFORMANCE OF COMPOSITE
WALL-FOUNDATION CONNECTOR ELEMENTS

A thesis submitted in partial fulfillment of
the requirements for the degree of

WASHINGTON STATE UNIVERSITY
Department of Civil and Environmental Engineering

AUGUST 2005

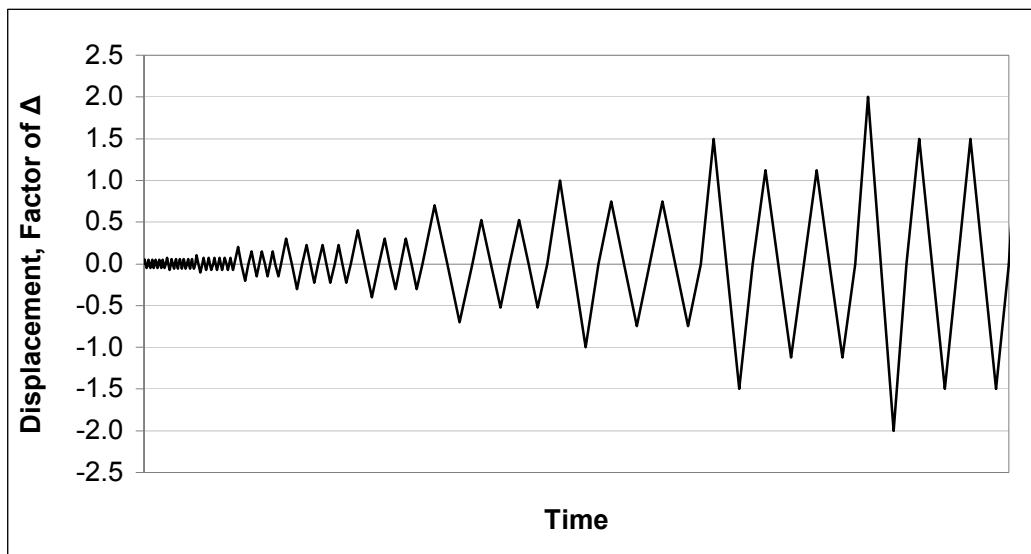
Figure 2.16 CUREE loading protocol

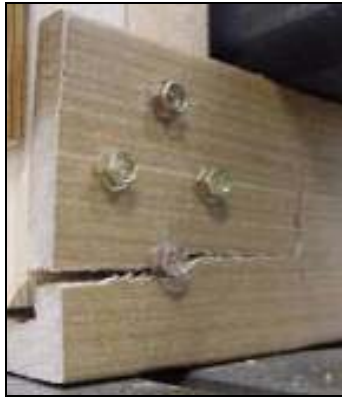
to-extrusion direction. It is at this bottom fastener where no fasteners are below to put compressive forces on this weak plane.

Figure 3.1 Typical failure path in connection tests (Specimen 4 shown)

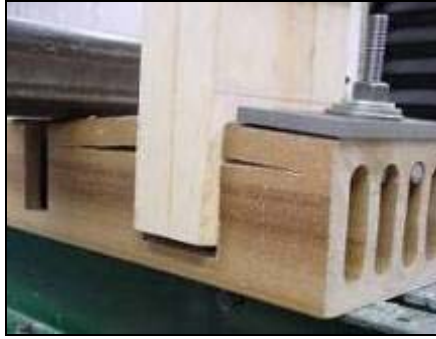
Figure 3.2 Failure perpendicular-to-extrusion between flange and webs from uplift force transferred to dowels

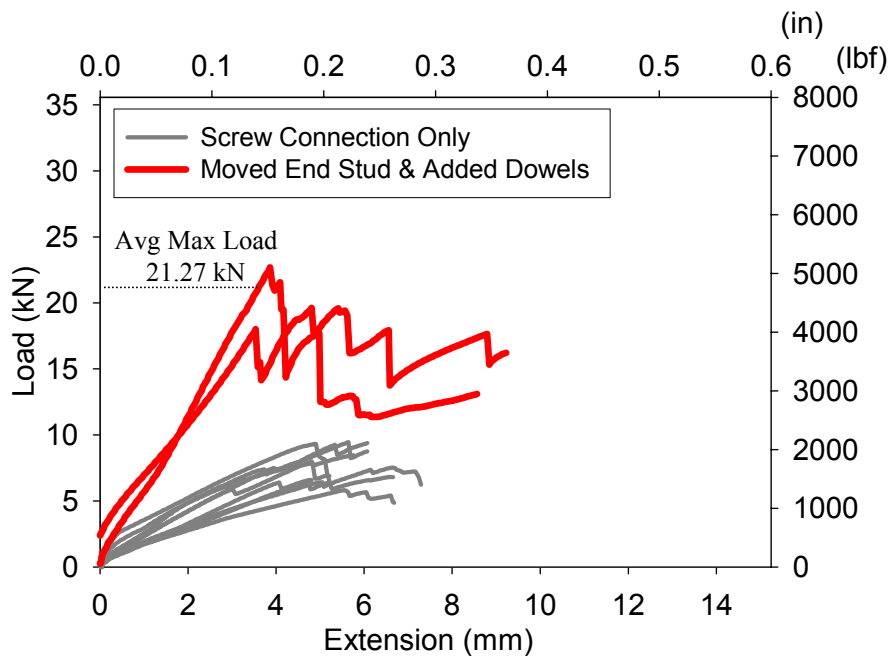
Figure 3.3 Comparison of load-deflection behavior from moving end stud position and adding dowels

Substantial changes in load-deflection behavior occurred when changing the end stud configuration from its traditional end-of-sill location. This can be seen in the load-deflection response in Figure 3.3. From having a symmetric connection to the stud, transferring the load from both stud faces as well as being centered in the width, the connection stiffness increased dramatically—triple that of connections between the stud and only the sidewall. Load capacities also doubled, likely due to engaging the full sill plate section rather than solely the sidewall. Subsequently, the work done by the connection more than doubled. The range of deflection capacities were similar to traditionally located end studs, as the load capacity increase was coupled with increased stiffness. Though, due to small changes in the deflections at peak and failure loads, the ductility increased with switching configurations (by approximately 15%). The largest increase in ductility and work done by the connection was when dowels were located in the center of the section, most efficiently transferring uplift force to the anchor bolt washer and into the foundation (minimizing the load path). The configuration in this specimen (#14) also included a plate washer which helped delay failure and allow dowel yielding, so the exact contribution of dowel location towards ductility and work done cannot be identified.

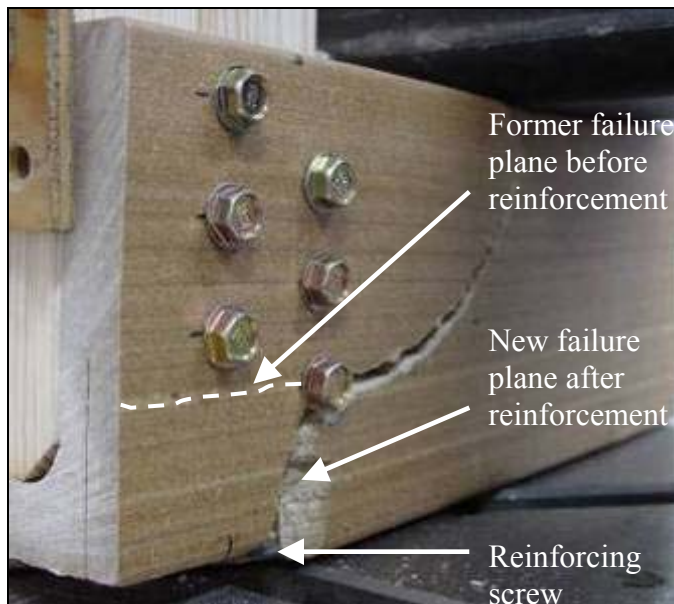
Figure 3.4 Reinforced sill failure photo (Specimen 10)

The effects of reinforcing were apparent in changing failure modes. The failure was most likely shifted to the next weak point in the connection system. For reinforced sidewalls, the failure along the strands at the end of the sill was eliminated. Instead, the failure initiates at the stress concentration the reinforcing screw creates and propagates up the section as before. This change in failure is shown in Figure 3.4. For the section reinforced with fiberglass/PP tape, the ultimate failure still occurred along the line of the bottom fastener, though it was delayed as the bond strength between the tape and sill had to be attained first. For those reinforced locations between the flange and webs in the sills in shifted configurations, the failure mode switched to flexural failure at the end stud location. Local crushing around reinforcing screws also occurred from the bending caused by the upward force of the dowels underneath the flange. Essentially, the shifted configuration with screw reinforcement eliminated the weakness perpendicular-to-extrusion in the section.

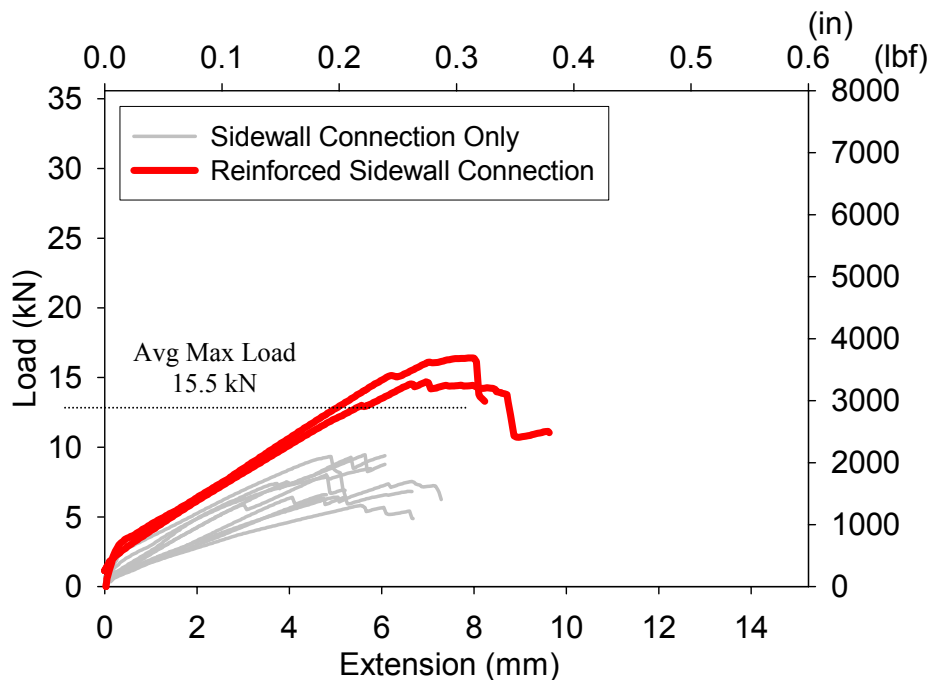
Figure 3.5 Effects of reinforcing sidewall connection

Reinforcing the sidewall connection created a better performing connection as shown in the load-deflection plots in Figure 3.5. Loads doubled and the work done almost tripled. Stiffness of the connection increased as tension loads were transferred to stiff screws and reinforcing tape, reducing the amount of separation between section strands. The maximum deflection capacity increased by 30%, with slightly higher increases in ultimate deflection capacities, thus improving ductility in the connection (approximately 10% increases—greatest for connections with tape reinforcing).

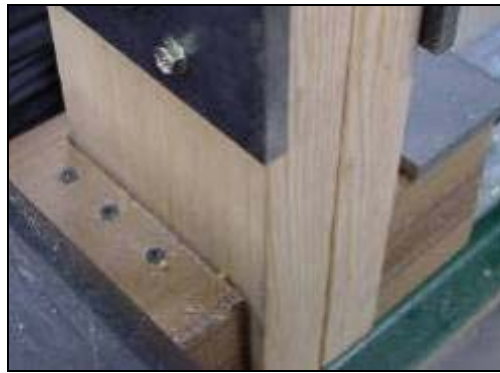
Figure 3.6 Perpendicular-to-extrusion screw reinforcement between flange and webs

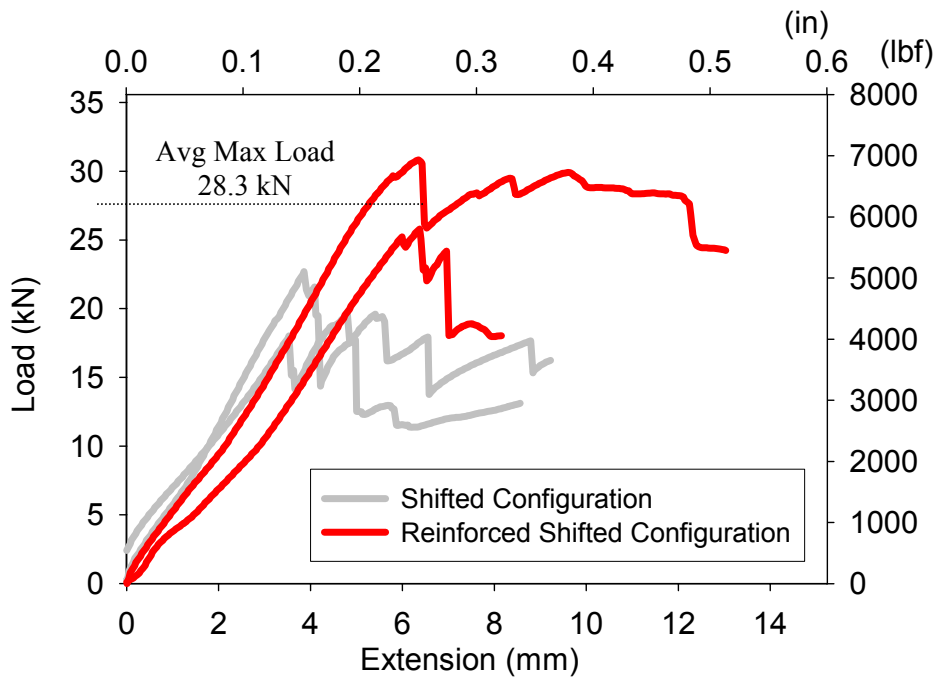
Figure 3.7 Effects of reinforcing top flange to web

increased (by 50%) and the work done increased by 2.5 times. This particular location of reinforcement did not affect stiffness dramatically, but increased the deflection at peak load by 30% and more substantially at failure. Therefore, increases in ductility reached 25%, creating more ideal connection behavior. The improvements in behavior from this reinforcing applied to the sidewall is illustrated in Figure 3.5, and that applied to the shifted configuration can be seen in Figure 3.7.

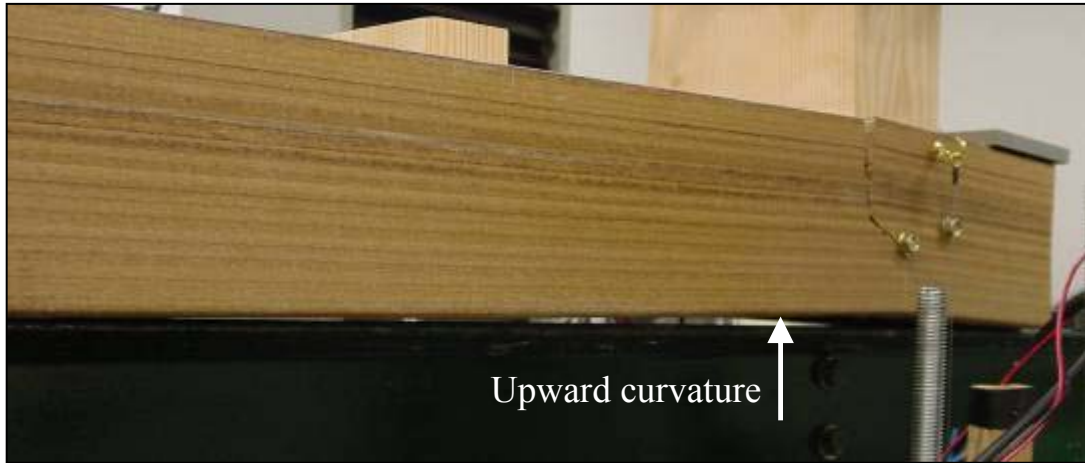
Figure 3.8 Beam bending in component tests from dowel uplift

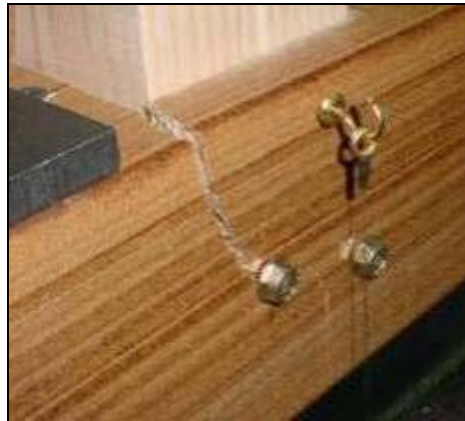
Figure 3.9 Typical component test flexural failure at end stud slot

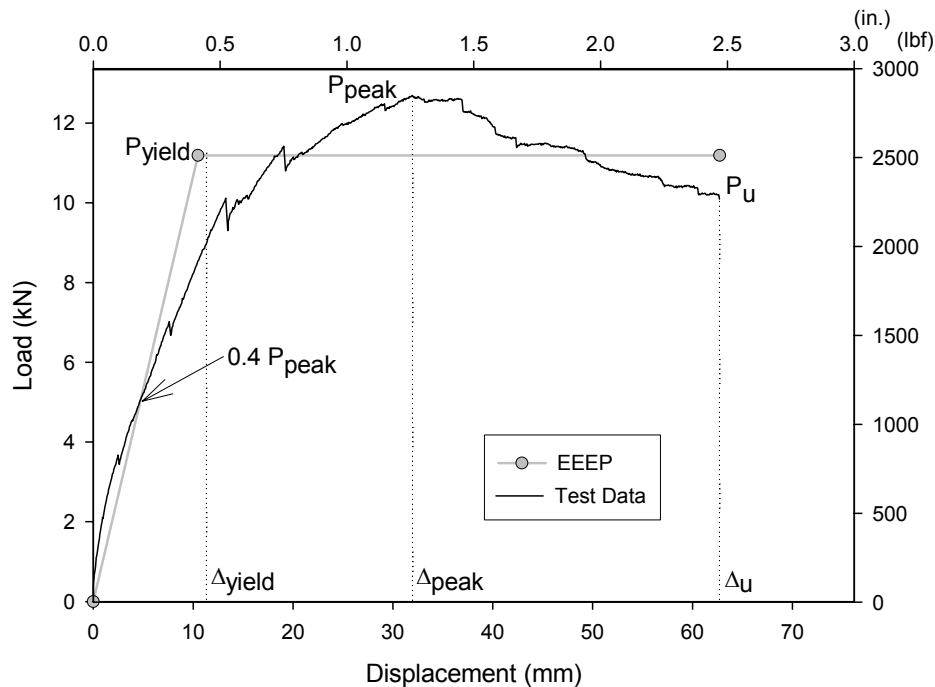
Figure 4.1 Response curve of monotonic wall test with traditional pressure-treated sill plate (WOOD4-M)

The response curve for Test WOOD4-M, having the traditional treated-lumber sill plate, is shown in Figure 4.1, along with the derived EEEP curve. Walls with wood sill plates reached a maximum absolute load of 12.7-kN (2849-lbf) with a corresponding displacement of 32-mm (1.26-in). This resulted in an ultimate shear capacity of 5.2 kN/m (356 lbf/ft). Failure occurred at a displacement of 63-mm (2.47-in), dissipating 643 kN-mm (5693 lbf-in) of energy. The elastic shear stiffness, k_e , equaled 1.1 kN/mm (6094 lbf/in).

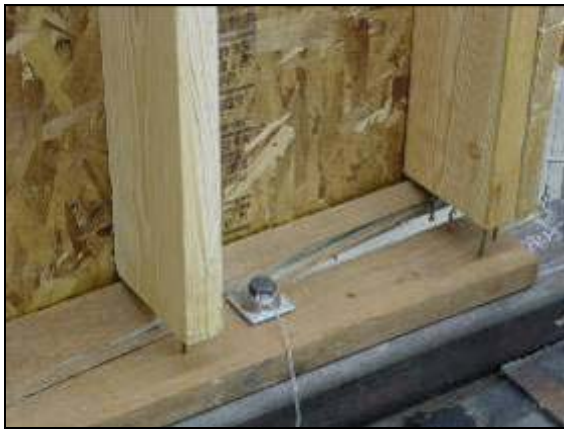
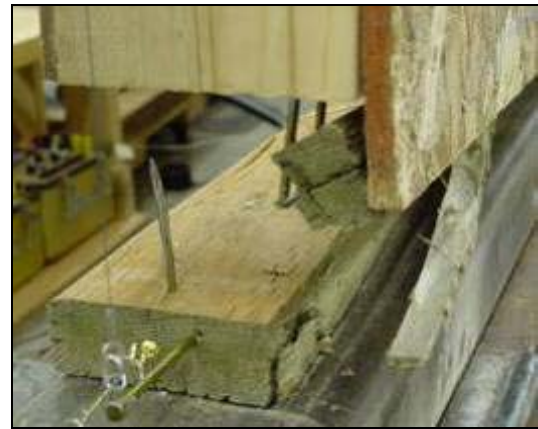
When loaded to failure, the wall exhibited rigid body rotation around the corner opposite load application, a typical response for walls without hold-down restraint. Sheathing and studs “unzipped” from the sill, beginning at the loaded end. Bottom sheathing nails bent and slightly withdrew from the sill. Failure occurred in the sill plate, splitting the entire length, down the line of plate washer edges, illustrated in Figure 4.2.

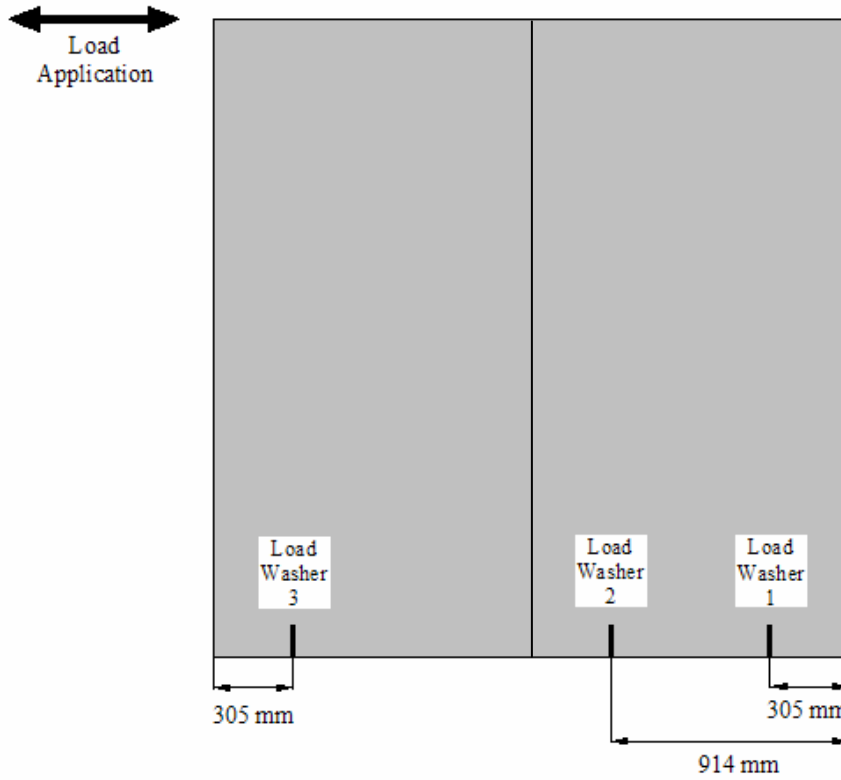
Figure 4.3 Load washer placement for WOOD4, PE3, and PP5

Load cell washers (LW) were installed at three of the four anchor bolts, as illustrated in Figure 4.3. Data shown in Figure 4.4 from load cell washers illustrates the distribution of forces throughout the test. Test 1-M results were predictable, with the load distribution attenuated from the load application to LW3, to LW2, and to LW1, where LW3 is located 12-inches from the loaded end, LW2 is 24-inches from the end and LW1 is 12-inches from the compression end. As load drops occur in the wall response, the percentage of load that LW3 carries is shifted to LW2. It is not until post-peak when the sill has split along the length that LW1 carries any load.

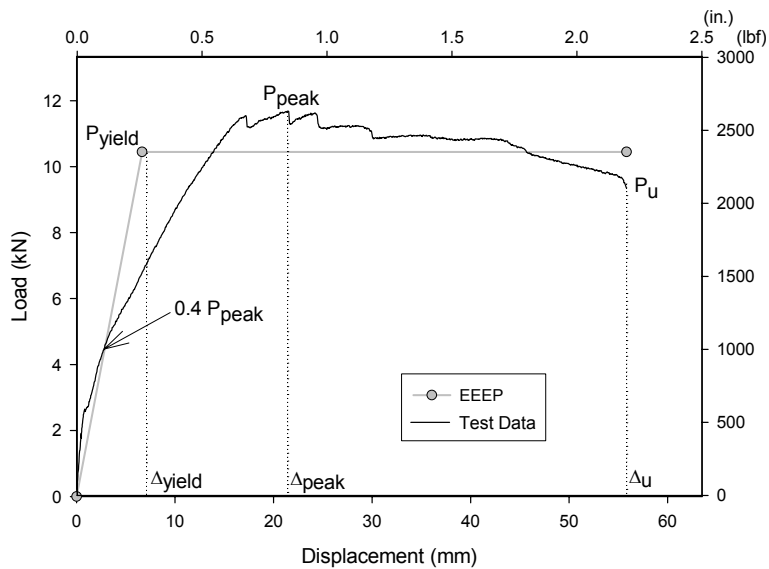
Figure 4.5 Response curve of monotonic wall test with solid polyethylene sill plate (PE3-M)

The response curve for Test PE3-M, having the solid polyethylene sill plate, is shown in Figure 4.5, along with the derived EEEP curve. Walls with solid polyethylene composite sill plates reached a maximum absolute load of 11.7-kN (2632-lbf) with a corresponding displacement of 21-mm (0.84-in). This resulted in a shear capacity of 4.8 kN/m (329 lbf/ft). Failure occurred at a displacement of 56-mm (2.20-in), dissipating 548 kN-mm (4853 lbf-in) of energy. The elastic shear stiffness, k_e , equaled 1.6 kN/mm (8939 lbf/in).

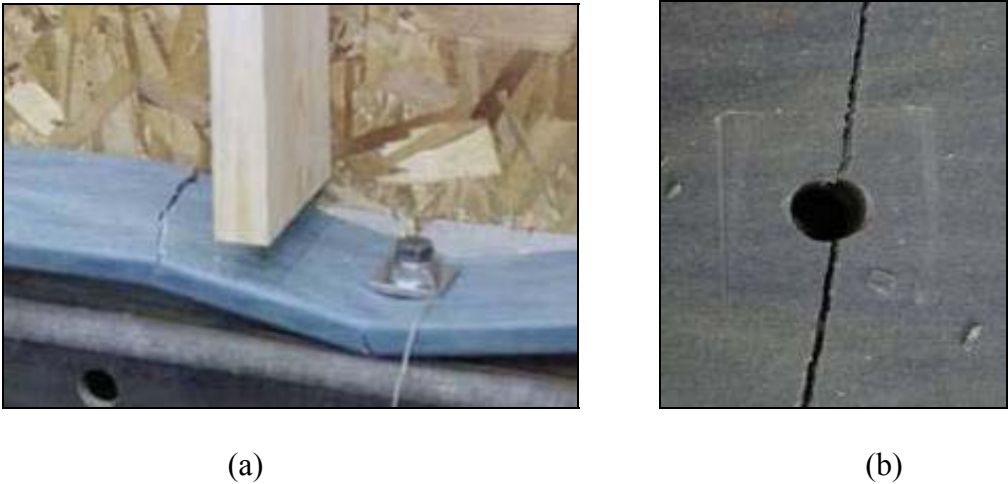
Figure 4.6 Sill failures: (a) Sill bending and flexural cracking at anchor bolt nearest loaded end stud, and (b) Plate washer indentation and anchor bolt hole size increase from bearing

bolt locations as the sill was unable to displace with the sheathing. Figures 4.6a and 4.7 illustrate the failures at locations of maximum curvature and stress. Slight indentation into sill material from plate washers and elongated holes from bearing forces of anchor bolts is shown in Figure 5.5b. The different displacement pattern of the sill plate (when compared to the traditional wood sill plate) can be attributed to the lower bending stiffness of the wood-plastic member and the higher nail holding power of the material. This caused the uplift to be distributed along the length of the wall more than was observed in the traditional wall.

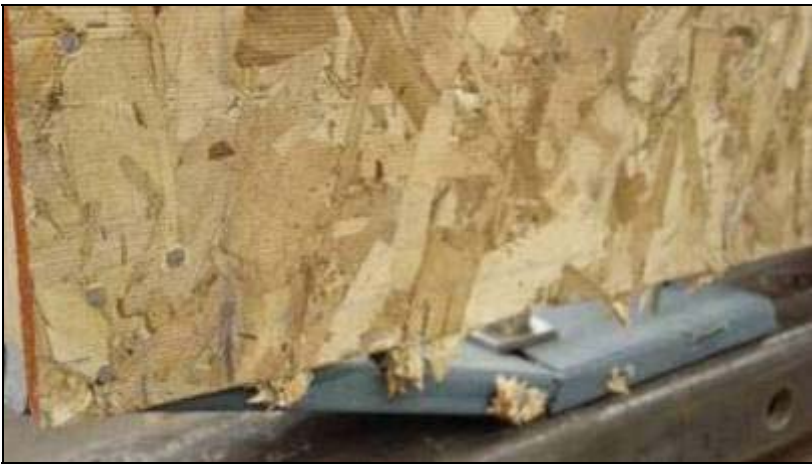
Figure 4.7 Nail bending and tear-out from sheathing and sill plate at loaded end of wall

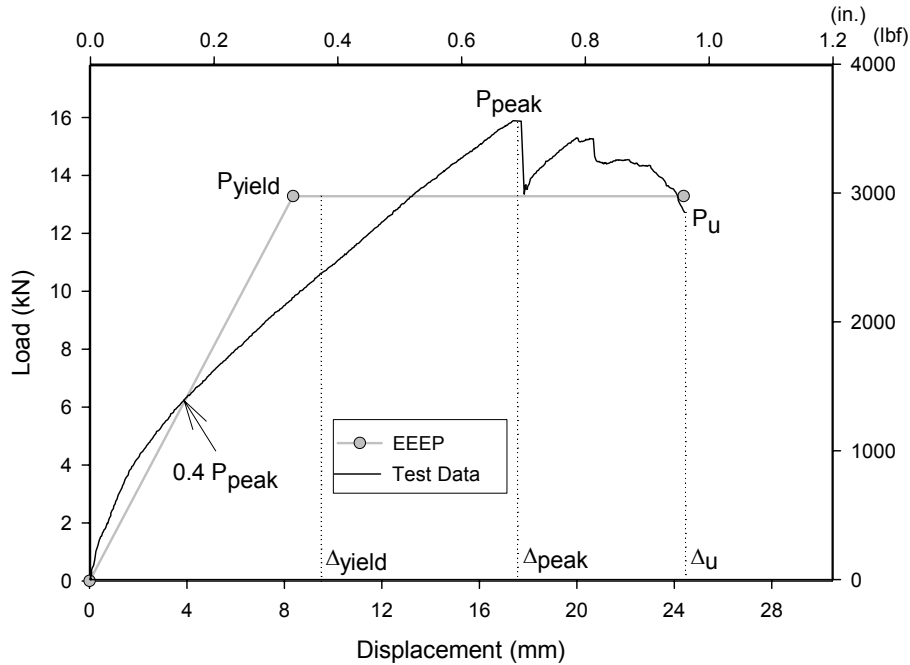
Figure 4.9 Response curve of monotonic wall test with hollow polypropylene three-box sill plate (PP5-M)

The response curve for Test PP5-M, having the hollow three-box polypropylene composite sill plate, is shown in Figure 4.9, along with the derived EEEP curve. Walls with polypropylene composite sills constructed using traditional methods reached a maximum absolute load of 15.8-kN (3561-lbf) with a corresponding displacement of 17-mm (0.68-in). This resulted in a shear capacity of 6.5 kN/m (445 lbf/ft). Failure occurred at a displacement of 24-mm (0.960-in), dissipating 268 kN-mm (2375 lbf-in) of energy. The elastic shear stiffness, k_e , equaled 1.6 kN/mm (9075 lbf/in).

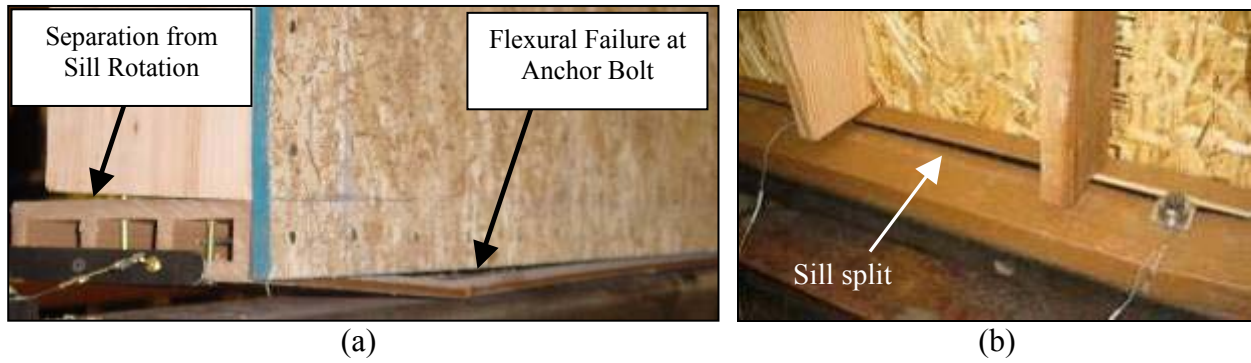
Figure 4.10 View of sill bending and splitting: (a) Overall behavior of sill end, (b) View from top of split along strand

When loaded to failure, the wall exhibited rigid body rotation around the corner opposite load application. Sheathing and studs “unzipped” from the sill, and the sill rotated in the perpendicular-to-extrusion direction—this behavior is illustrated in Figure 4.10a. Failure was brittle, occurring in flexure at the location of the anchor bolt. The brittle failure occurred when the outside box, resisting the largest load, split along strands formed during processing. The split on the top surface paralleled the plate washer edges, and the side split occurred at the intersection of the side web and bottom flange, as shown in Figures 4.10b and 4.11. The failure was due to the inherent weakness of this material in the perpendicular-to-extrusion direction. Sheathing nails appeared to have withdrawn along the bottom edge at locations of greatest flexure—at the anchor bolt on the loaded end. Indentation from plate bearing, as occurred in the polyethylene composite, was not apparent for this polypropylene section.

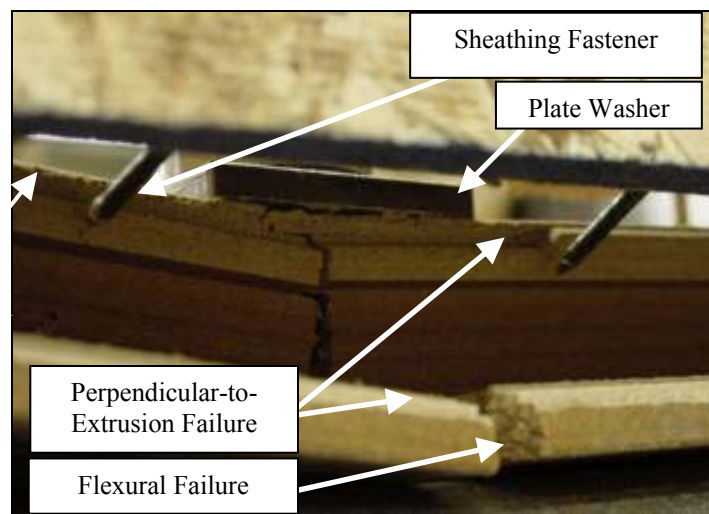
Figure 4.11 View of failure at anchor bolt location, shown from outside bottom edge

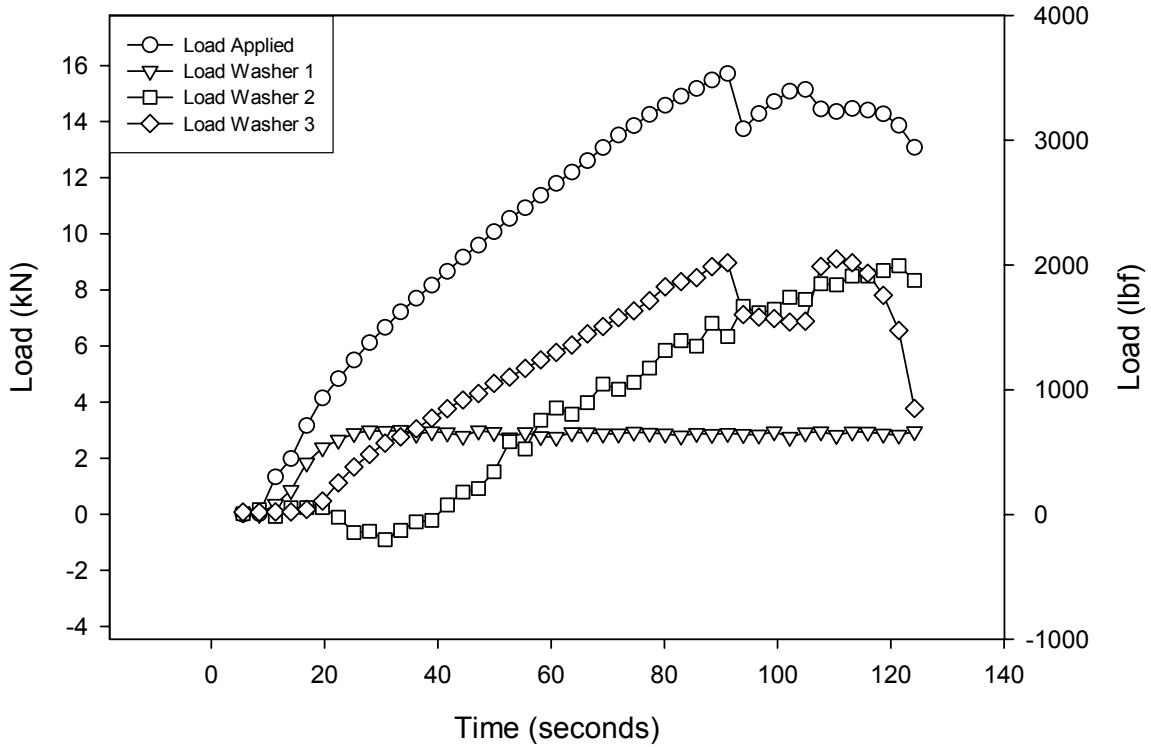
Figure 4.12 Test PP5-M Load washer readings over time

Anchor bolt readings for the three box section are presented in Figure 4.12. The plots show that rate of loading increases similarly for LW2 and LW3, with LW2 being attenuated in its load gain. Load carried by LW1 increased early in the test and then showed no further increases, suggesting the tension load was created from lateral forces in the wall.

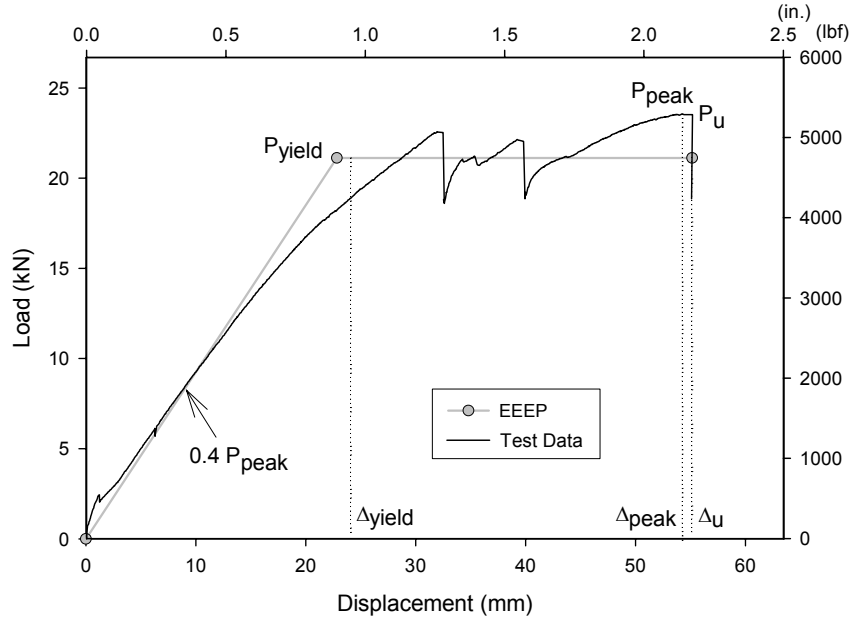
Figure 4.13 Response curve of monotonic wall test with polypropylene 100 mm x 152 mm hollow sill plate (PP10)

The response curve for Test PP10-M, having the hollow polypropylene 4x6 sill plate, is shown in Figure 4.13 along with the derived EEEP curve. Walls with machined polypropylene 4x6 sill plates reached a maximum absolute load of 23.5-kN (5293-lbf) with a corresponding displacement of 54-mm (2.14-in), resulting in a shear capacity of 9.7 kN/m (662 lbf/ft). Failure occurred at a displacement of 55-mm (2.17-in), dissipating 924 kN-mm (8175 lbf-in) of energy. The elastic shear stiffness, k_e , equaled 0.9 kN/mm (5285 lbf/in).

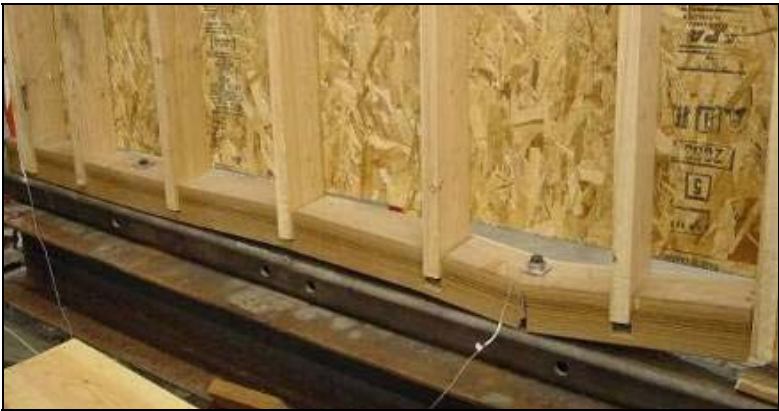
Figure 4.14 Overall PP10 hollow sill plate behavior (load being applied from right side)

both sheathing panels was transferred to the sill plate. Splitting occurred in interior studs from the screw fasteners. Both interior stud failures are depicted in Figures B.3 in Appendix B. Indentation from plate bearing was not apparent for this polypropylene section. Resulting failure modes of PP10-M began resembling those of traditional construction using hold-down anchors, as nail tear out was apparent in sheathing edges. Nails were bent and sheathing was bearing on the sill top edge near the compression chord, displacing 13-19 mm (0.5-0.75 in) past the sill edge. Though, not all failure modes indicative of fully-restrained walls were present (Heine, 1997).

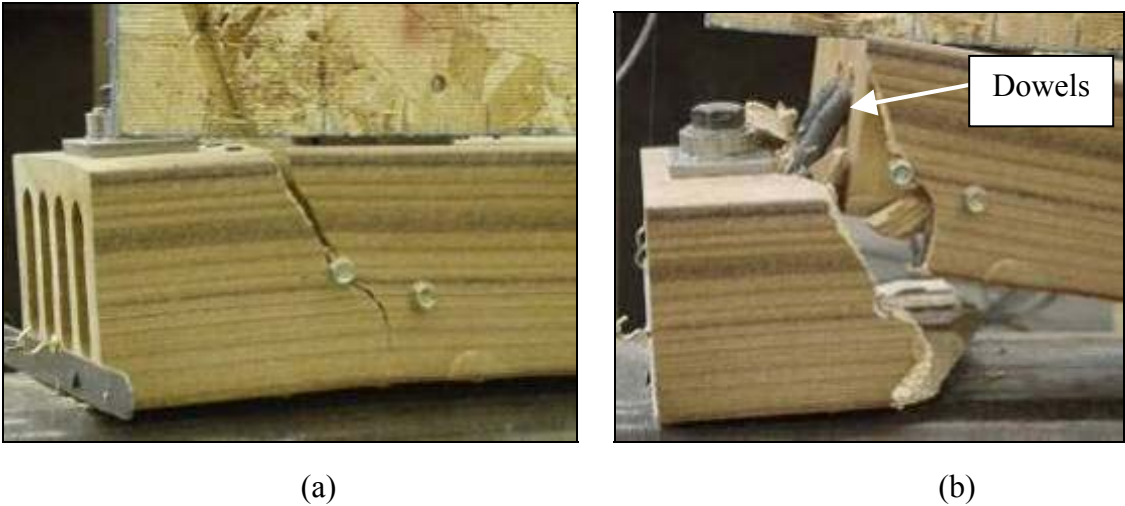
Figure 4.15 Sill failure at end stud: (a) First flexural failure, (b) Failure through section and dowels crushing upper flange and yielding

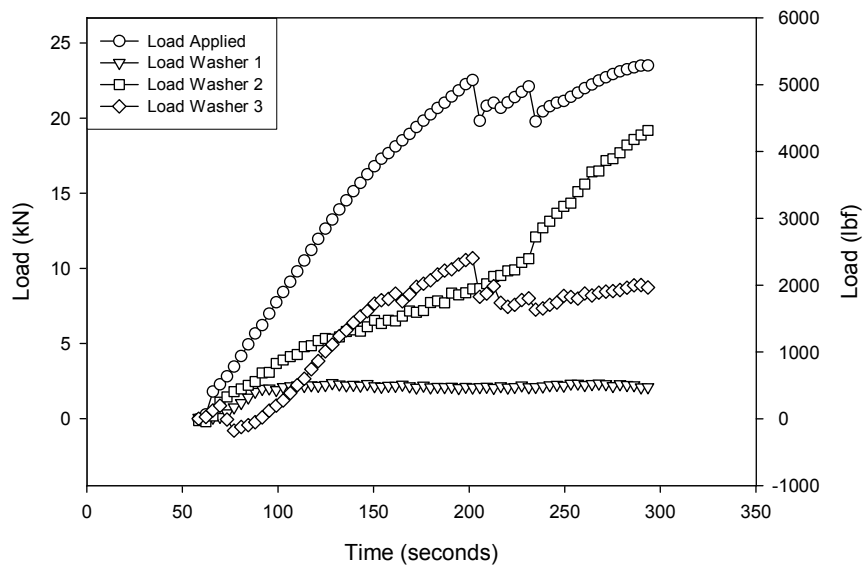
Figure 4.16 Test PP10-M Load washer readings over time

Load washer data in Figure 4.16 for PP10-M showed practically zero load carried in Load Washer 1. Load Washers 2 and 3 had similar responses to each other. Load Washer 2 gained load sooner from resisting uplift from the end stud as well as from the center stud, but its rate of increase reduced as the test progressed. Load Washer 3 gained load at a rate similar to the rate of load application, though, as wall load drops from sill failure, load shifted from Load Washer 3 to Load Washer 2.

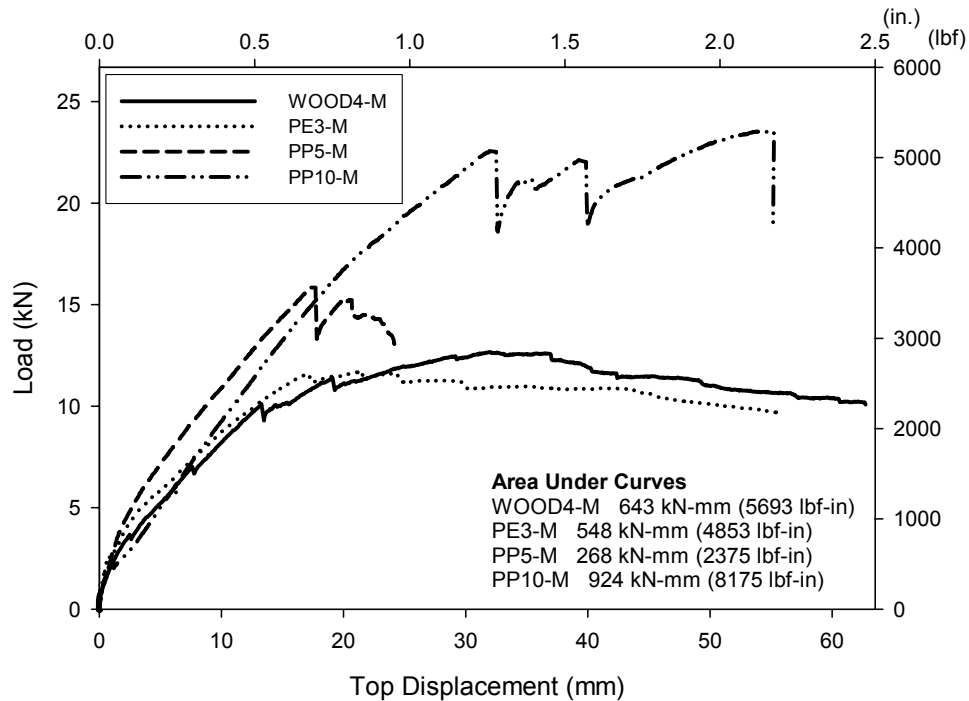
Figure 4.17 Load-displacement curves for monotonic tests

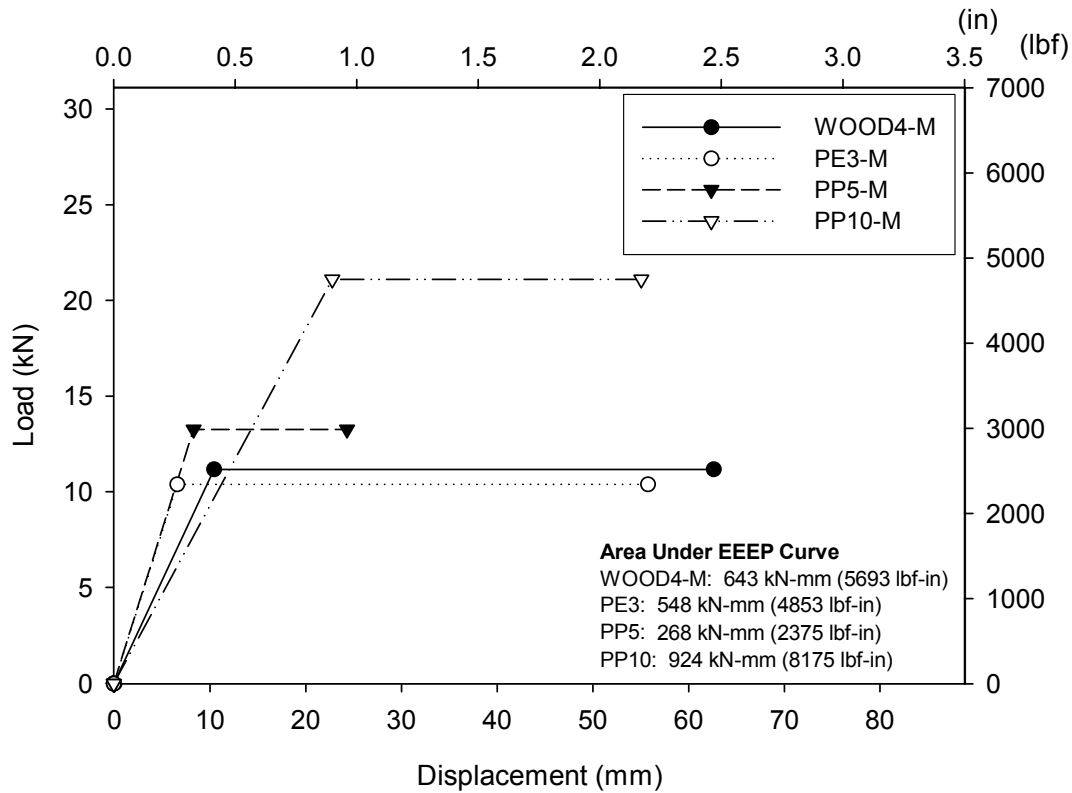
Figure 4.18 EEEP curves from monotonic test results

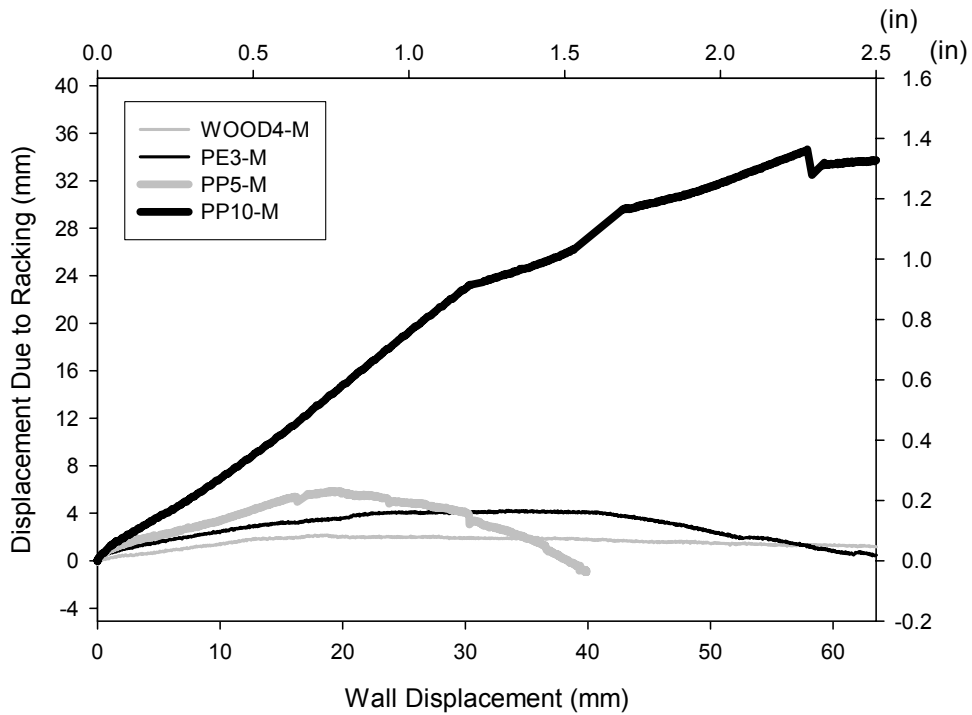
Figure 4.19 Racking displacement of walls in monotonic tests

PP10-M exhibits substantially more racking movement, which increases at a linear rate. This is consistent with damage observations unique to Test PP10-M, having more sheathing fasteners yielded and visible sheathing movement relative to studs. The majority of top wall displacement for Tests WOOD4-M, PE3-M, and PP5-M are contributed to uplift of wall ends from rigid body rotation. The deformation pattern of Specimen PP10-M is more desirable as it results in a more distributed damage pattern by activating more of the structure and increases the damping effects of the system.

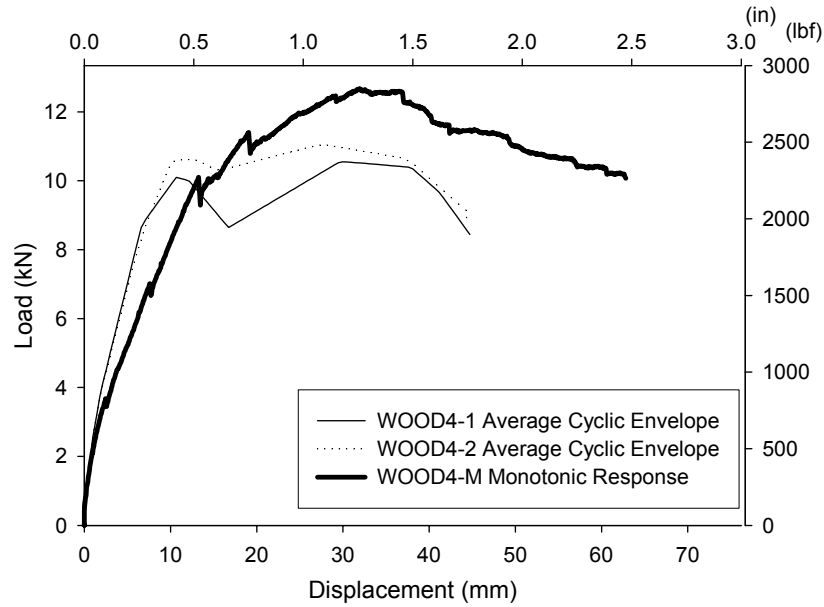
Figure 4.20 WOOD4 response curves

Two walls with traditional treated sill plates were tested cyclically. Envelope curves for each test are plotted in Figure 4.20, along with the corresponding monotonic response curve for Specimen WOOD4-M. Cyclic results achieved lower load and displacement capacities than the monotonic results with the CUREE protocol, as elastic stiffness increased and the yield point lowered. This type of change in performance was observed in other cyclic tests of walls and is expected (Heine, 1997).

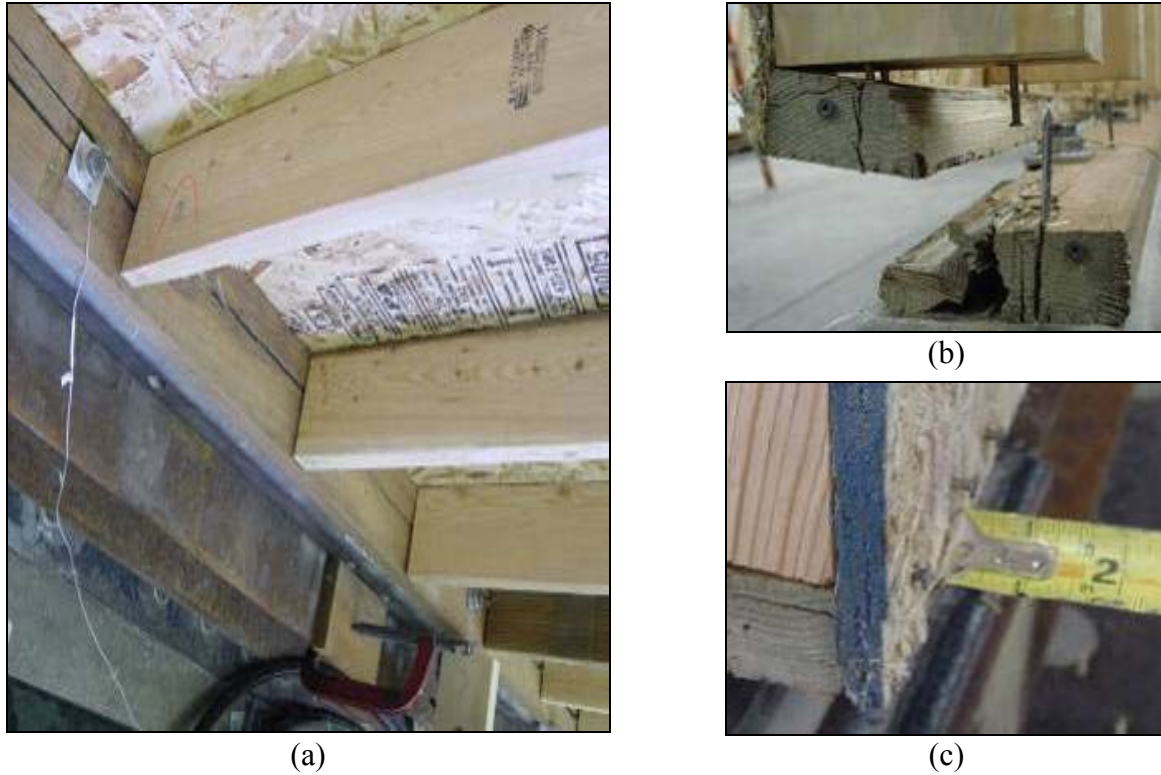
Figure 4.21 WOOD4 failures: (a) Typical sill splitting full length (Test WOOD4-1), (b) Sill end split (Test WOOD4-2), and (c) Sheathing nail pull-out at wall end (Test WOOD4-1)

Walls rotated in rigid body motion about the bottom corners. Sill splitting began at around 12-mm (0.5-inch) displacement (0.3 Δ_{ref}), initiating from the loaded end and propagating along the grain down the entire length of sill, as seen in Figures 4.21a and 4.21b. Because of rigid body motion, sheathing connectors were not taxed as would be in walls with hold-down hardware. Nail pull-out only occurred along the bottom edge of sheathing, nearest wall corners, as shown in Figure 4.21c. Sheathing remained well in contact with stud and sill edges.

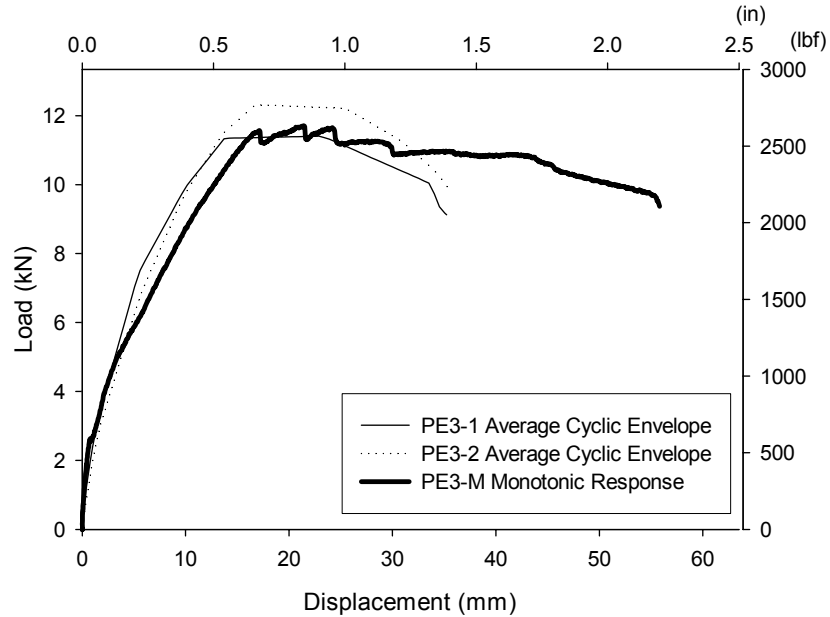
Figure 4.22 PE3 response curves

Cyclic shear strength averaged 4.9 kN/m (333 lbf/ft) at peak, with a corresponding average displacement of 20-mm (0.78-in). Load resistance dropped 20% after the 7th loading sequence ($1.0 \Delta_{ref}$) for PE3, reaching an average failure load of 9.5-kN (2134-lbf) and ultimate displacement of 5-mm (1.75-in). A ductility factor of 4.7 was achieved and 1602 kN-mm (14,176 lbf-in) of energy was dissipated.

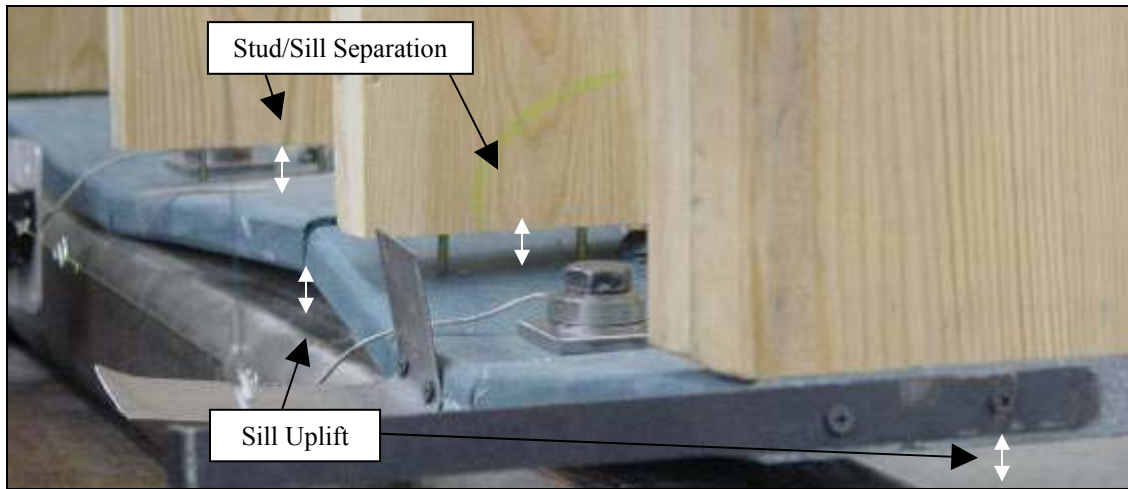
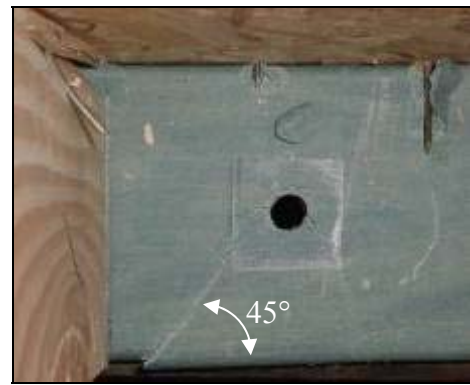
Walls rotated as a rigid body about bottom corners. Sill behavior was characterized by upward bending at stud locations as shown in Figure 4.23a, creating noticeable curvature between anchor bolts when wall displacements reached $0.7 \Delta_{ref}$. At $1.0 \Delta_{ref}$, nails began tearing through sill top edges at end anchor bolt locations, and “popping” was audible. At this same time, interior stud separation from the sill was apparent. Flexure failure occurred inside the 1st interior stud on both ends at $1.5 \Delta_{ref}$, and propagated from the anchor bolt, out to the edge at a 45 degree angle, at the next primary cycle. These failure modes are depicted in Figures 4.23b and 4.23c. Because of rigid body rotation, nails were only pulled out along the bottom sheathing edge. Of the nails that pulled out, one pulled out greater than 25-mm (1-inch). Significantly more nail pull-through occurred in the sheathing and the sill plate in PE3 versus WOOD4, as the clamping force on fasteners is greater, and the sill resisted longitudinal splitting and continued to transfer sheathing forces to the foundation. Unique to this test group behavior, only interior studs unzipped from sills, whereas both end studs remained in contact.

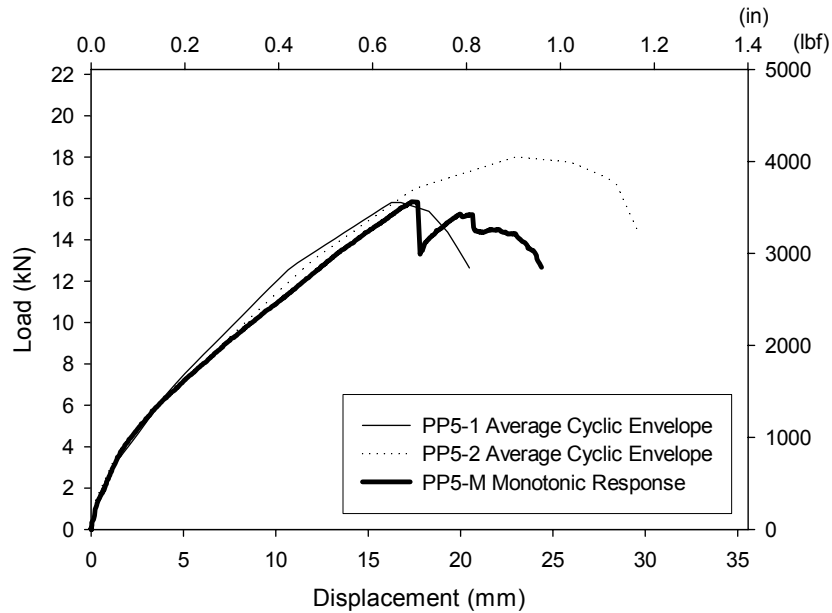
Figure 4.24 PP5 response curves

Test 3-1 and 3-2, respectively. At these points of failure, average load and displacement reached 13.5-kN (3038-lbf) and 25-mm (0.99-in). A ductility factor of 2.6 was achieved at failure, along with 1532 kN-mm (13,562 lbf-in) of energy dissipation.

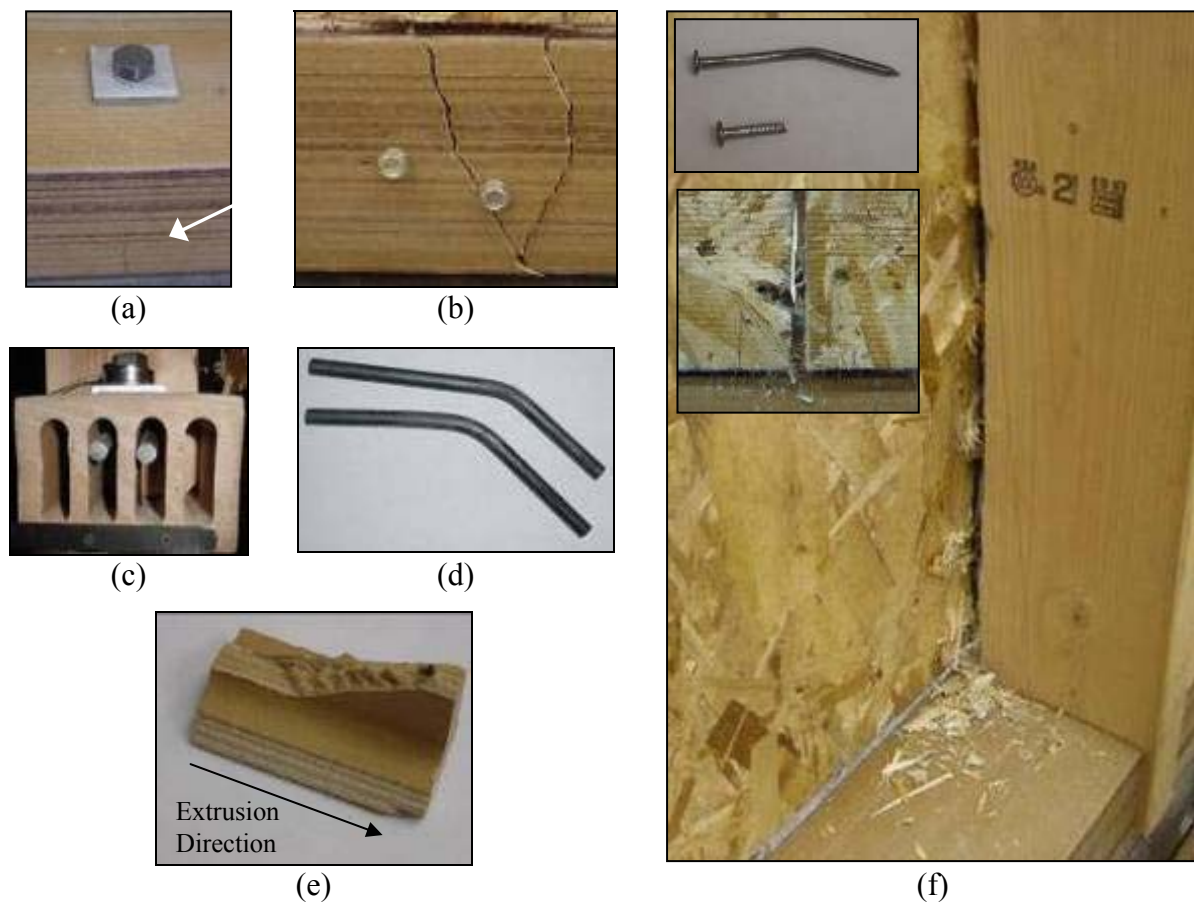
Figure 4.27 PP10 failures: (a) Flexural failure at interior anchor bolt, (b) Flexural failure at end stud connection, (c) End view of dowels yielding, (d) Yielded dowels from Test PP10-2, (e) Failure plane along section strands, and (f) Nail pull-through at panel joint (inset photos of yielded fasteners and view of panel joint from outside)
