STRUCTURAL DESIGN AND PERFORMANCE OF COMPOSITE
WALL-FOUNDATION CONNECTOR ELEMENTS

A thesis submitted in partial fulfillment of
the requirements for the degree of

WASHINGTON STATE UNIVERSITY
Department of Civil and Environmental Engineering

AUGUST 2005

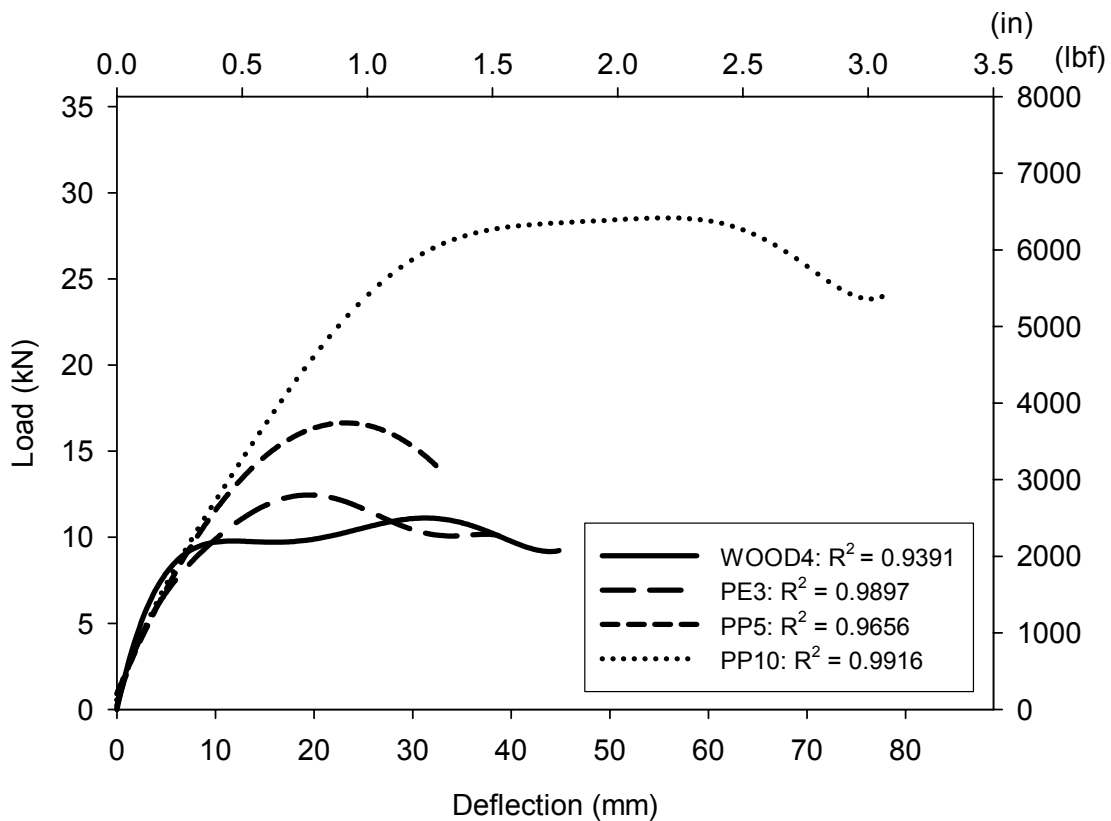
Figure 4.28 Best fit lines for each test group

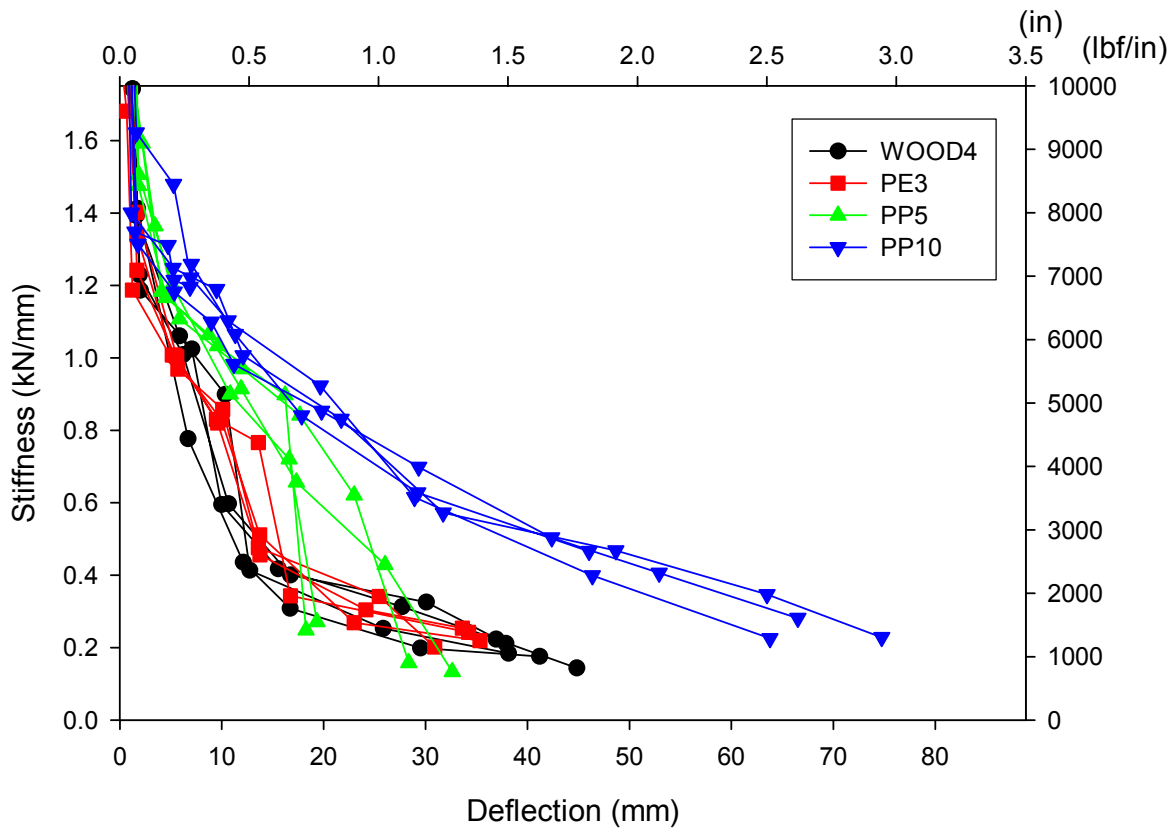
Figure 4.30 Stiffness degradation from cyclic loading

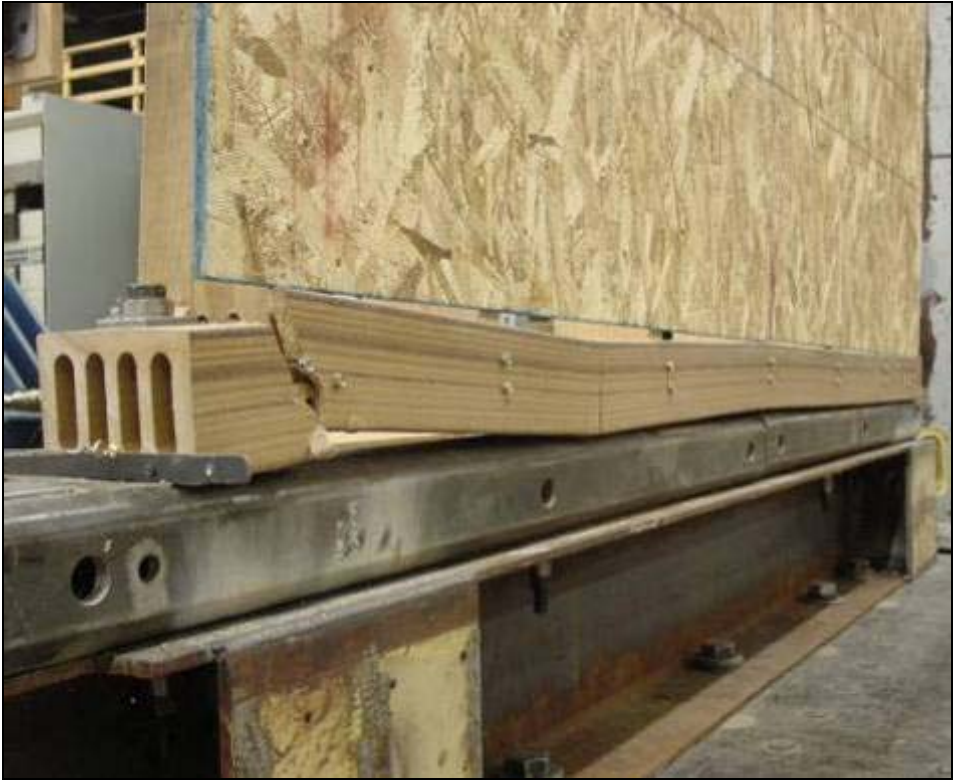
Figure B.2 Test PP10-M sill failure and overall behavior

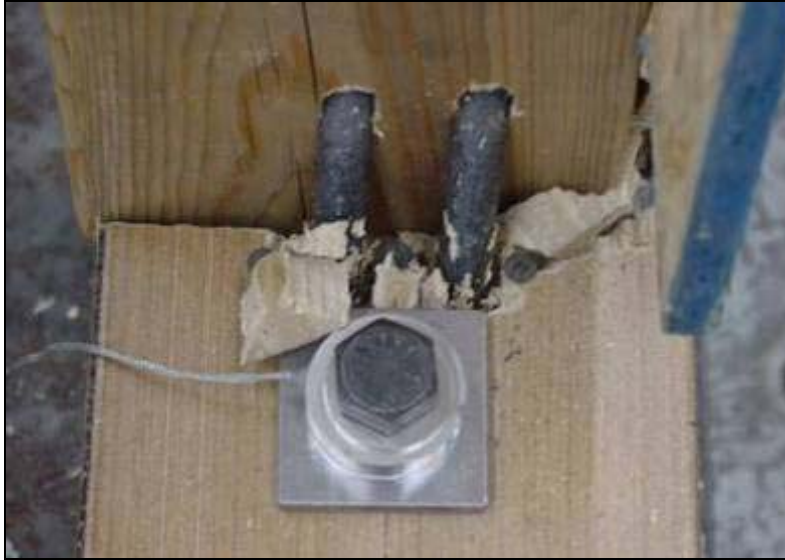
Figure B.5 End stud failed connection (top view): dowels yielded, top flange crushed, sill cracked through

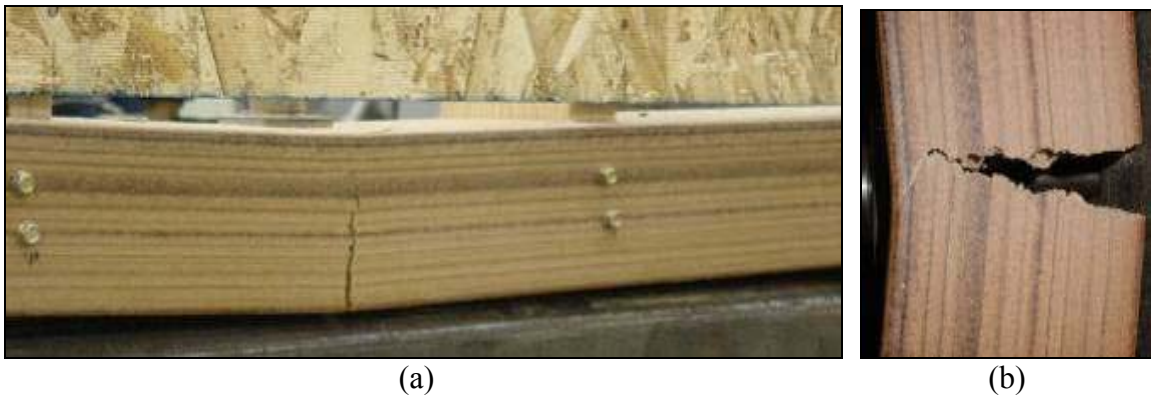
Figure B.6 Flexural failure at second anchor bolt: (a) Location along sill, (b) Failure exposes anchor bolt within

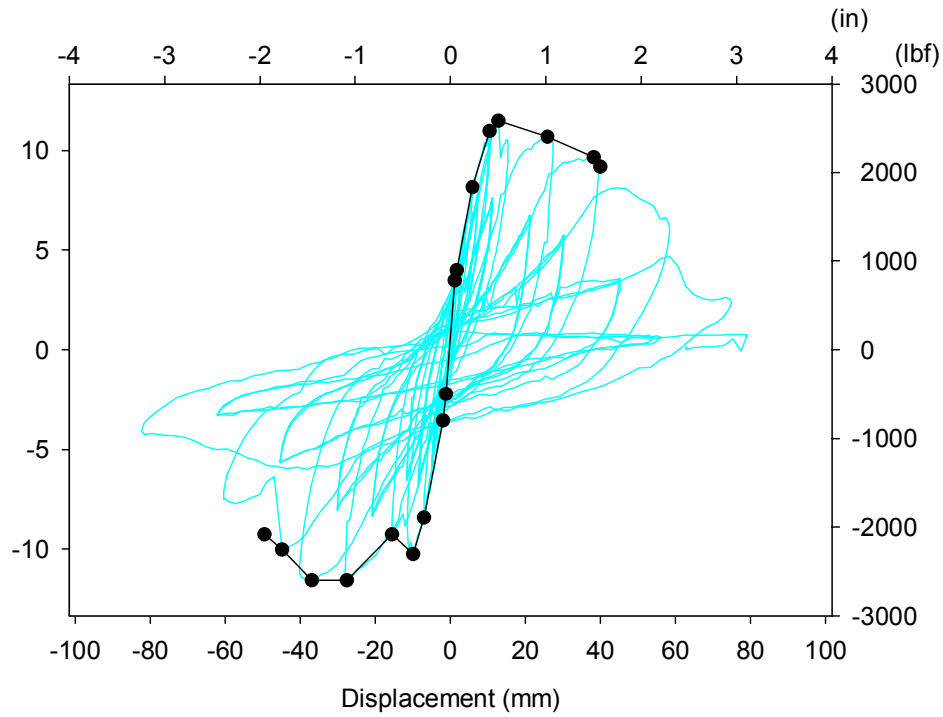
Figure B.7 Test WOOD4-1 Hysteresis: Reference Displacement = 41 mm (1.61 in)

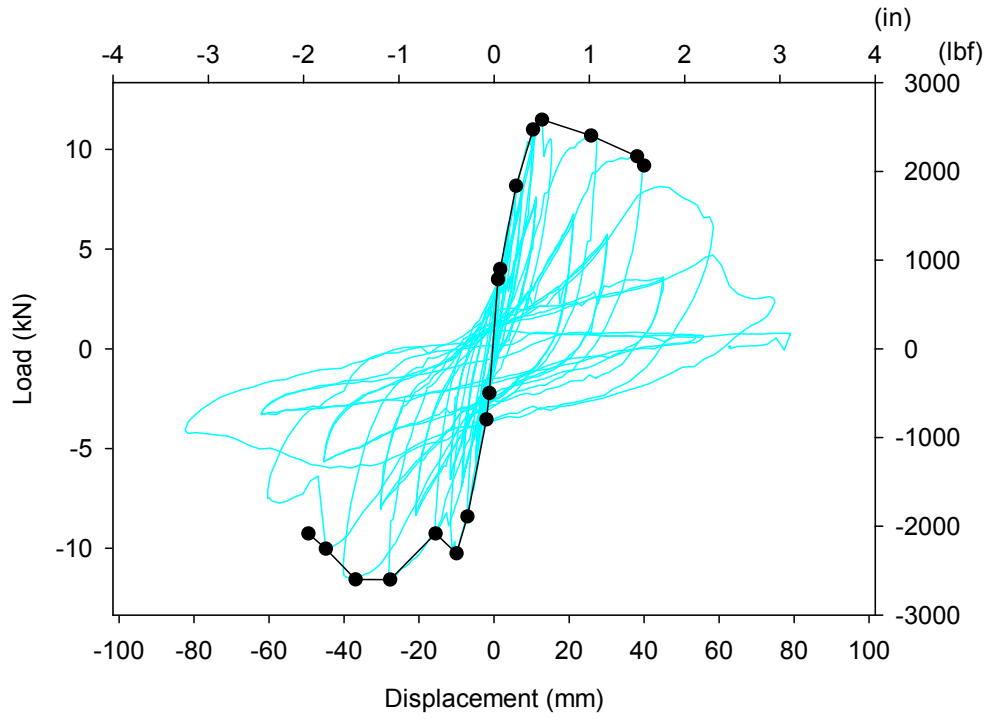
Figure B.9 Test WOOD4-2 Hysteresis: Reference Displacement = 41 mm (1.61 in)

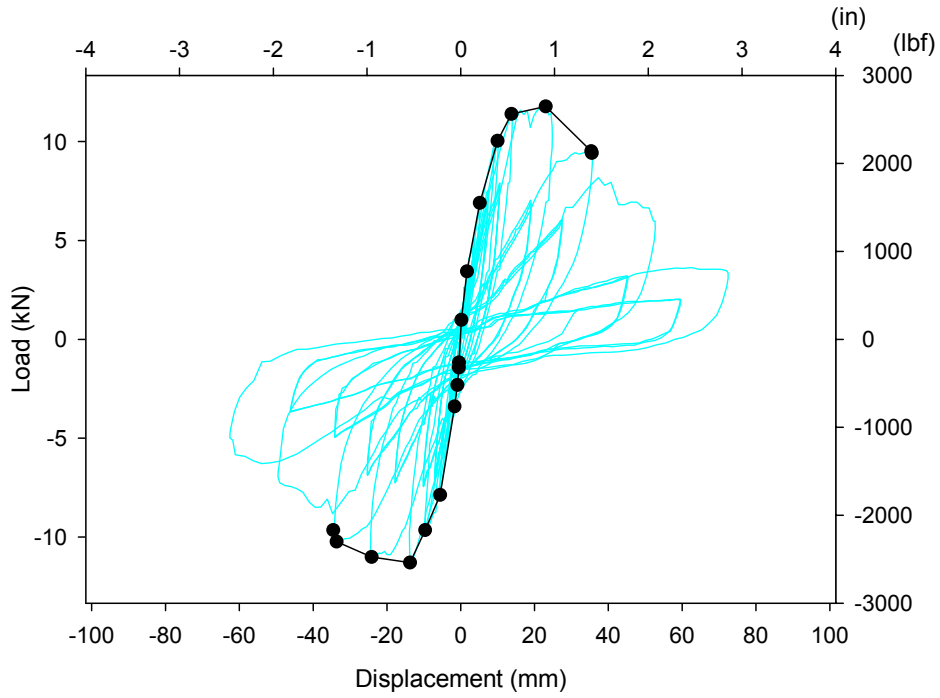
Figure B.11 Test PE3-1 Hysteresis: Reference Displacement = 36 mm (1.40 in)

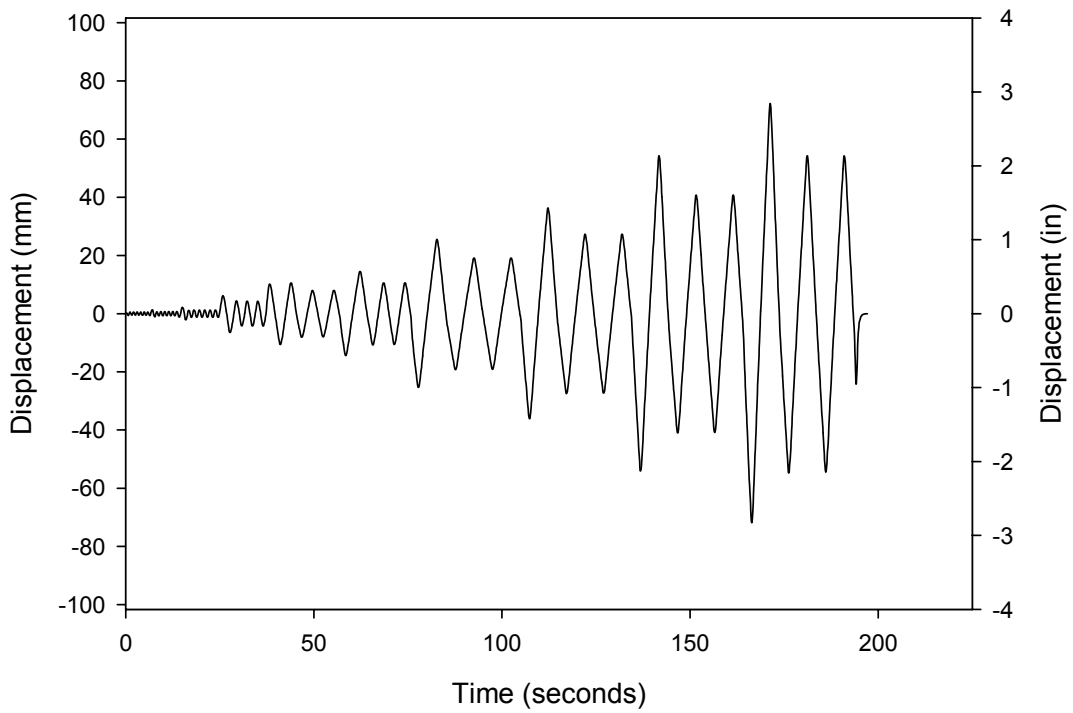
Figure B.12 Time history for Test PE3-1

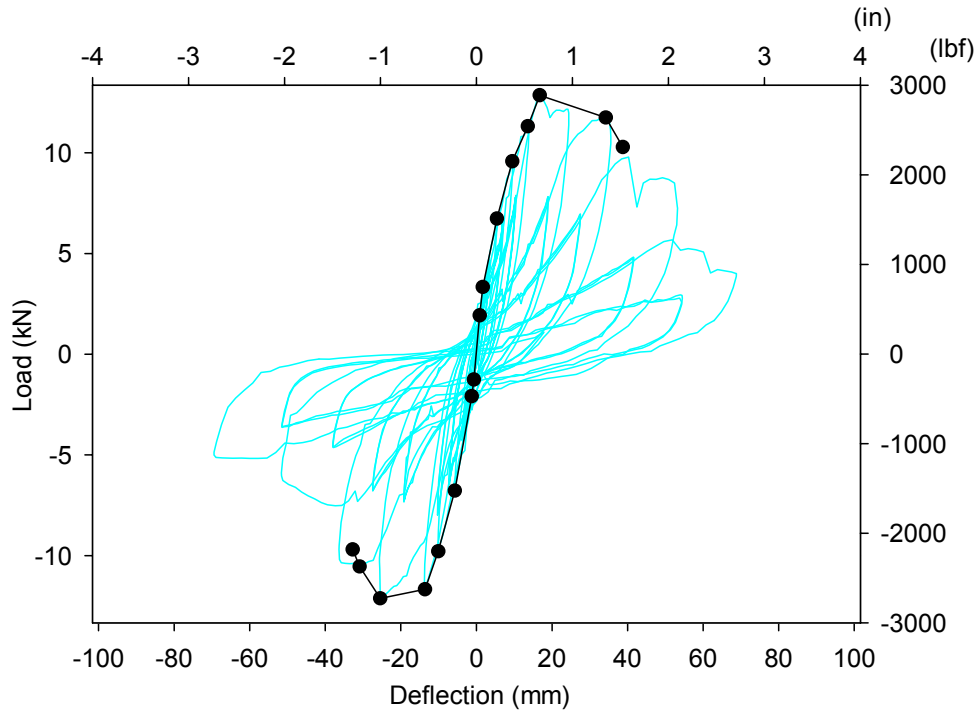
Figure B.13 Test PE3-2 Hysteresis: Reference Displacement = 36 mm (1.40 in)

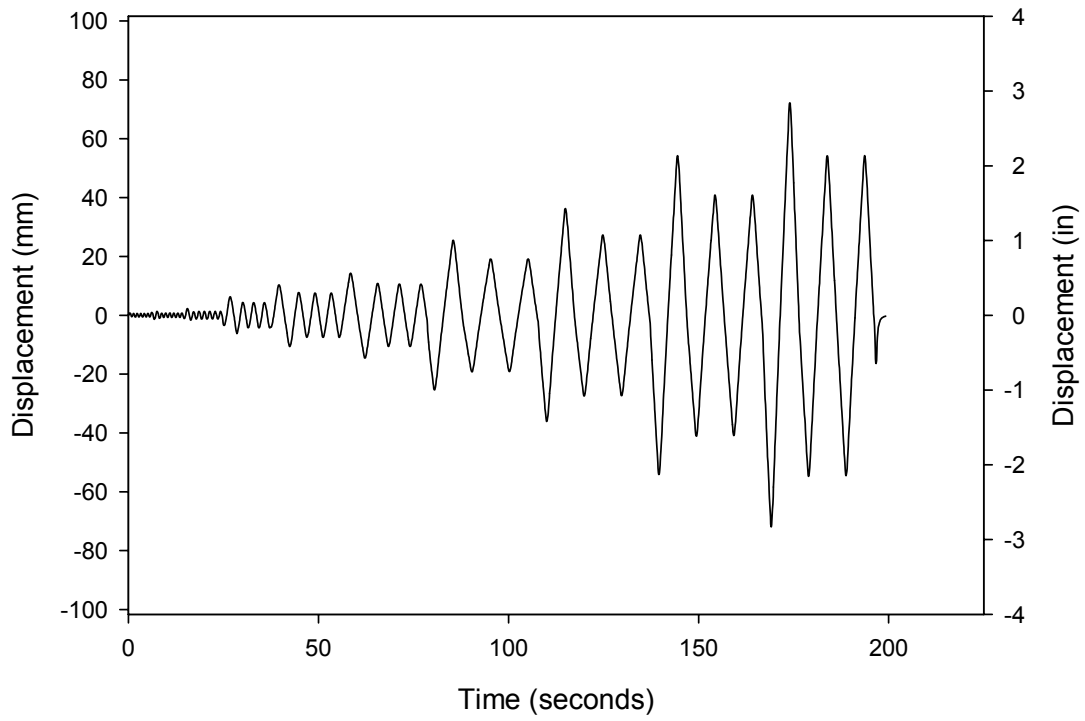
Figure B.14 Time history for Test PE3-2

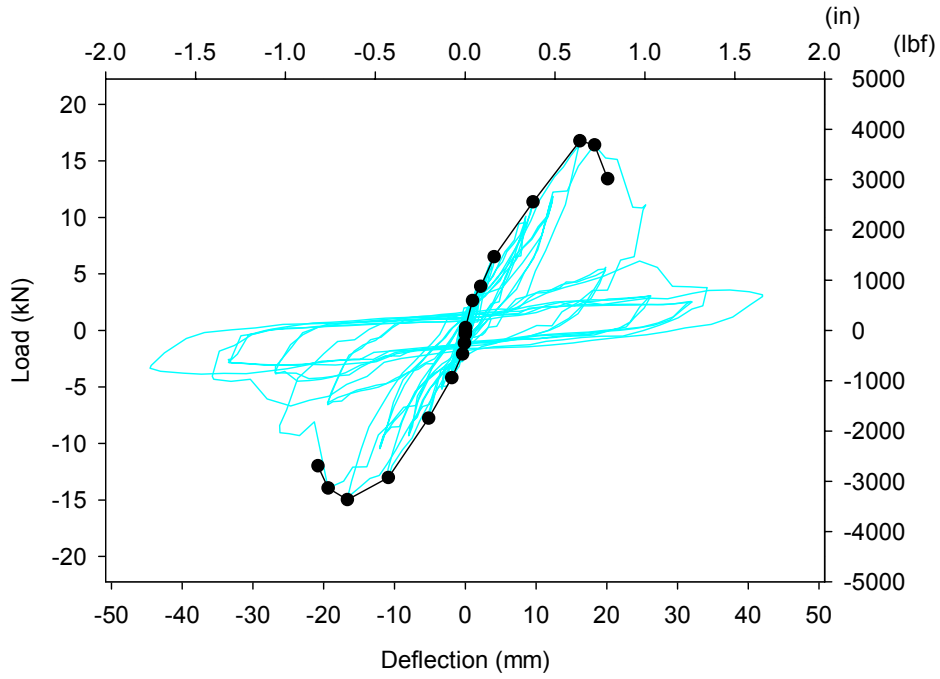
Figure B.15 Test PP5-1 Hysteresis (Reference Displacement = 18 mm (0.70 in))

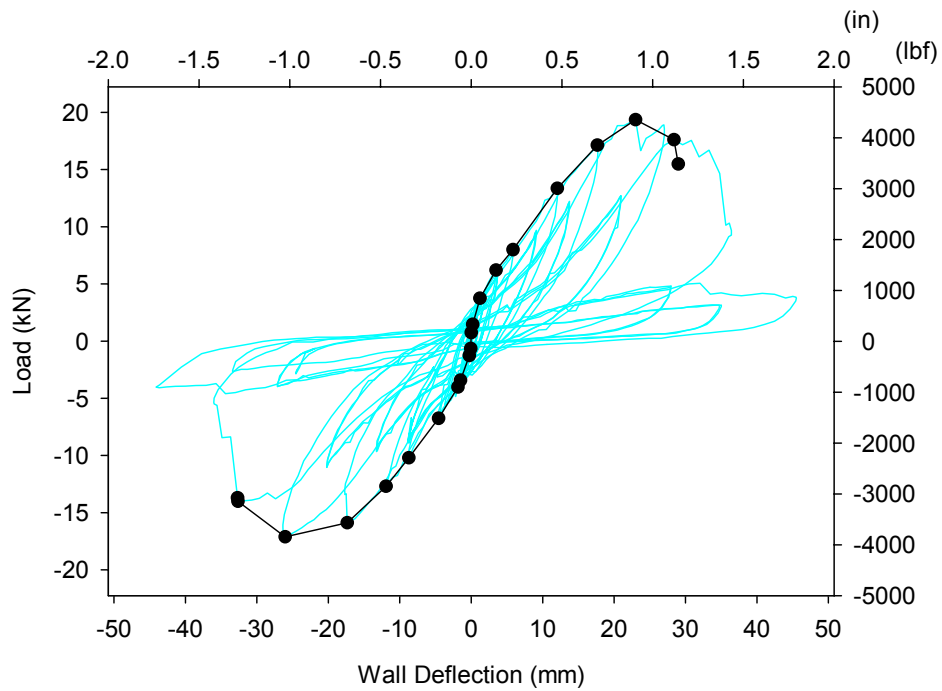
Figure B.17 Test PP5-2 Hysteresis (Reference Displacement = 18 mm (0.70 in))

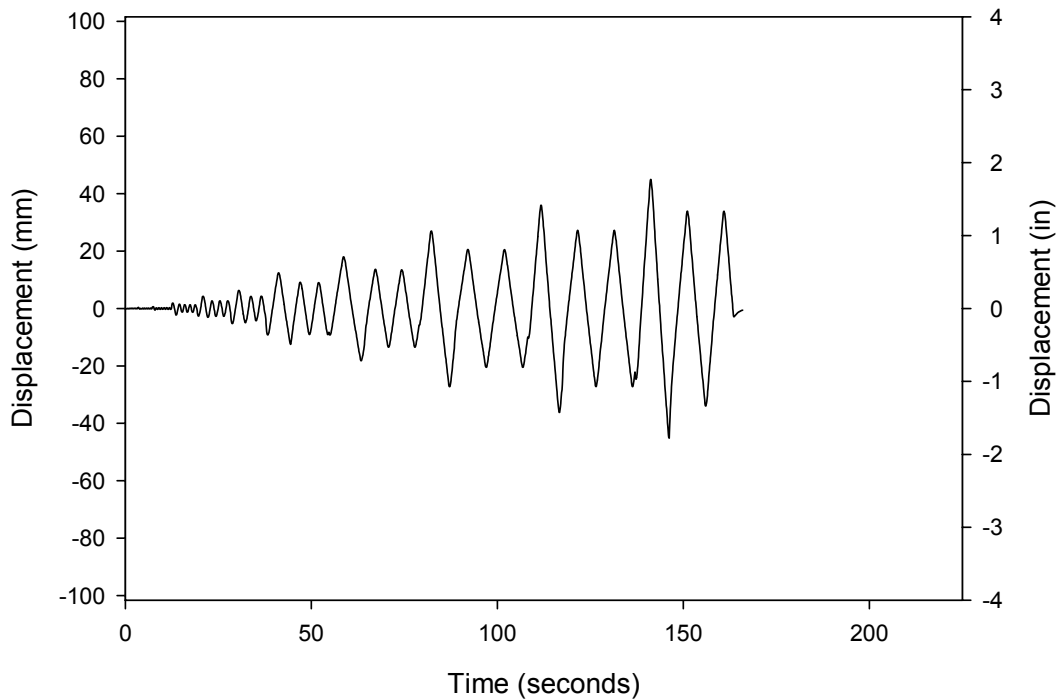
Figure B.18 Time history for Test PP5-2

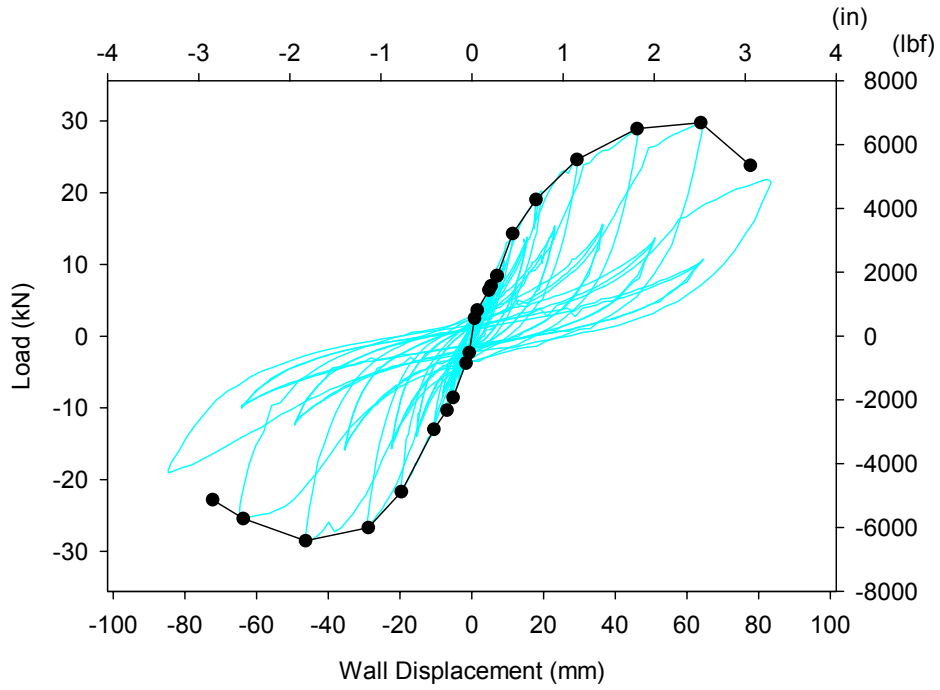
Figure B.19 Test PP10-1 Hysteresis (Reference Displacement = 35 mm (1.39 in))

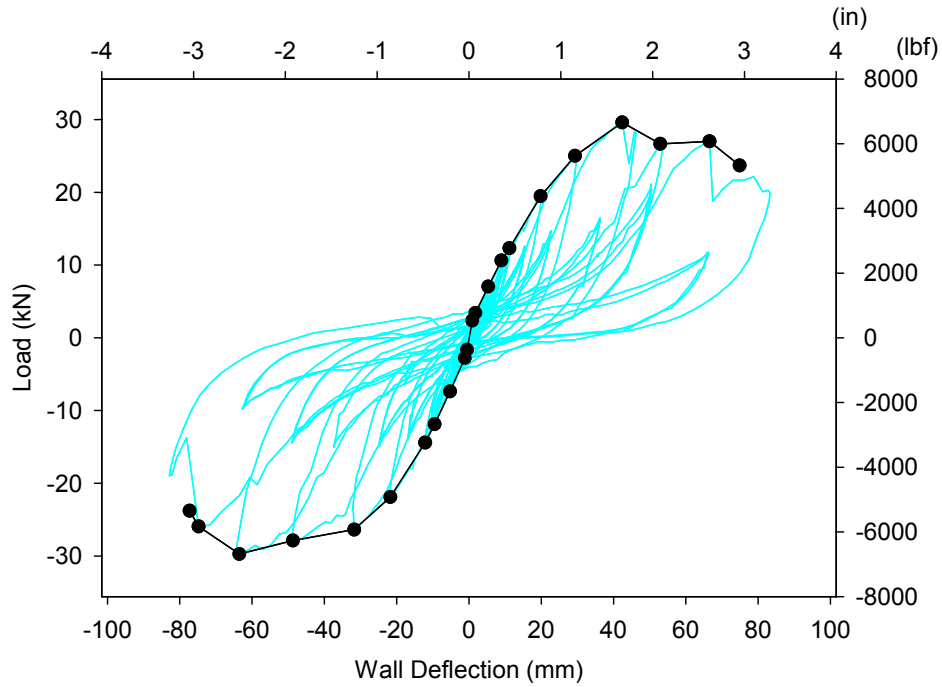
Figure B.21 Test PP10-2 Hysteresis (Reference Displacement = 35 mm (1.39 in))

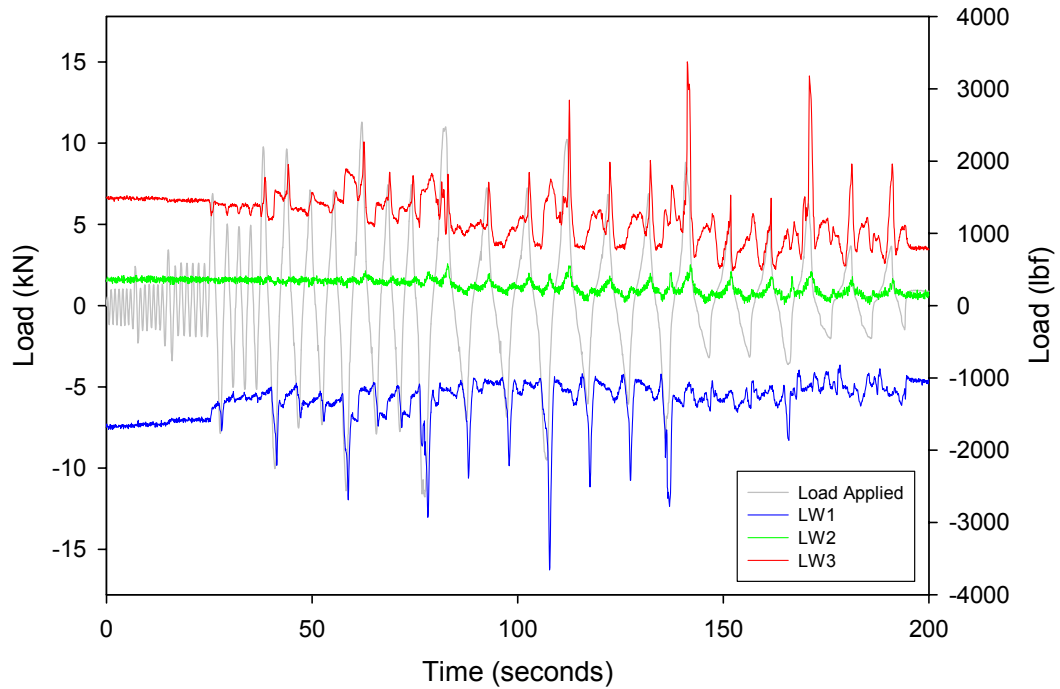
Figure B.33 Test WOOD4-2 load washer time history

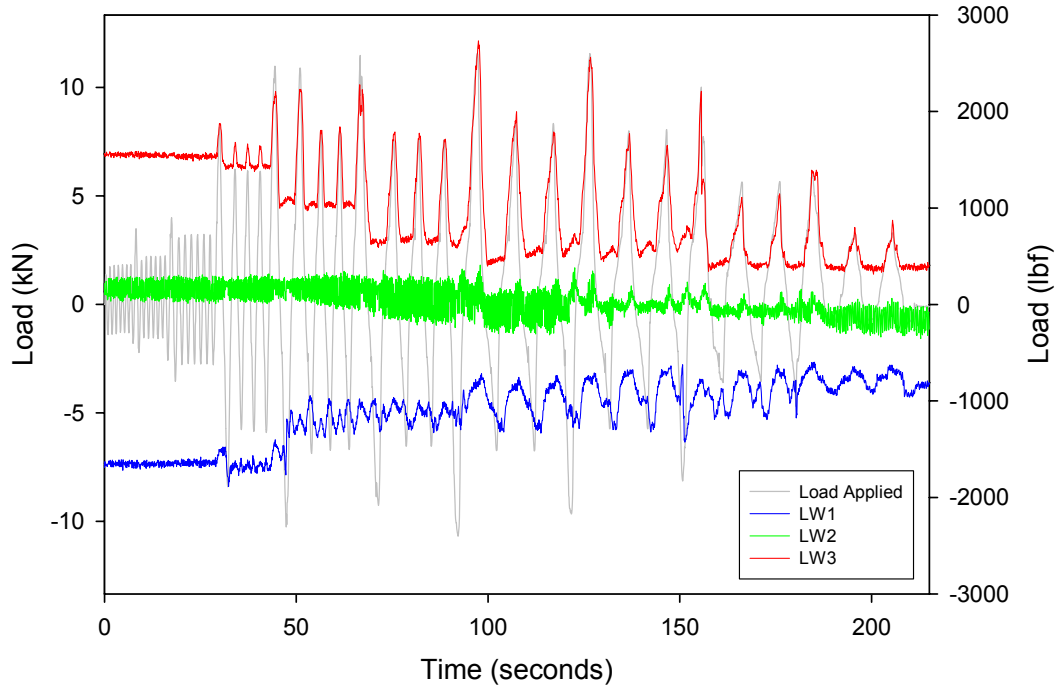
Figure B.34 Test PE3-1 load washer time history

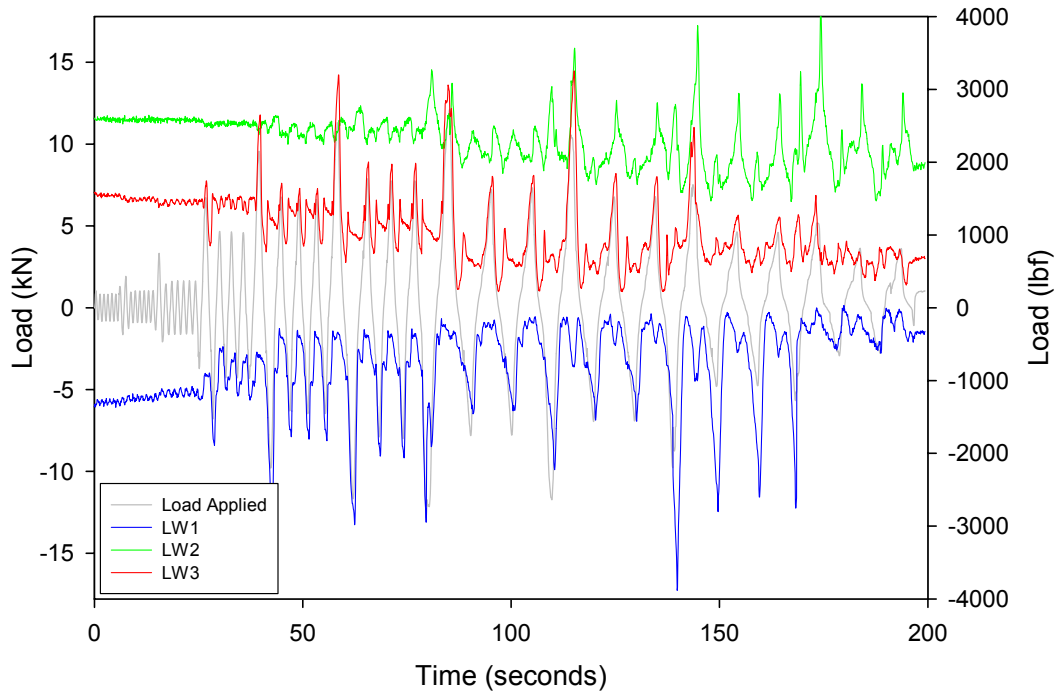
Figure B.35 Test PE3-2 load washer time history

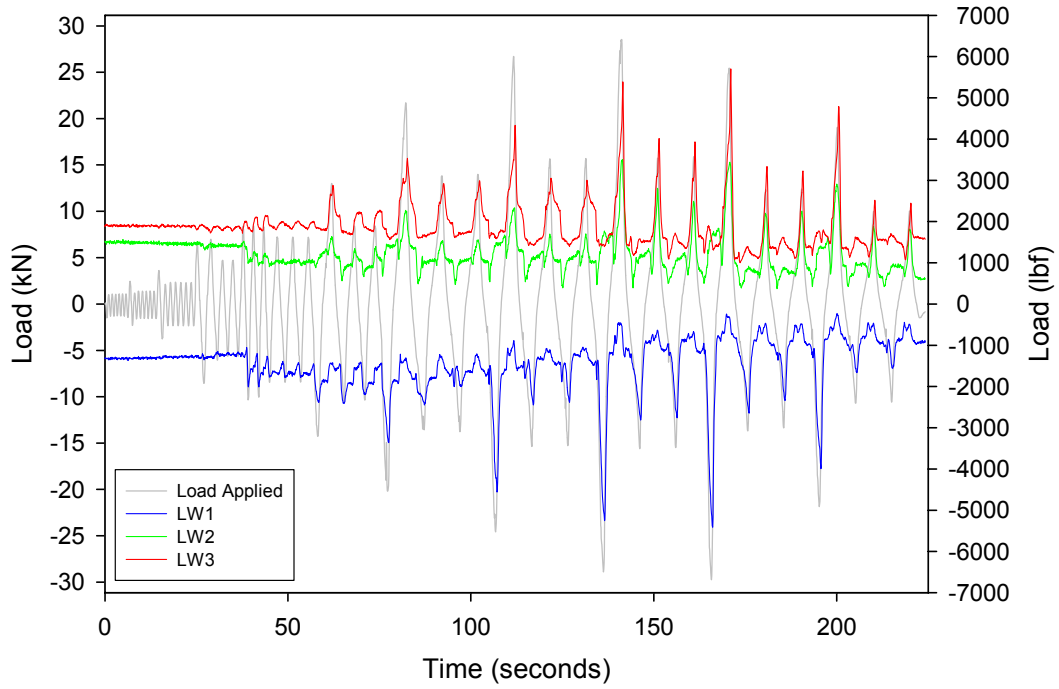
Figure B.38 Test PP10-1 load washer time history

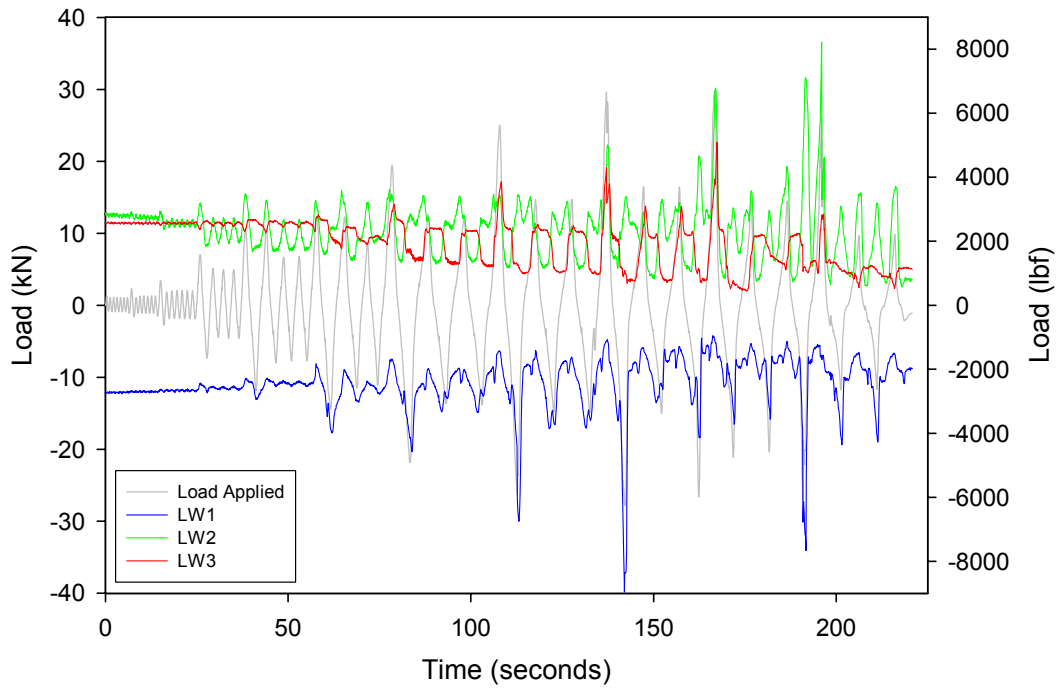
Figure B.39 Test PP10-2 load washer time history
