SHEAR STRENGTH OF PARTIALLY GROUTED
SQUAT MASONRY SHEAR WALLS

A thesis submitted in partial fulfillment of
the requirements for the degree of

WASHINGTON STATE UNIVERSITY
Department of Civil and Environmental Engineering

AUGUST 2010

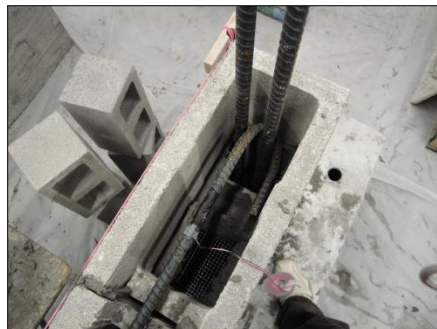
Figure 2.1 The 180° hook as used in the specimens

The specimens were reinforced horizontally and grouted at courses No. 4, 8, 9, and 10. Each one of these courses included 1#5 (D 16), except for specimens PG180-48 and PG254-48, where 1#6 (D 19) and 2#5 (D 16) were used, respectively. The horizontal reinforcements were hooked according to MSJC (2008) using a 180° hook around the vertical bars in both outermost cells, as shown in Figure 2.1.

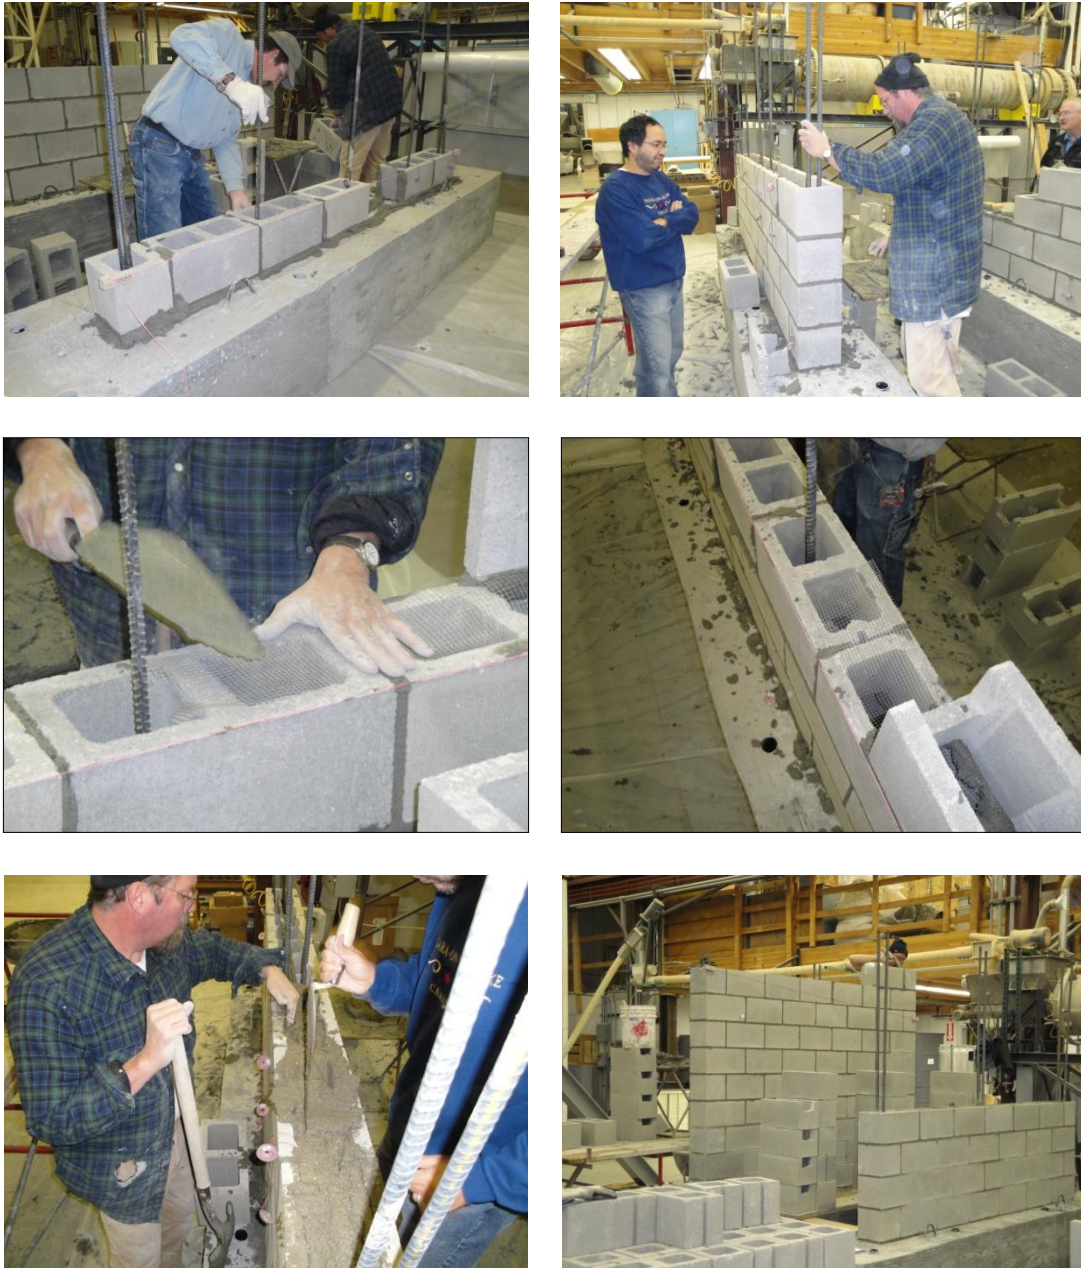
Figure 2.4 Specimens during construction

placed below the course to be grouted along every horizontal bond beam to prevent the grout from flowing to the lower courses during pouring, as shown in Figure 2.4.

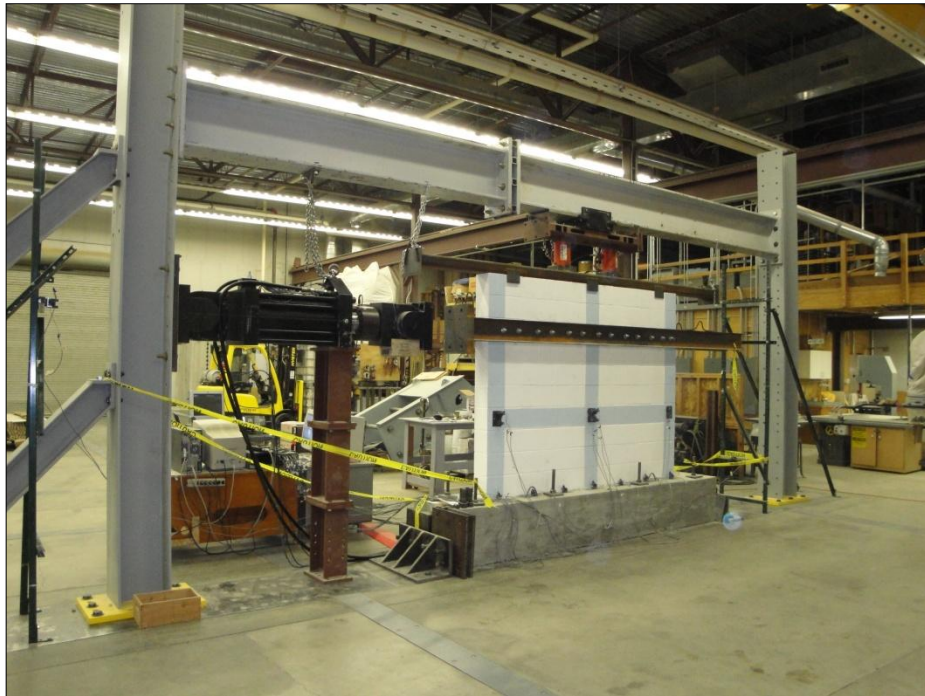
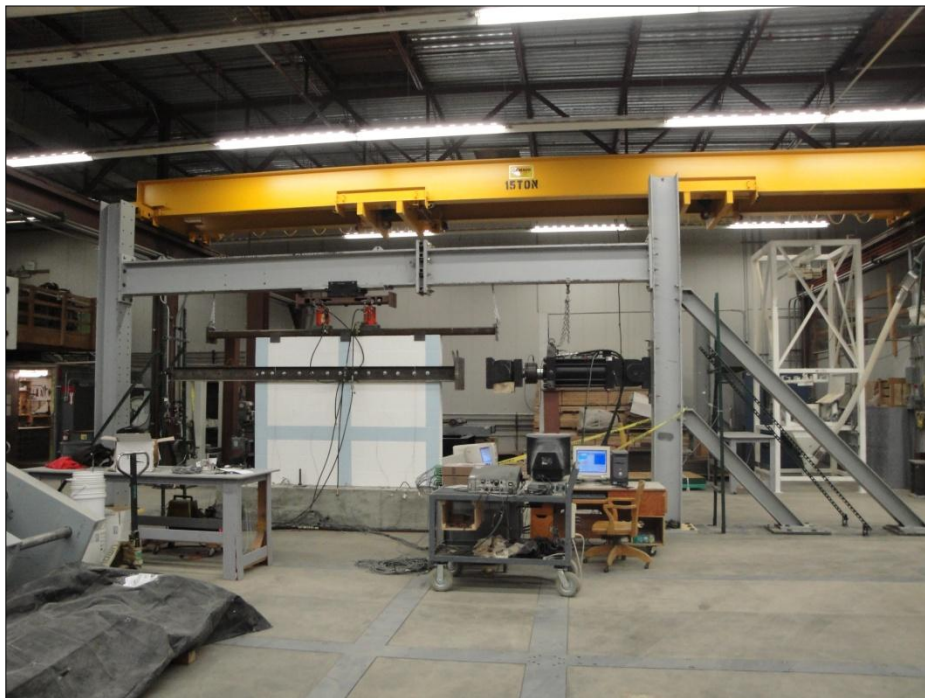
Figure 2.5 Shear wall test set up

In order to eliminate any sliding in the concrete base during the cyclic loading, the concrete base was braced using two stiff built-up steel angles bolted to the laboratory strong floor, as shown in Figure 2.5.

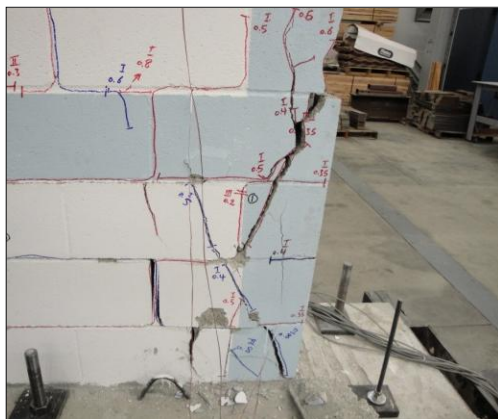
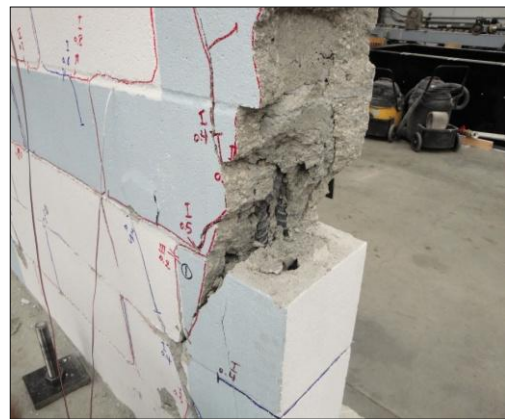
Figure 3.3 Failure in the grouted cells at drift of 1.1%
