IN-PLANE SHEAR PERFORMANCE OF PARTIALLY
GROUTED MASONRY SHEAR WALLS

A thesis submitted in partial fulfillment of
the requirements for the degree of

WASHINGTON STATE UNIVERSITY
Department of Civil and Environmental Engineering

AUGUST 2010

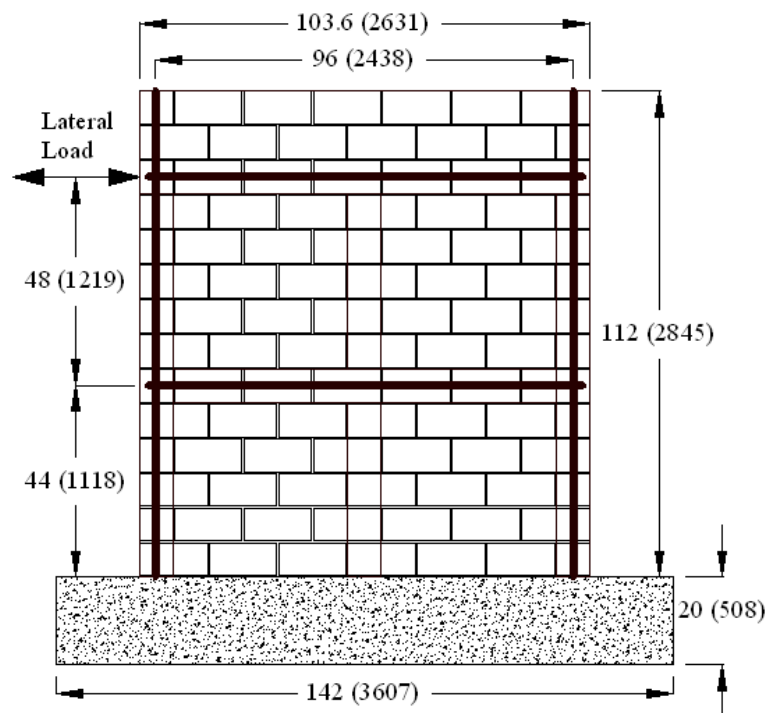
Figure 2-1: Dimensions common to all wall specimens, given as in. (mm)

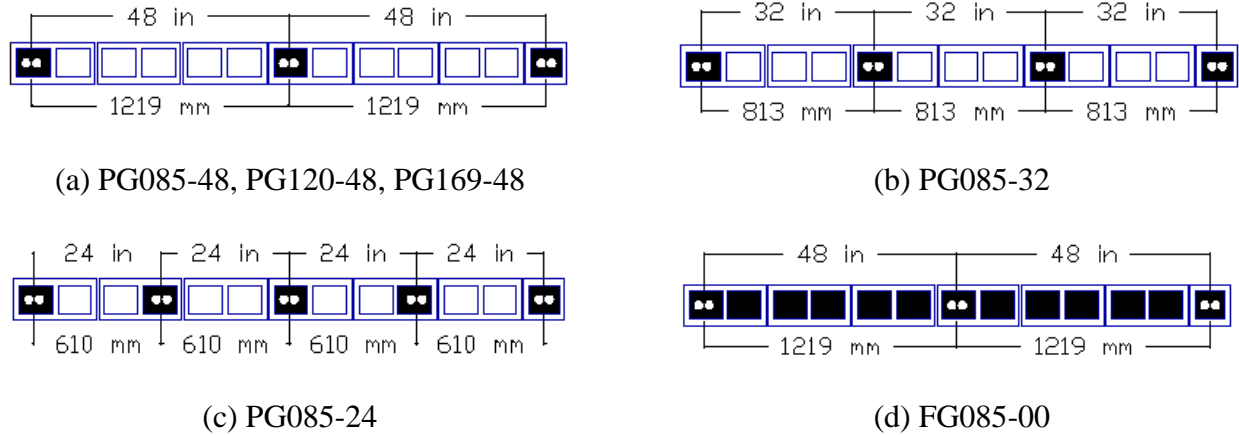
Figure 2-2: Horizontal cross-sections of wall specimens. Dimensions are center-to-center of the flexural (vertical) reinforcement. Grouted cells are indicated with shading. Specimen (a) PG085-48, PG120-48, PG169-48, (b) PG085-32, (c) PG085-24, and (d) FG085-00.

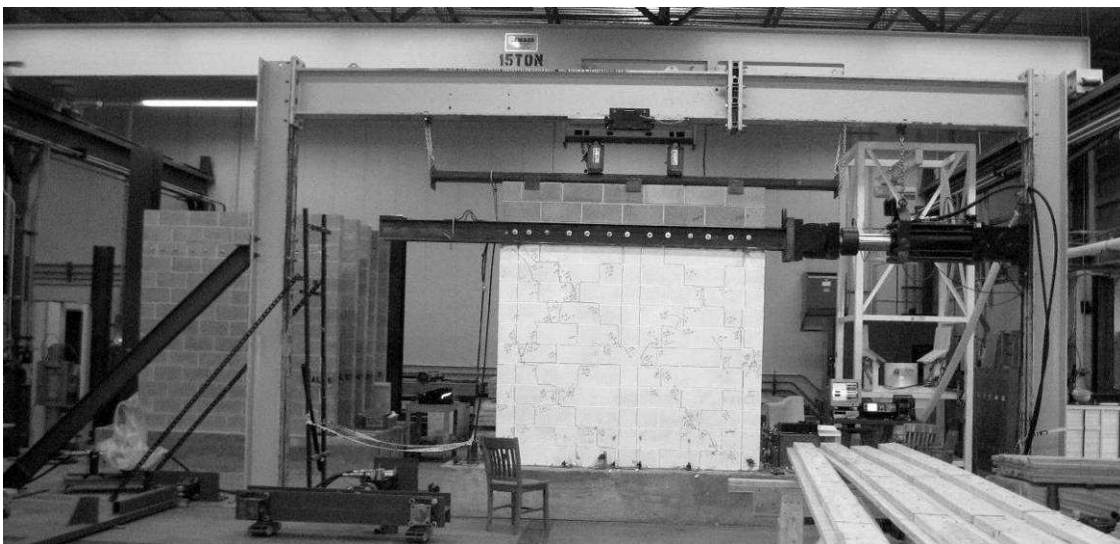
Figure 2-3: PG085-48 after testing in the H-frame using the single knee-brace.

The test specimens were designed to act as cantilever shear walls, i.e. fixed at the base to the laboratory strong floor and free to deflect and rotate at the wall top. Specimen foundations were post-tensioned to the reaction floor with six threaded rods, three at each end. Foundations were braced laterally with steel fixtures to prevent sliding of the foundation on the reaction floor.

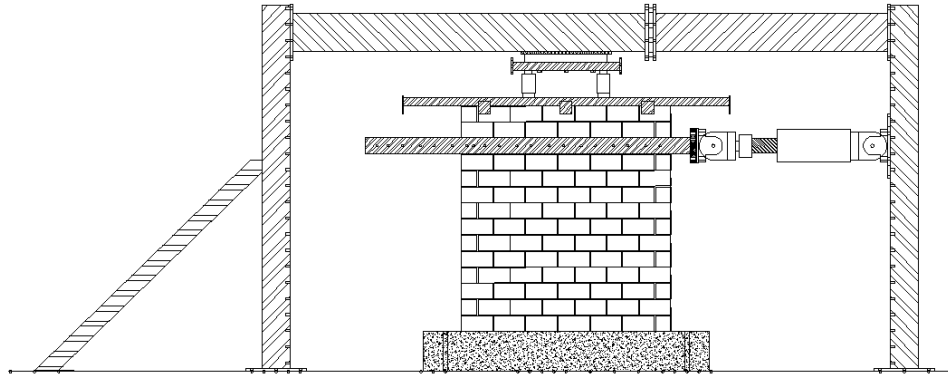
Figure 2-4: H-frame setup using single knee brace

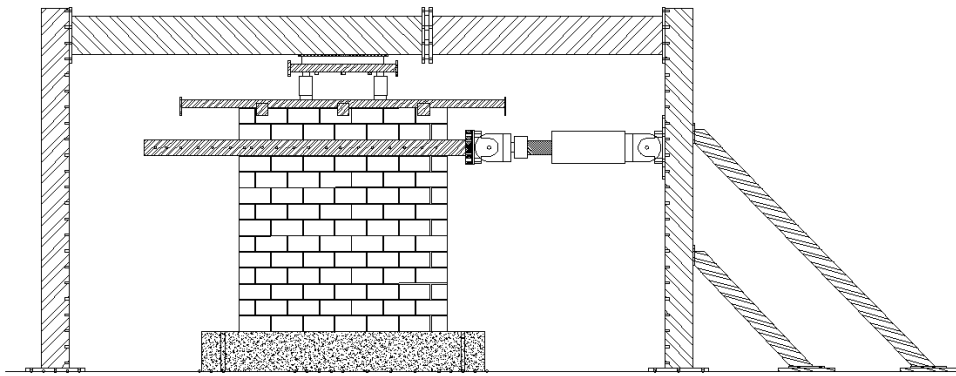
Figure 2-5: H-frame setup using dual knee brace

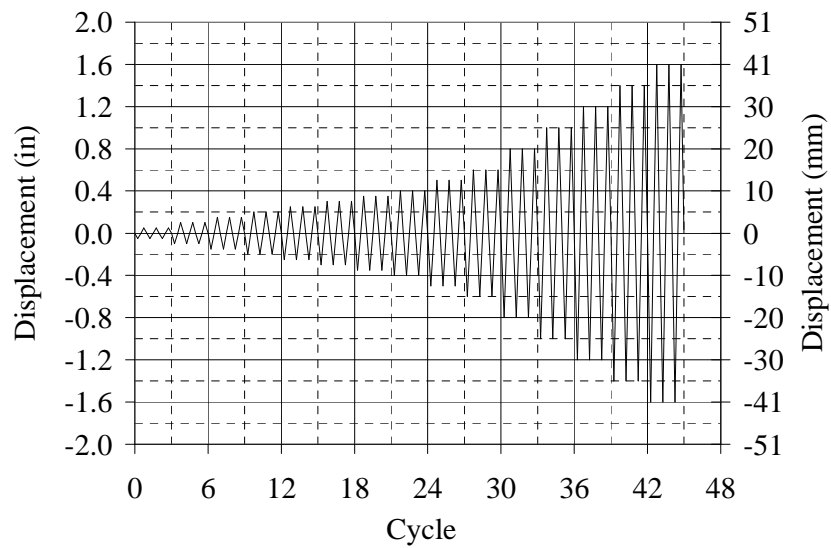
Figure 2-6: Testing protocol showing displacement at each cycle

Specimens were tested using a displacement based protocol consisting of three cycles at each peak displacement value. An estimate of Δ_y was obtained using Equations 2-1 and 2-2 (Priestley et al. 2007). Using the equations with the values listed after Equations 2-1 and 2-2, Δ_y was estimated to be 0.10 in. (2.5 mm), corresponding to a lateral drift of 0.11%. Displacement peaks started at $0.5 \Delta_y$ and increased in $0.5 \Delta_y$ steps to $4 \Delta_y$. Displacement peaks were then $5 \Delta_y$ and $6 \Delta_y$. Peaks were then increased in $2 \Delta_y$ steps until failure was achieved. The displacement protocol is shown in Figure 2-6. The displacement rate was kept constant at 0.1875 in./min. (4.76 mm/min.) for the entire test duration.

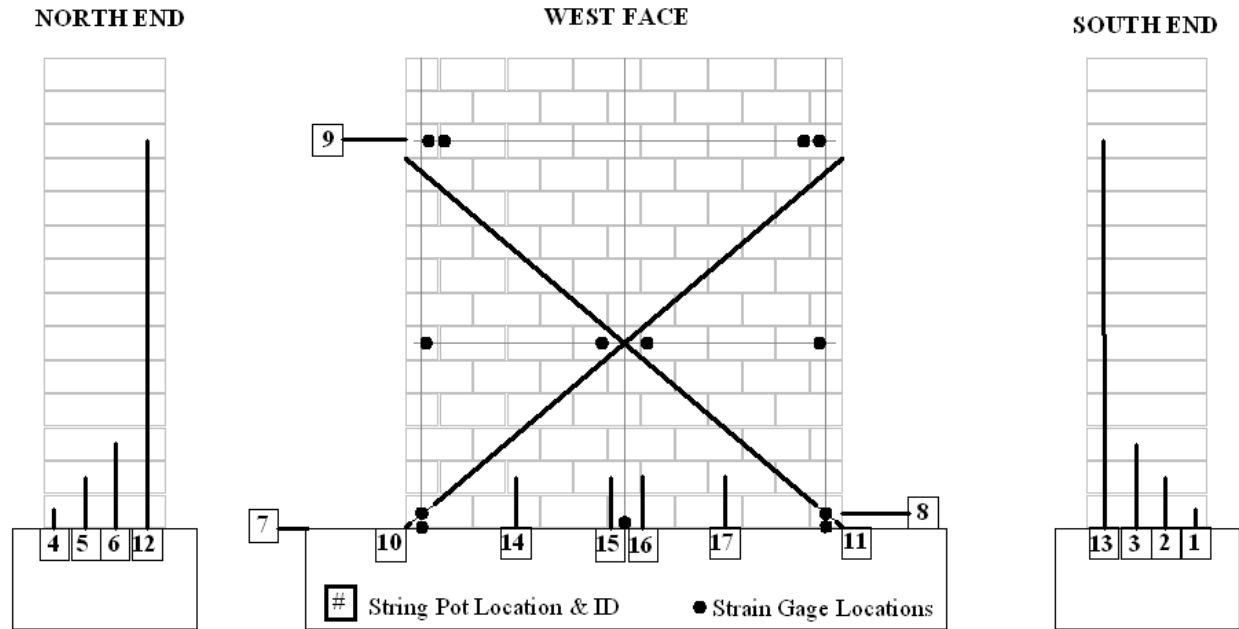
Figure 2-7: Typical location of strain gages and typical location and identifier for string pots on specimens PG085-48, PG120-48, PG169-48 and FG085-00

Figure 2-7 shows the typical location of strain gages for specimens PG085-48, PG120-48, PG169-48 and FG085-00. The flexural (vertical) reinforcement strain gages were located at or just above the top of the foundation. The middle and top shear reinforcement had four strain gages each. Also shown in Figure 2-7 is the placement and identification number for string pots mounted on specimens PG085-48, PG120-48, PG169-48 and FG085-00. Appendix D contains further information for these specimens and for specimens PG085-32 and PG085-24.

String pot 9 measured the global displacement at the level of force application. String pot 8 measured sliding of the wall on the foundation. String pot 7 measured sliding of the foundation on the reaction floor. String pots 1, 2, 3, 4, 5, 6, 12 and 13 measured vertical displacement at the wall ends. String pots 11 and 12 measured the diagonal displacements. String pots 14, 15, 16 and 17 measured vertical displacements along the west face of the wall.

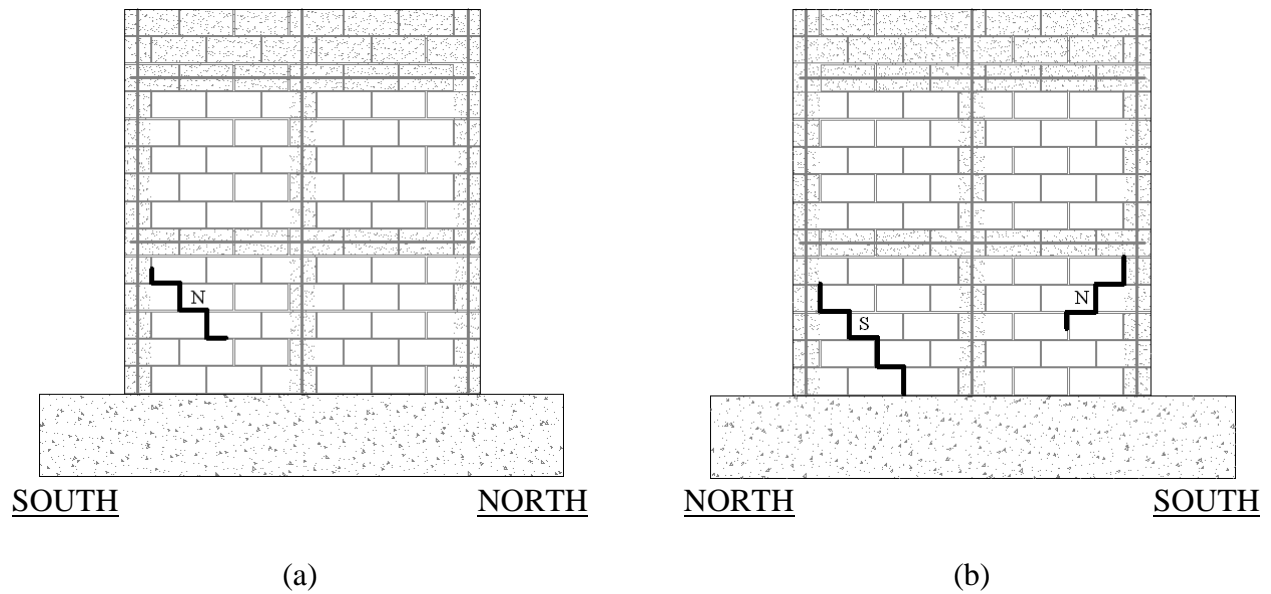
Figure 3-2: Specimen PG085-48, location of first crack at a drift of 0.11% (9.0 kips (40.0 kN)),
 (a) east face, (b) west face. Crack opened with a N = north push, S = south pull.

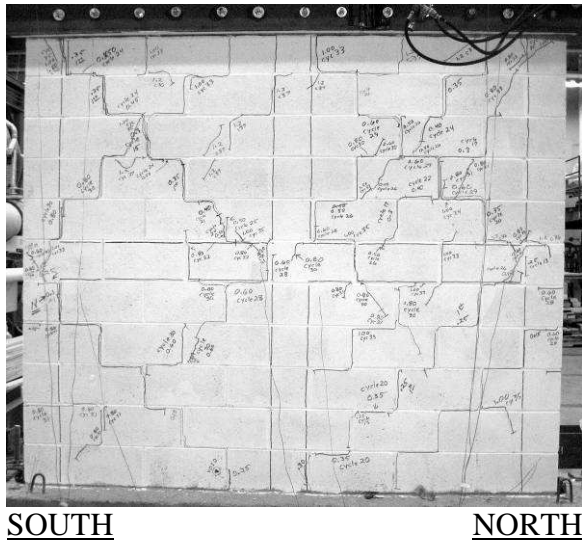
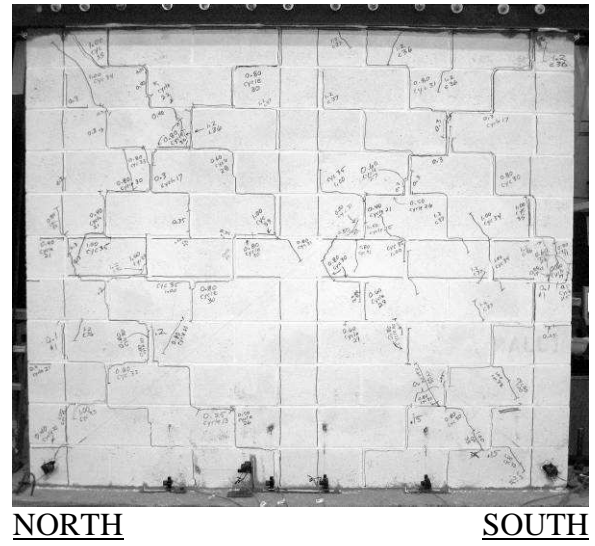
Figure 3-3: Specimen PG085-48, left/right are east/west faces, respectively, after testing to a drift of: (a/b) 0.65% (34.8 kips (155 kN)), and (c/d) 1.5% (42.7 kips (190 kN))

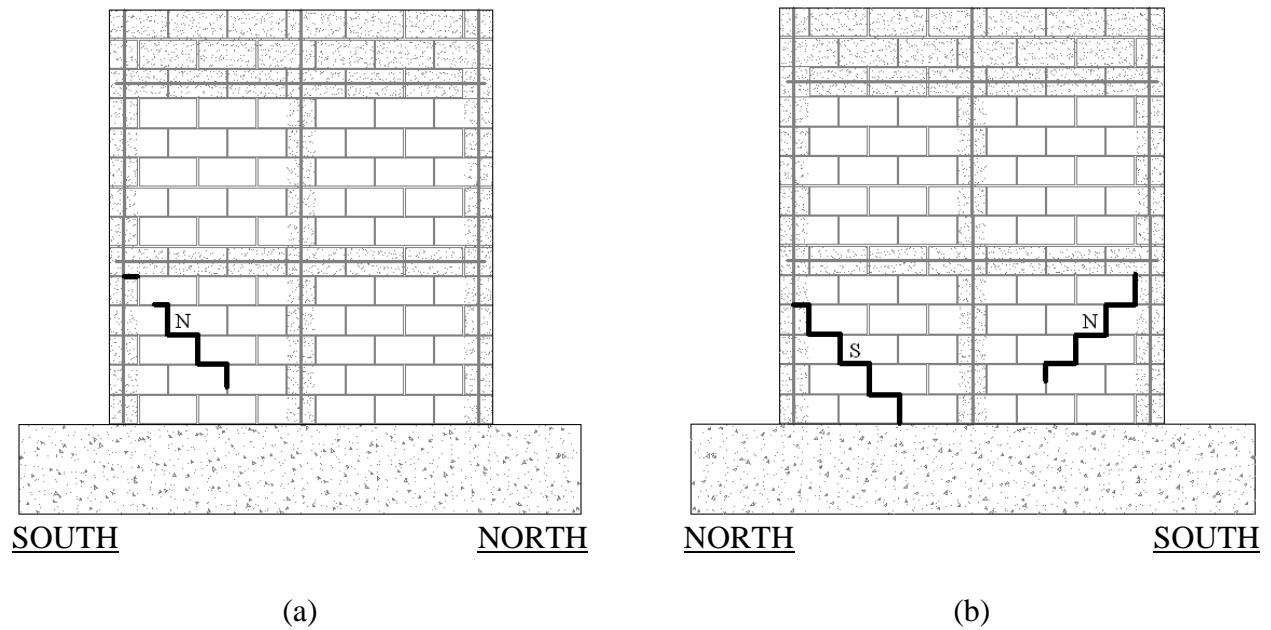
Figure 3-5: Specimen PG120-48, location of first crack at a drift of 0.11% (8.7 kips (38.7 kN)), (a) east face, and (b) west face. Crack opened with a N = north push, S = south pull.

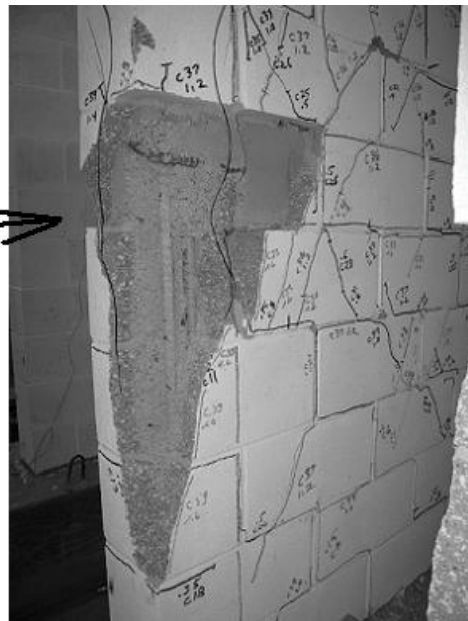
Figure 3-7: Specimen PG120-48, state of damage to south end at end of test, (a) south end and west face, and (b) south end and east face with detached masonry removed

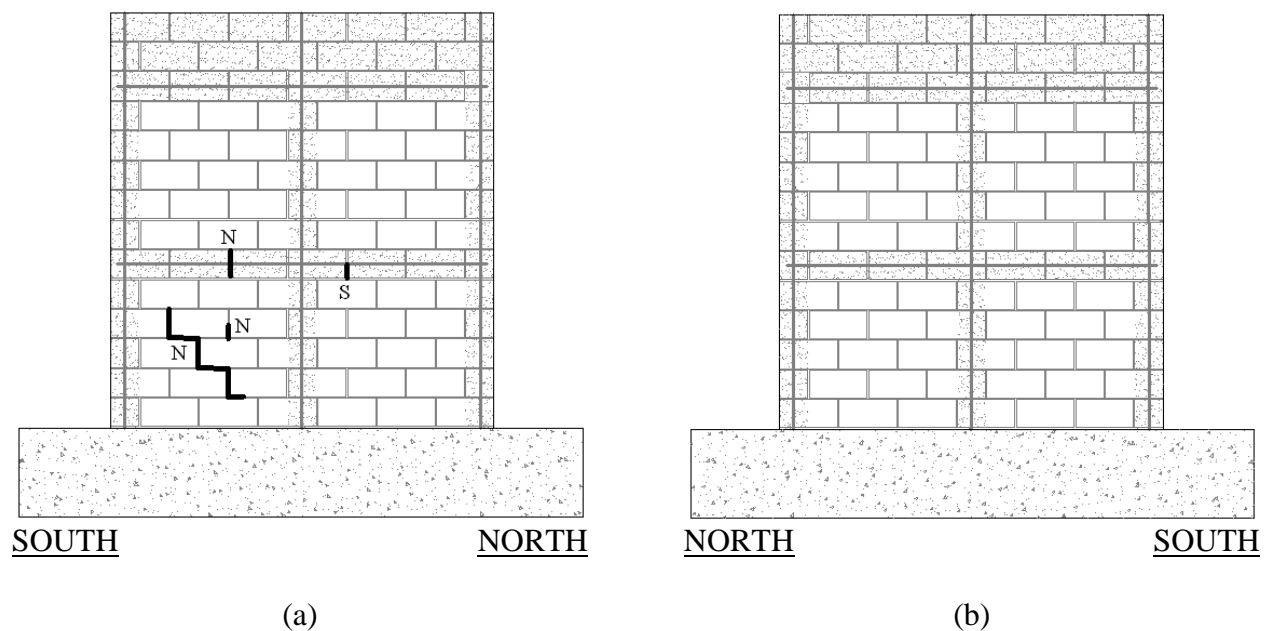
Figure 3-8: Specimen PG169-48, location of first crack at a drift of 0.05% (7.5 kips (33.4 kN)),

(a) east face, and (b) west face. Crack opened with a N = north push, S = south pull.

The first main crack was a stair-step crack and it appeared in the lower south masonry panel during pushing to a drift of 0.05% (7.5 kips (33.4 kN)). Stair-step cracks had formed in all lower panels on or before testing to a drift of 0.22% (21.3 kips (94.7 kN)). During testing to a drift of 0.22%, stair-step cracks from north and south forces formed in the upper panels. During

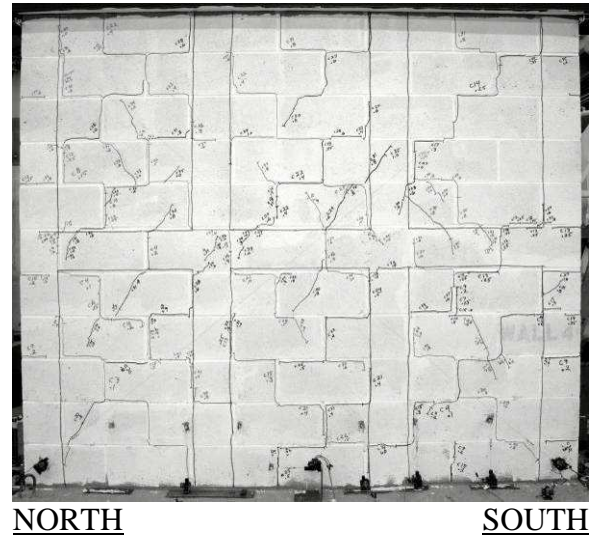
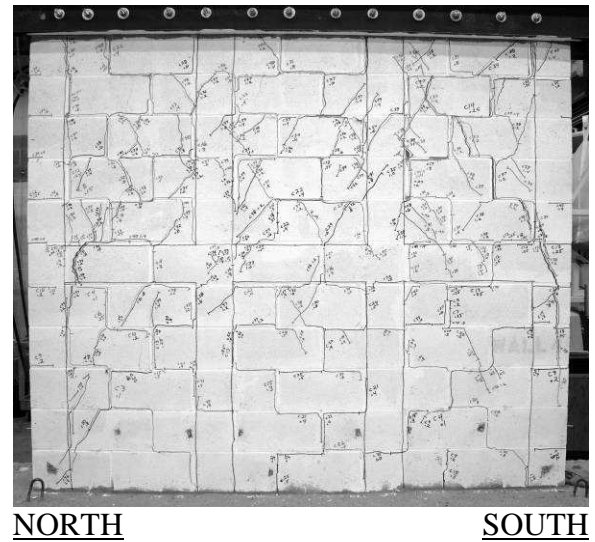
Figure 3-12: Specimen PG085-32, left/right are east/west faces, respectively, after testing to a drift of: (a/b) 0.65% (39.7 kips (177 kN)), (c/d) 1.3% (58.5 kips (260 kN)), and (e/f) 1.5% (53.3 kips (237 kN))

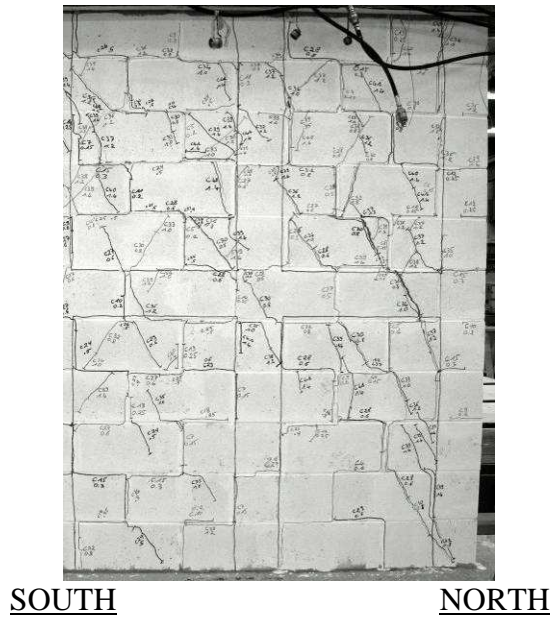
Figure 3-13: Specimen PG085-32, east face, north end cracking at a drift of 1.5%

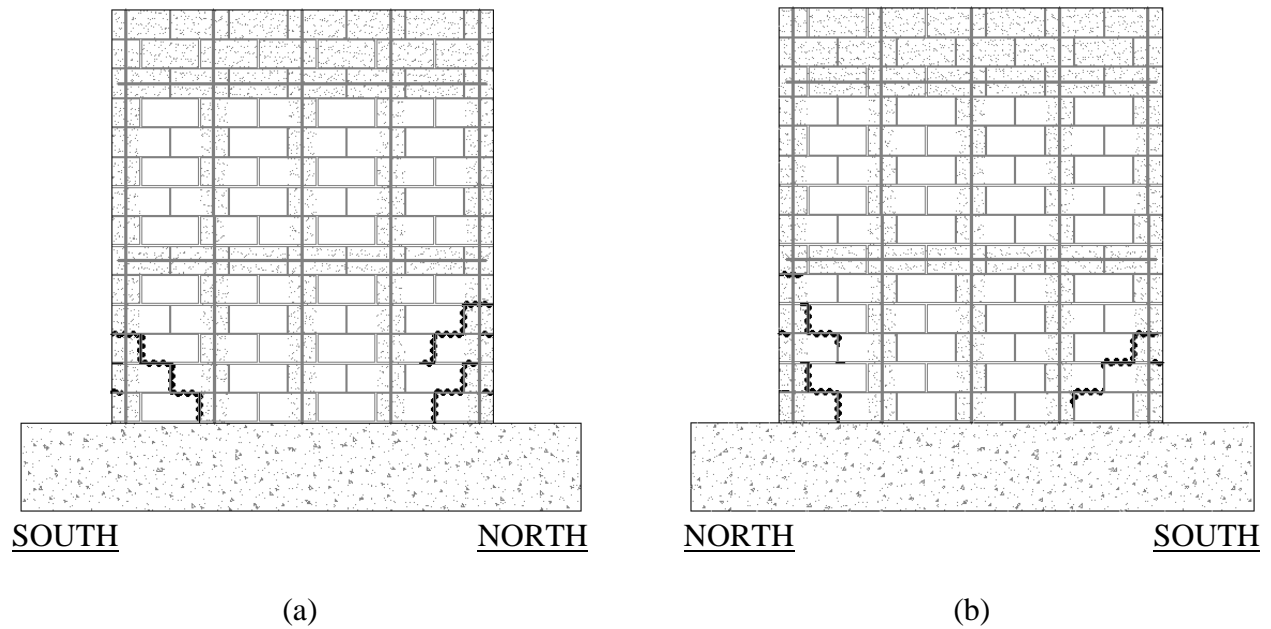
Figure 3-14: Specimen PG085-24 cracking prior to testing, (a) east face, and (b) west face

Unique to specimen PG085-24 were minor stair-step cracks that developed while moving the specimen into the testing frame. Cracks developed in the lower northern and southern most panels (Figure 3-14). Once testing commenced, the first new crack was a vertical crack in the middle bond beam that formed while pushing the specimen to a drift of 0.05% (4.3 kips (19.1 kN)) (Figure 3-15).

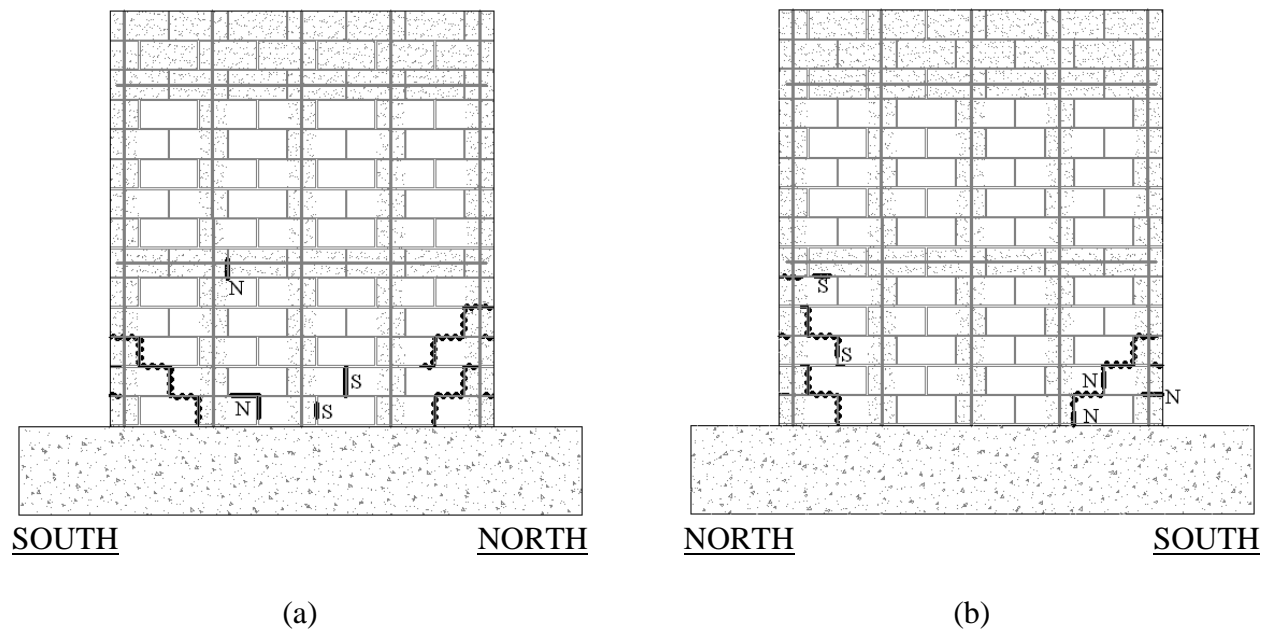
Figure 3-15: Specimen PG085-24, location of first crack at a drift of 0.05% (4.3 kips (19.1 kN)),

(a) east face, and (b) west face. Jagged lines represent pre-test cracks.

Crack opened with a N = north push, S = south pull.

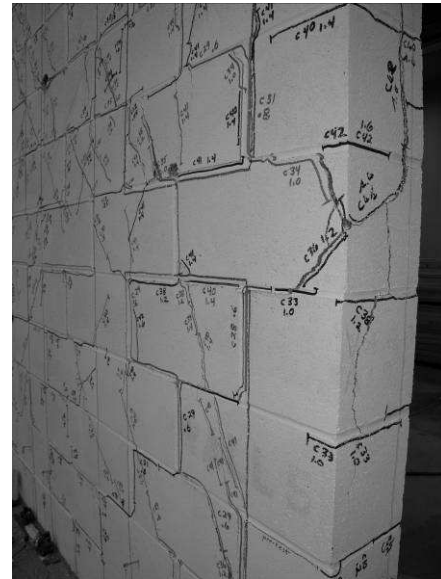
Figure 3-17: Specimen PG085-24 south end damage after testing, (a) south end with east face, and (b) south end with west face

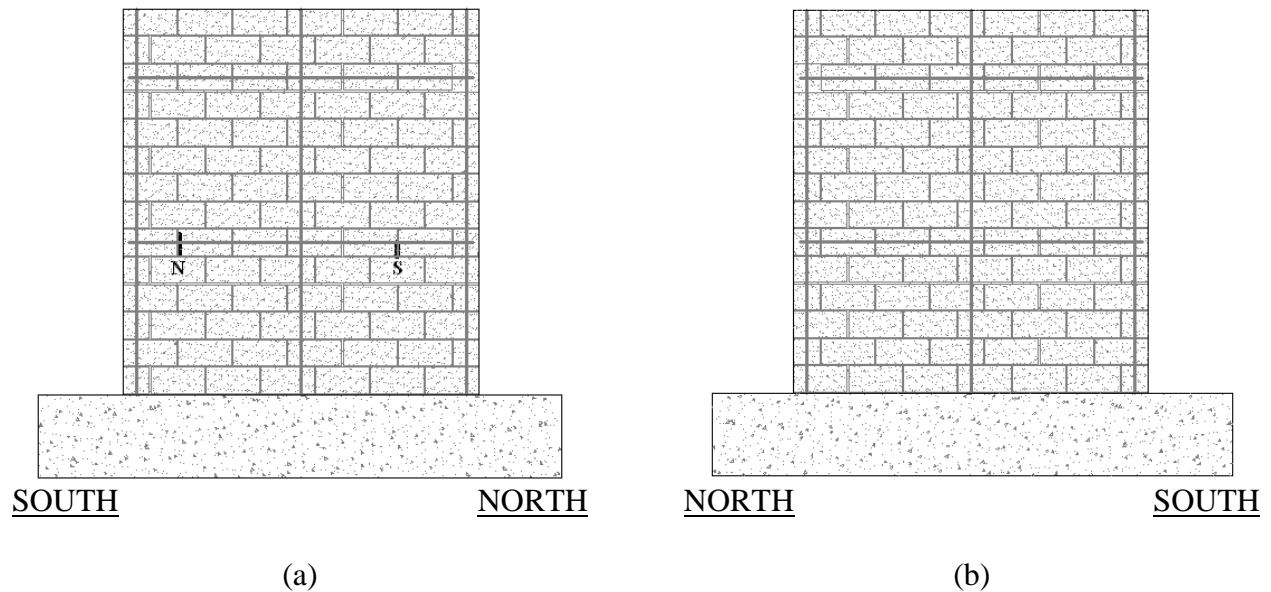
Figure 3-18: Specimen FG085-00, location of first crack at a drift of 0.11% (9.0 kips (40.0 kN)), (a) east face, and (b) west face. Crack opened with a N = north push, S = south pull.

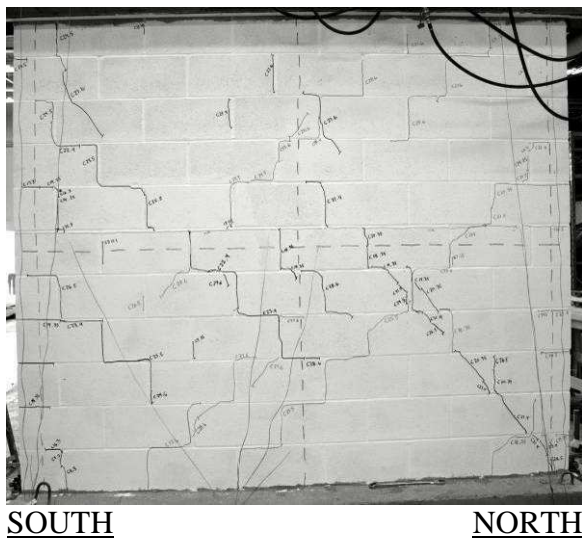
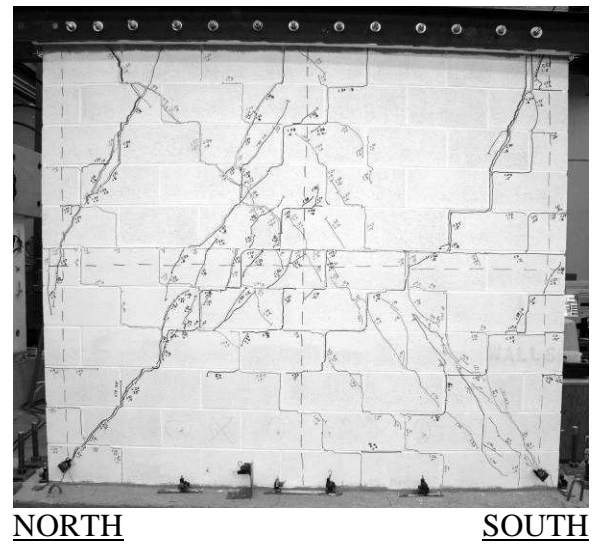
Figure 3-19: Specimen FG085-00, left/right are east/west faces, respectively, after testing to a drift of: (a/b) 0.65% (60.4 kips (269 kN)), and (c/d) 1.3% (69.6 kips (310 kN))

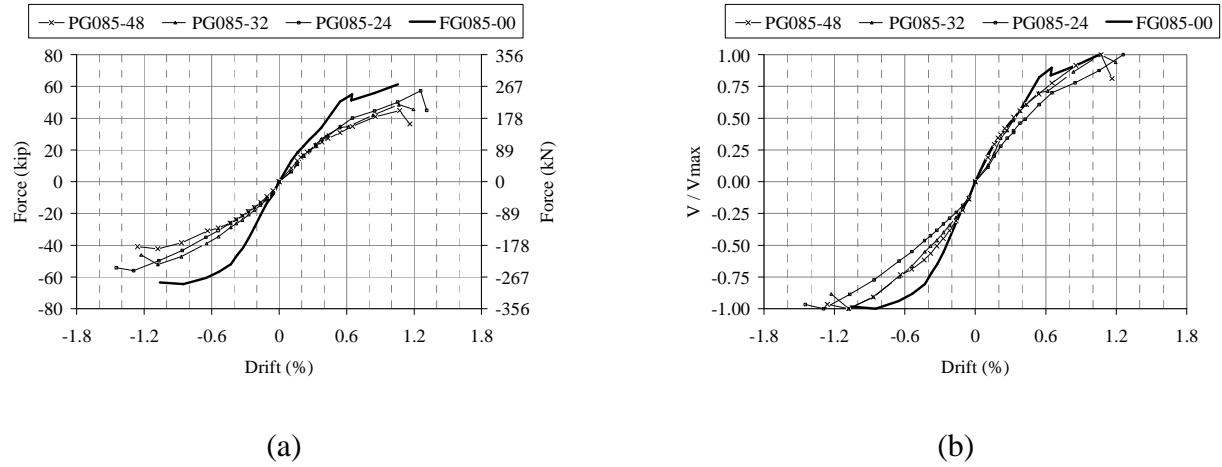
Figure 4-2: (a) Backbone curves for specimens with the same horizontal reinforcement ratio and differing grout horizontal spacing, and (b) backbone curves normalized to peak strength.

For the partially grouted specimens, the grout horizontal spacing did not significantly effect the initial stiffness or the idealized initial stiffness. However, specimen FG085-00 which is the fully grouted specimen has significantly higher initial stiffness (133 kips/in. (23.2 kN/mm)) and idealized initial stiffness (117 kips/in. (20.5 kN/mm)).

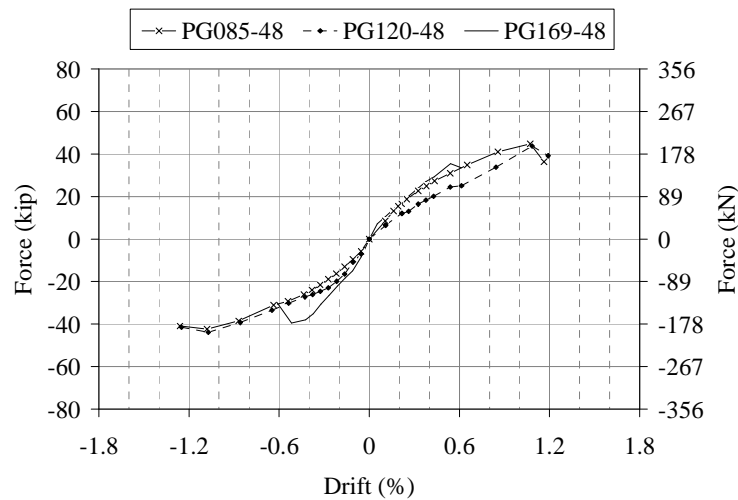
Figure 4-6: Backbone curves for specimens with 48 in. (1219 mm) grout horizontal spacing and varying horizontal reinforcement ratios.

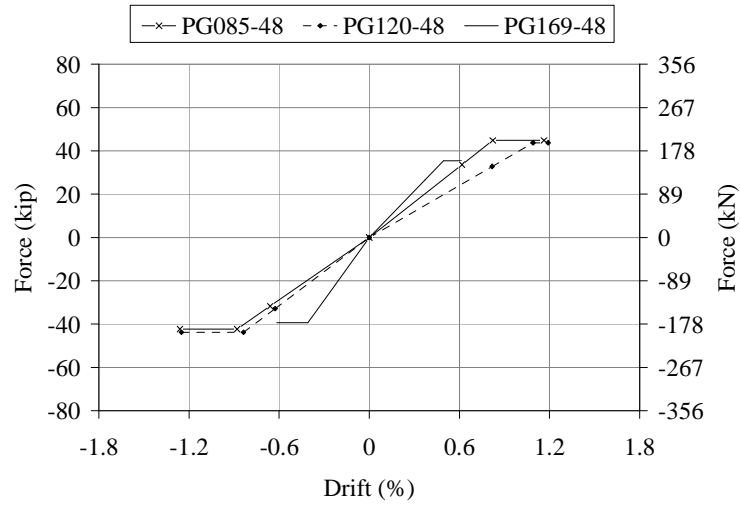
Figure 4-7: Idealized backbone curves for specimens with 48 in. (1219 mm) grout horizontal spacing and varying horizontal reinforcement ratios.

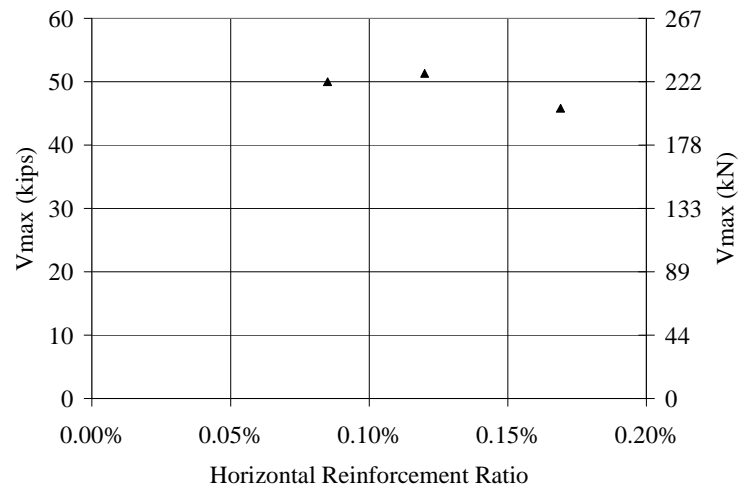
Figure 4-8: Effects of ρ_h on shear strength

Horizontal reinforcement was provided at ratios of 0.085% (specimen PG085-48), 0.120% (specimen PG120-48) and 0.169% (specimen PG169-48). The three specimens had a grout horizontal spacing of 48 in. (1219 mm). For specimens PG085-48, PG120-48, and PG169-48, Figure 4-6 show the backbone curves, Figure 4-7 shows the bilinear idealizations, and Figure 4-8 shows the average peak strength vs. provided horizontal reinforcement ratio.

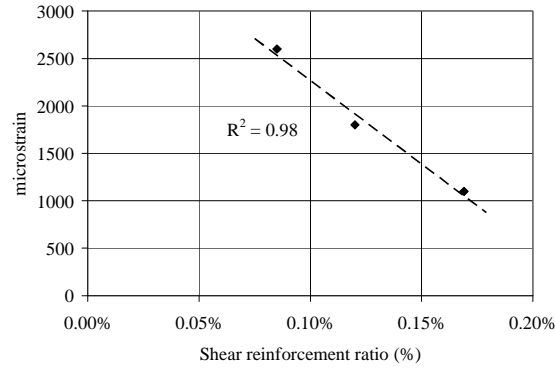
Figure 4-9: Shear reinforcement ratio (%) vs. maximum strain in shear reinforcement

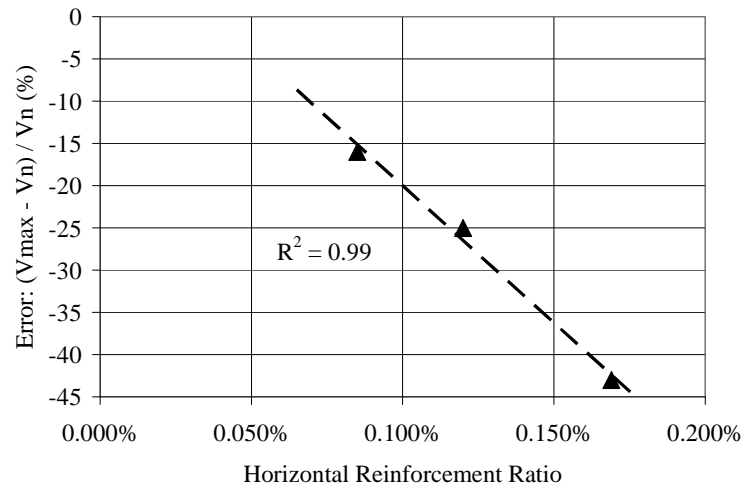
Figure 4-12: Effects of ρ_h on the predictions using MSJC (2008) shear design equations

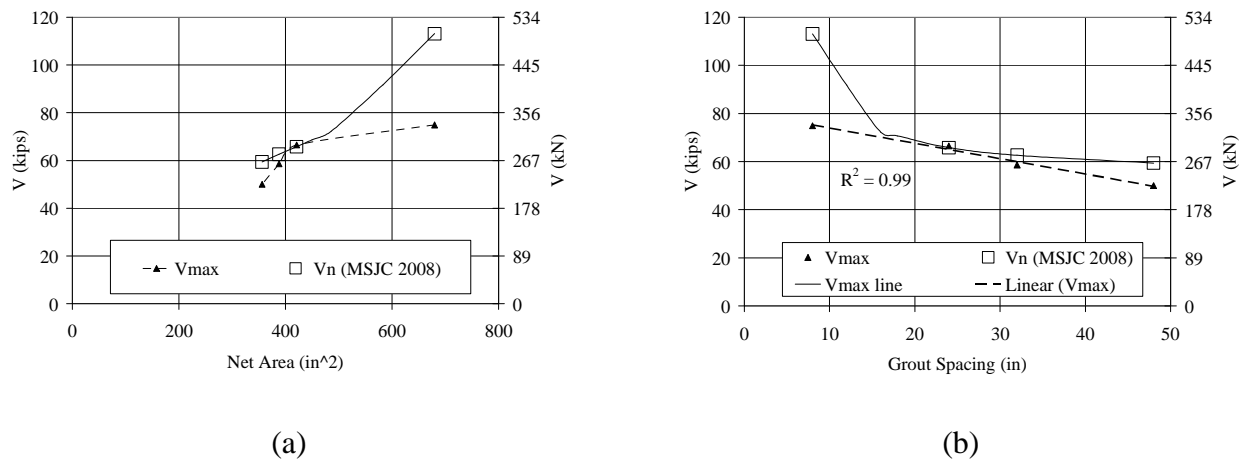
Figure 4-13: Specimens with $\rho_h = 0.085\%$, (a) net area vs. V_{max} and V_n , and (b) grout horizontal spacing vs. V_{max} and V_n , with linear trendline for V_{max}

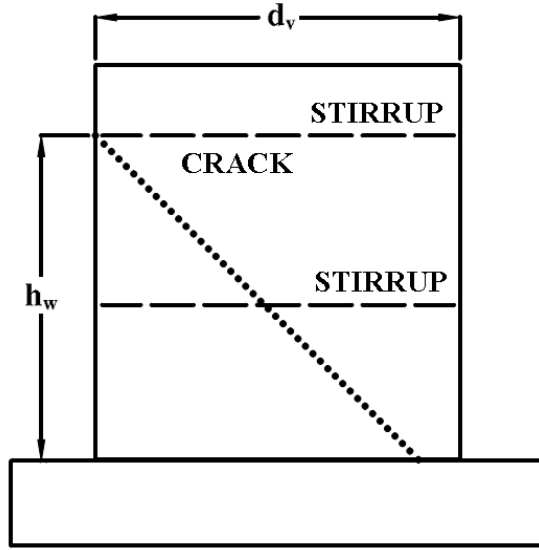
Figure 4-15: 45° shear crack

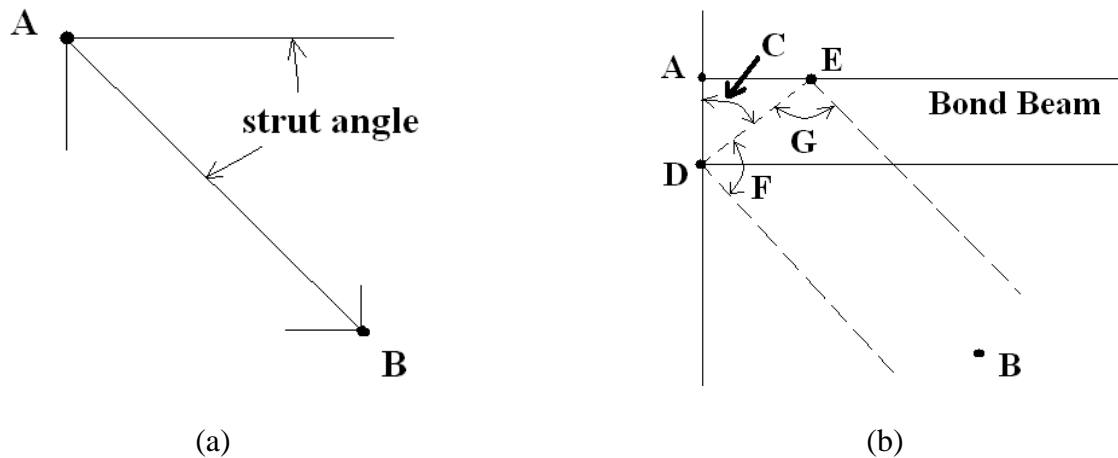
Figure 4-18: Determination of (a) strut angle, and (b) strut width.

The strut width was determined as shown in Figure 4-18. Figure 18(a) shows how to determine the strut angle between nodes A and B. A straight line is drawn from node A to node B (line AB). The angle between a horizontal line and line AB is the strut angle. Figure 4-18(b) shows how to determine the strut width. Point D is located at the bottom edge of the bond beam. A line is drawn from point D, as shown, such that angle C is equal to the strut angle. Point E is the intersection of this line with the top edge of the bond beam. Lines are drawn from points D and E extending to node B such that angles F and G are equal to 90° . These lines form the sides of the strut. The strut width is the distance from point D to point E, i.e. the length of line DE.

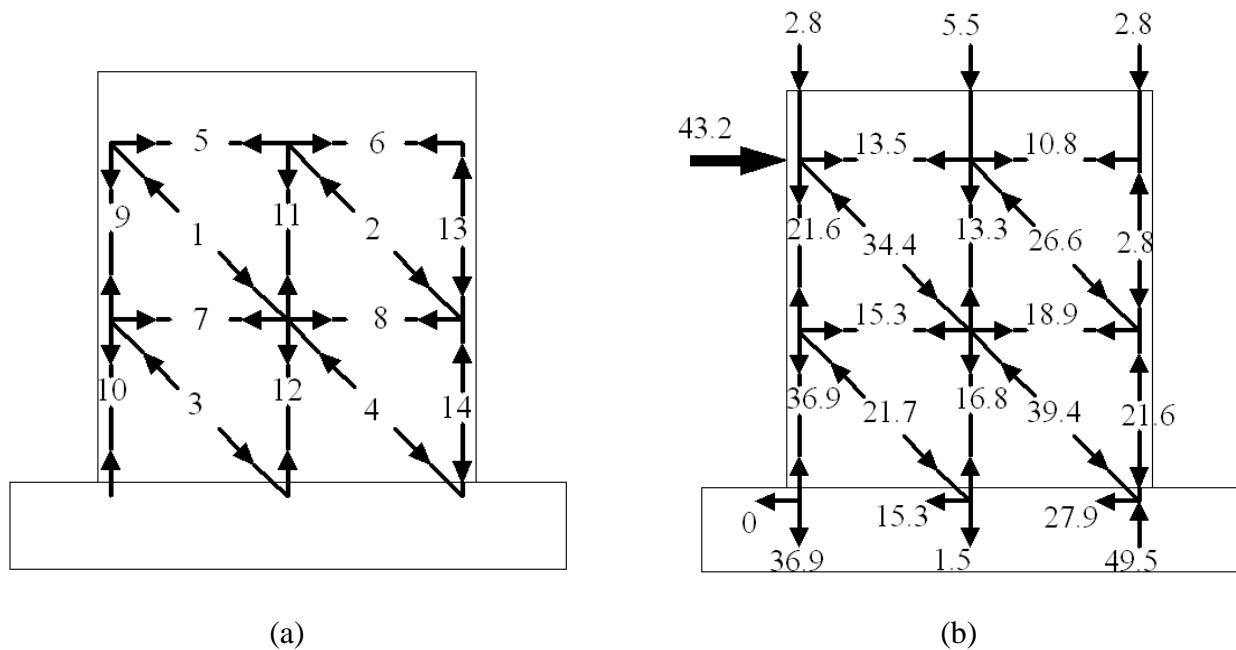
Figure 4-19: Strut and tie model for partially grouted specimens with 48 in. (1219 mm) grout horizontal spacing (a) member labels, and (b) member forces at yield in kips

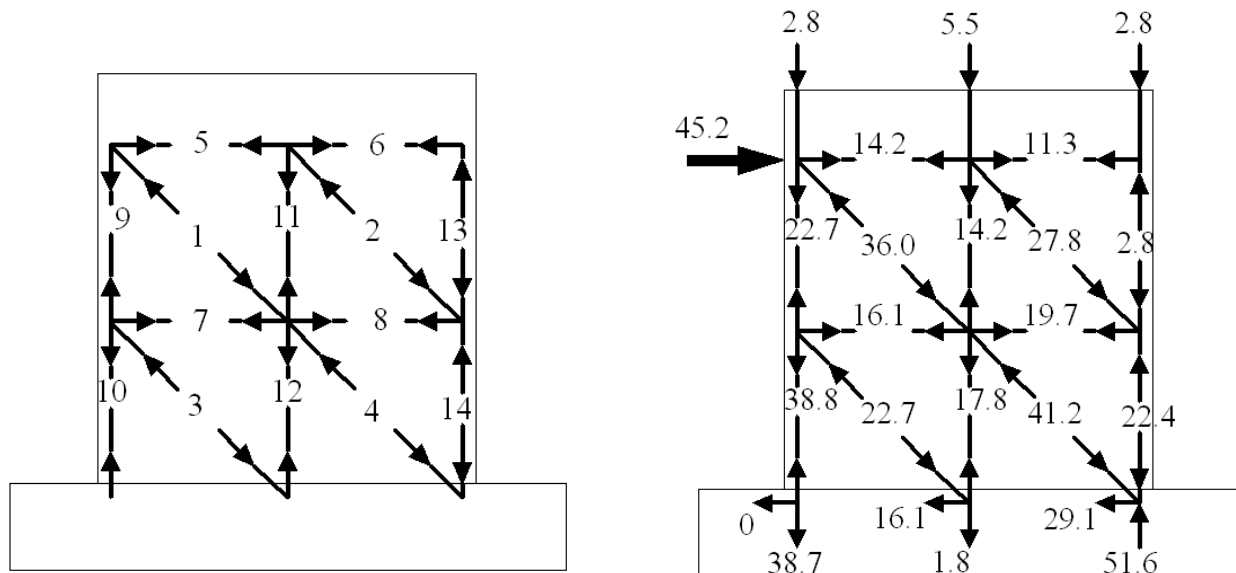
Figure 4-20: Strut and tie model for specimen FG085-00 at first yield, (a) member labels, and (b) member forces at yield in kips

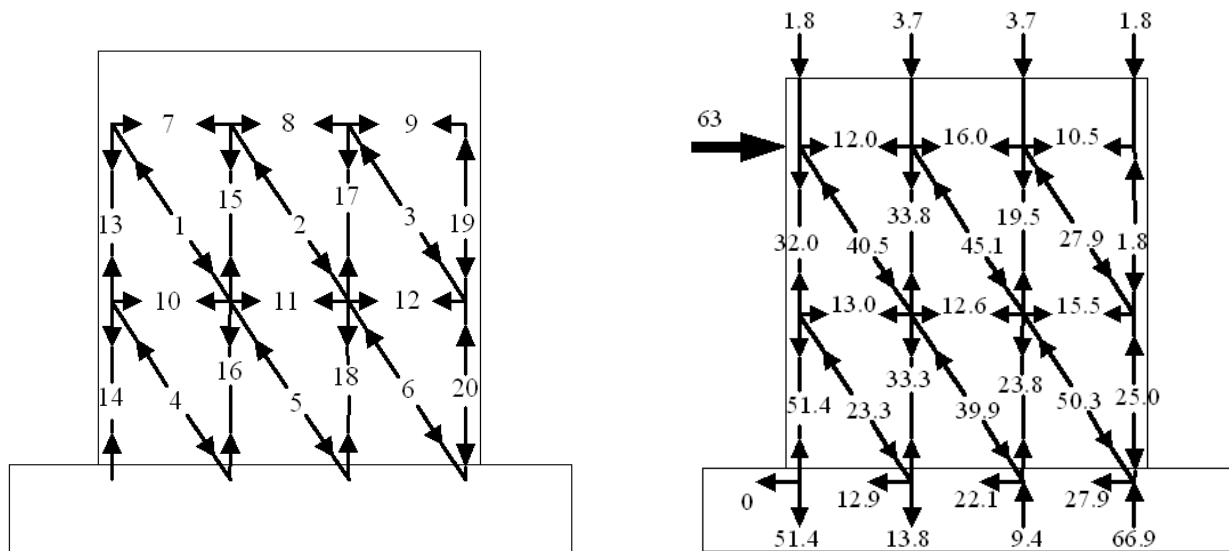
Figure 4-22: Most conservative strut and tie model for specimen PG085-32,
(a) member labels, and (b) member forces at yield in kips.

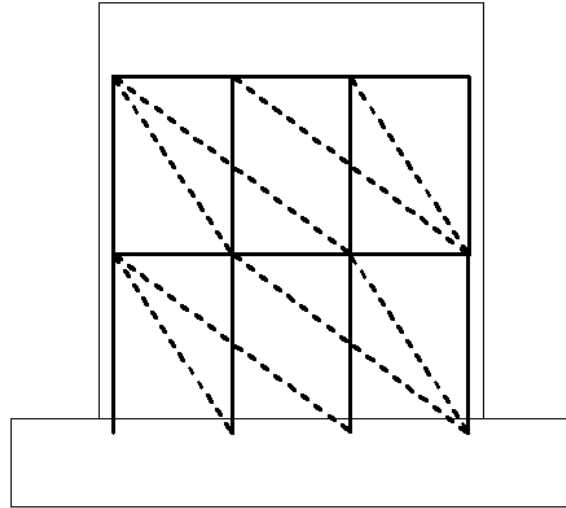
Figure 4-23: Rejected strut and tie model for specimen PG085-32. Dashed lines are compression struts, heavy solid lines are tension ties.

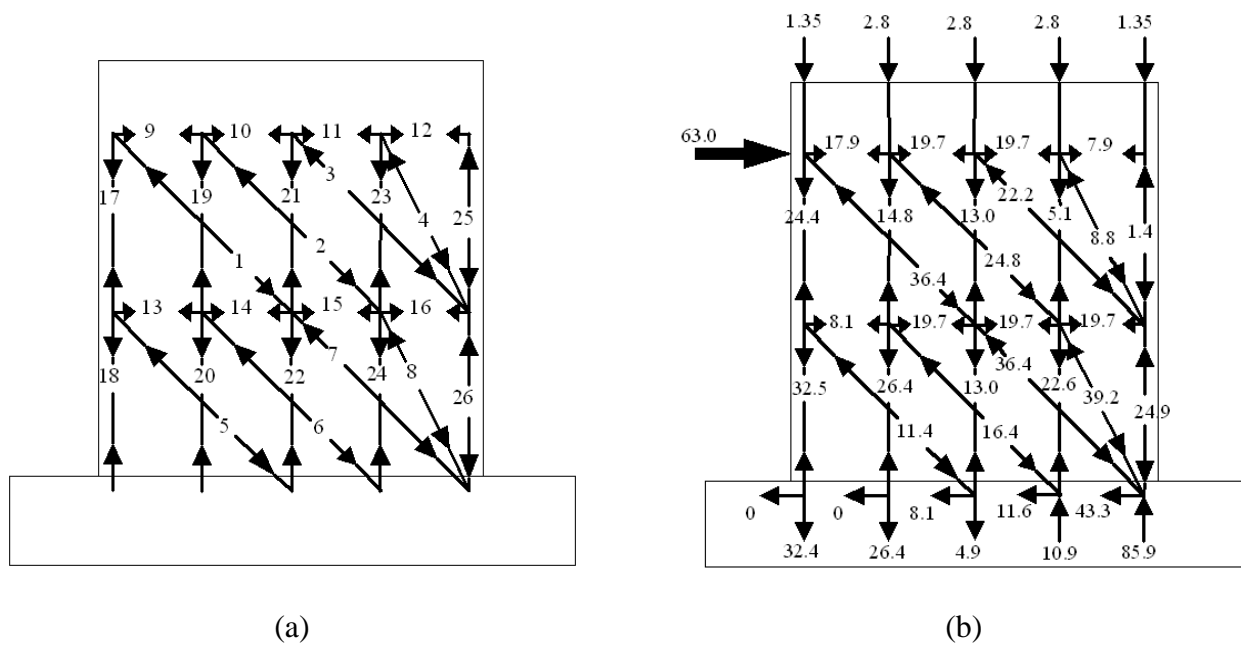
Figure 4-24: Most conservative strut and tie model for specimen PG085-24, (a) member labels, and (b) member forces at failure in kips.

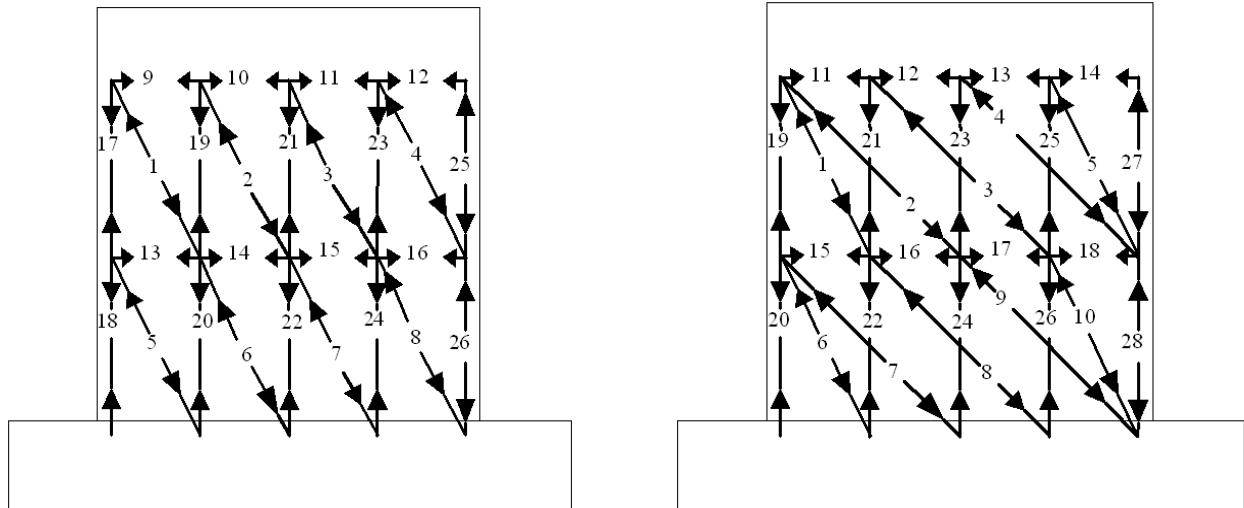
Figure 4-25: Rejected strut and tie models for specimen PG085-24, model reached failure at (a) 84.9 kips (378 kN) and (b) 112 kips (498 kN).

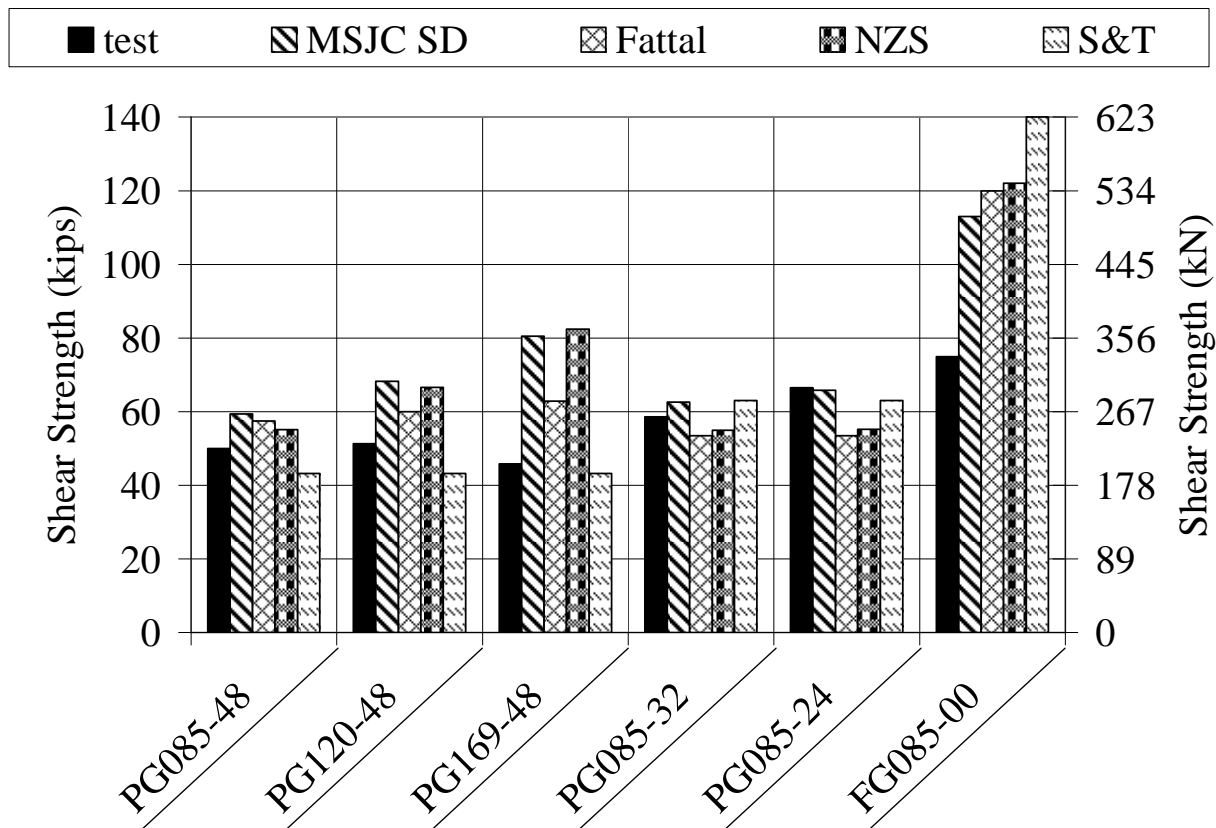
Figure 5-1: Experimental shear strength and shear strength predictions using MSJC (2008) Strength Design, Fattal equations, New Zealand code, and strut and tie model.

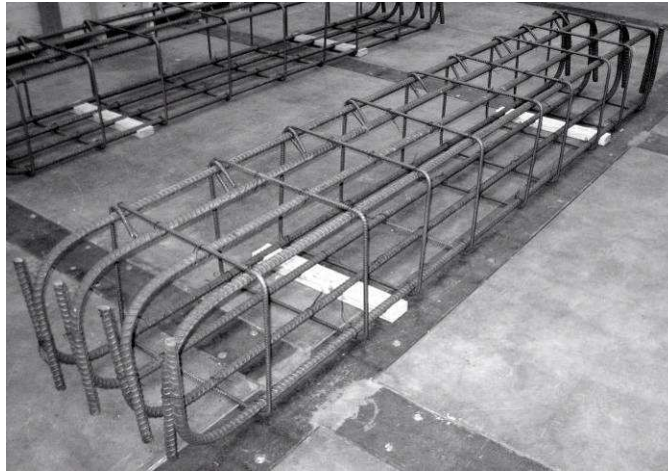
Figure A-1: Foundation reinforcement

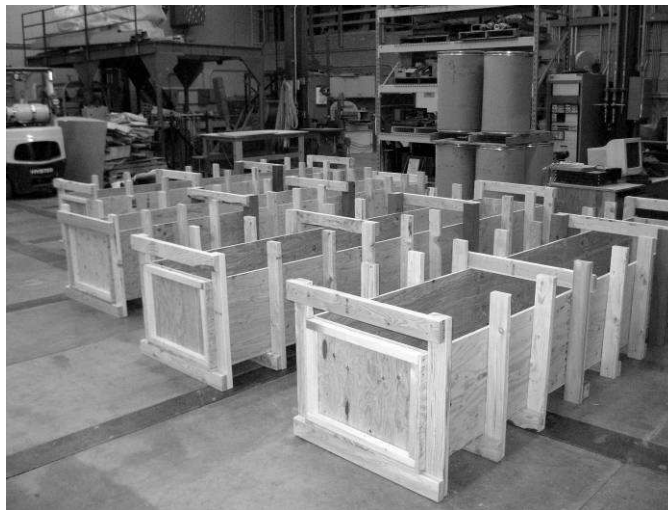
Figure A-2: Foundation forms
