IN-PLANE SHEAR PERFORMANCE OF PARTIALLY
GROUTED MASONRY SHEAR WALLS

A thesis submitted in partial fulfillment of
the requirements for the degree of

WASHINGTON STATE UNIVERSITY
Department of Civil and Environmental Engineering

AUGUST 2010

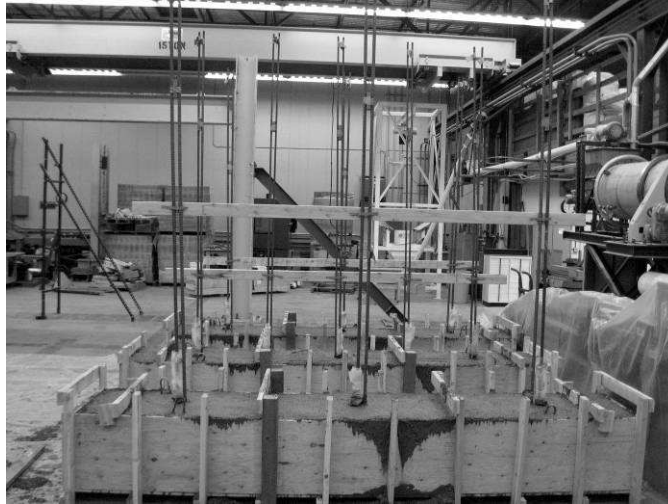
Figure A-3: Freshly poured foundations

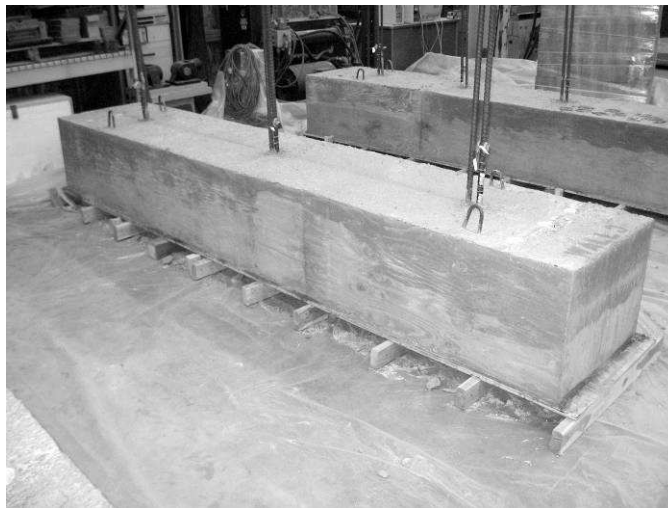
Figure A-4: Foundation with flexural reinforcement at 48 in. (1219 mm).

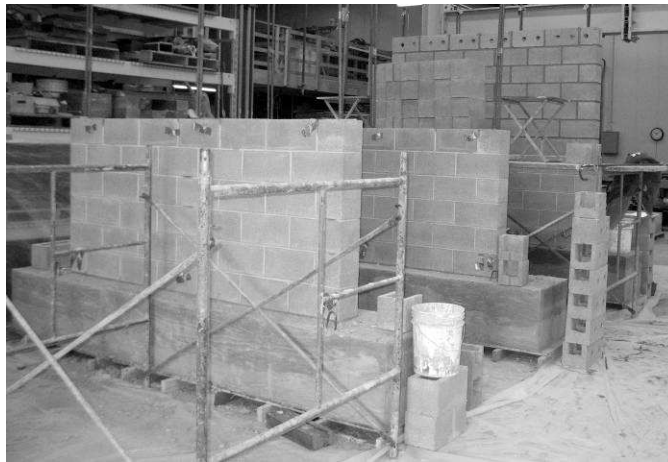
Figure A-5: Wall specimens at mid-construction

Figure A-5 shows three specimens During the second day of construction. The first six courses have been grouted and courses 7 through 12 are under construction. Figure A-6 shows a completed specimen. The OSB boards at the 12th course are a template holding the bolts at the correct spacing.

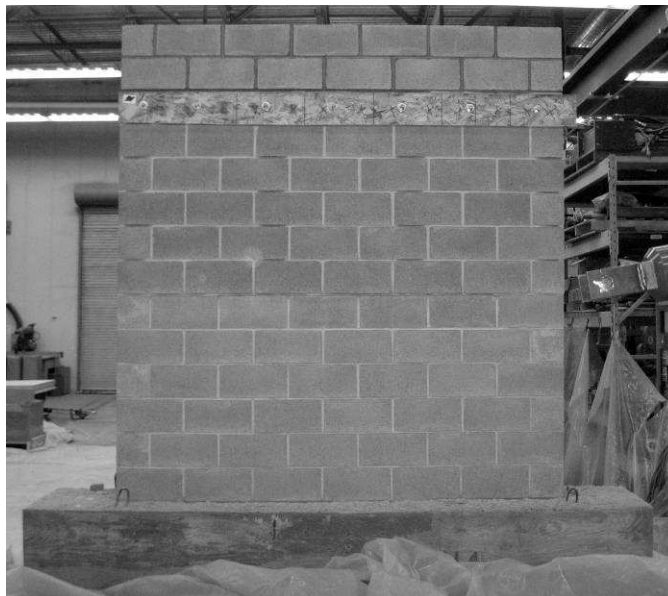
Figure A-6: Finished wall specimen

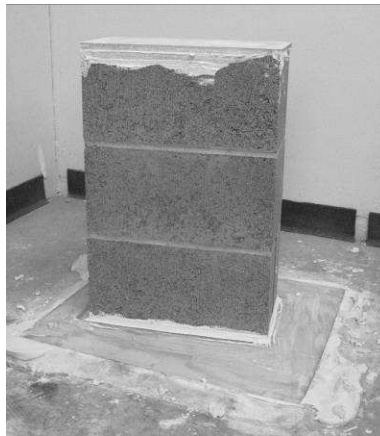
Figure B-1: Station for applying gypsum caps.

Masonry prisms were constructed from masonry units randomly selected from the shipment of units used to construct the wall specimens. Four ungrouted and four grouted prisms comprised of three CMU each were prepared. Prisms were prepared according to ASTM C1314-07. Gypsum caps were cast on the top and bottom of each prism as shown in Figure B-1.

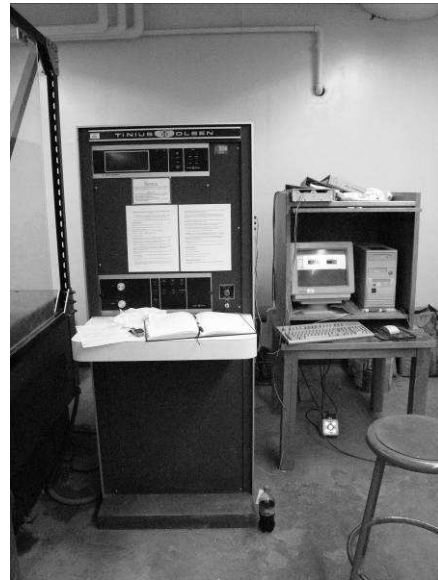
Figure B-2: Material properties testing equipment, (a) tension/compression press, and (b) controller and data acquisition system.

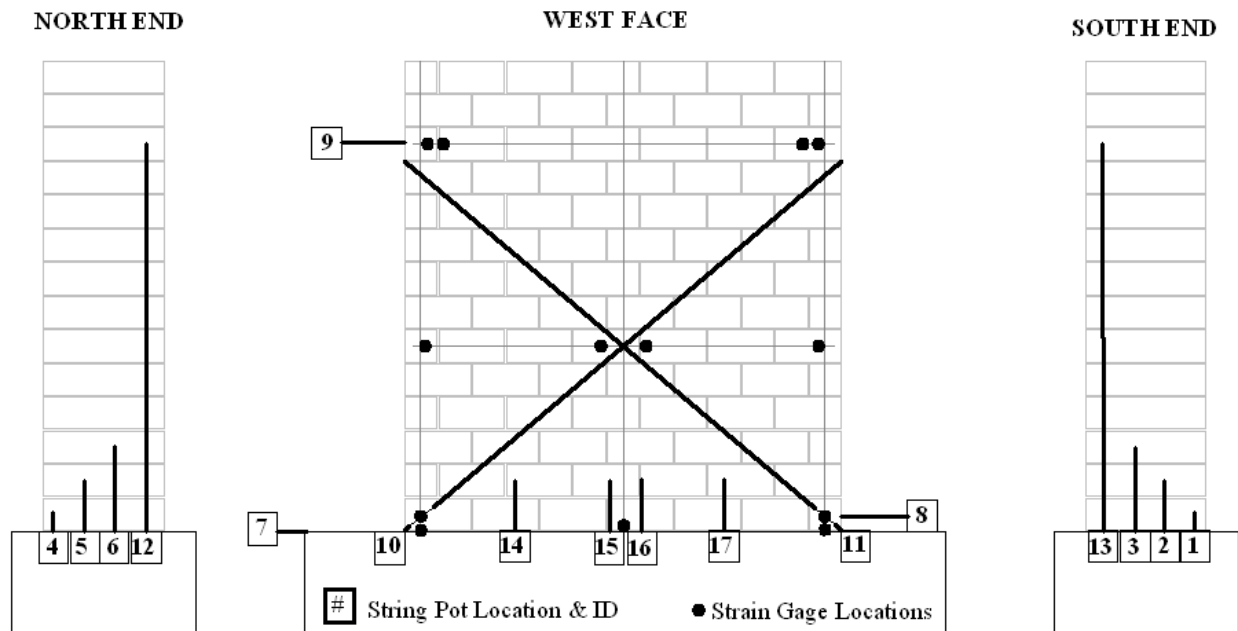
Figure D-1: Location of strain gages and location and identifier for string potentiometers on specimens PG085-48, PG120-48, PG169-48 and FG085-00

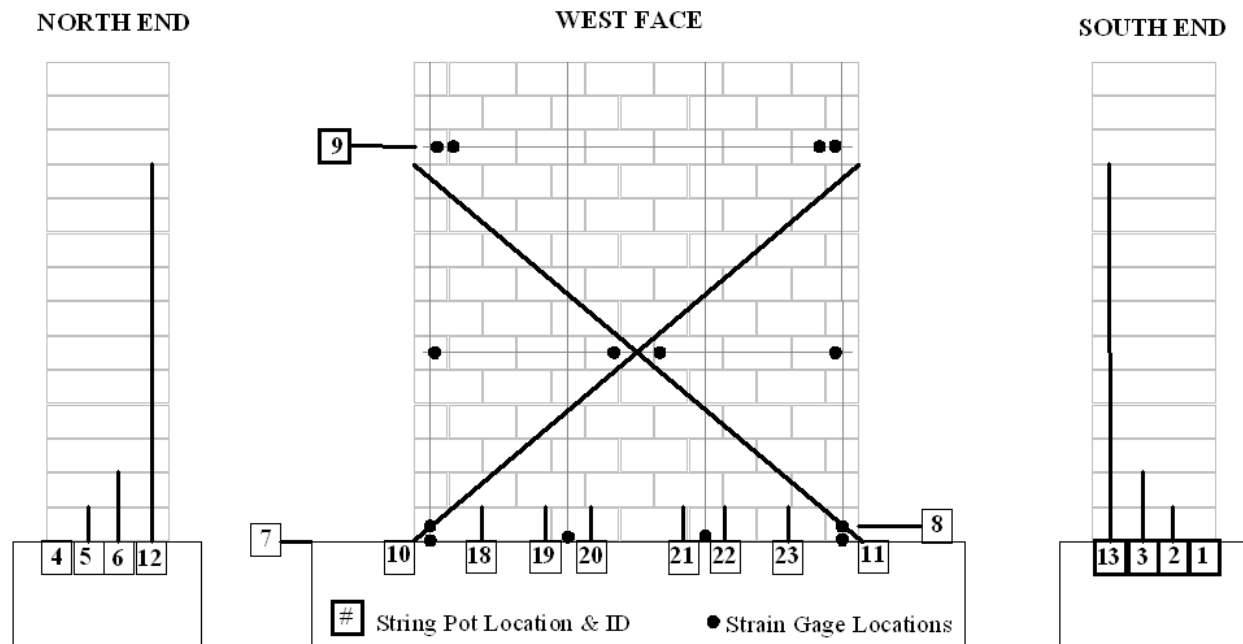
Figure D-2: Location of strain gages and location and identifier for string potentiometers on specimen PG085-32

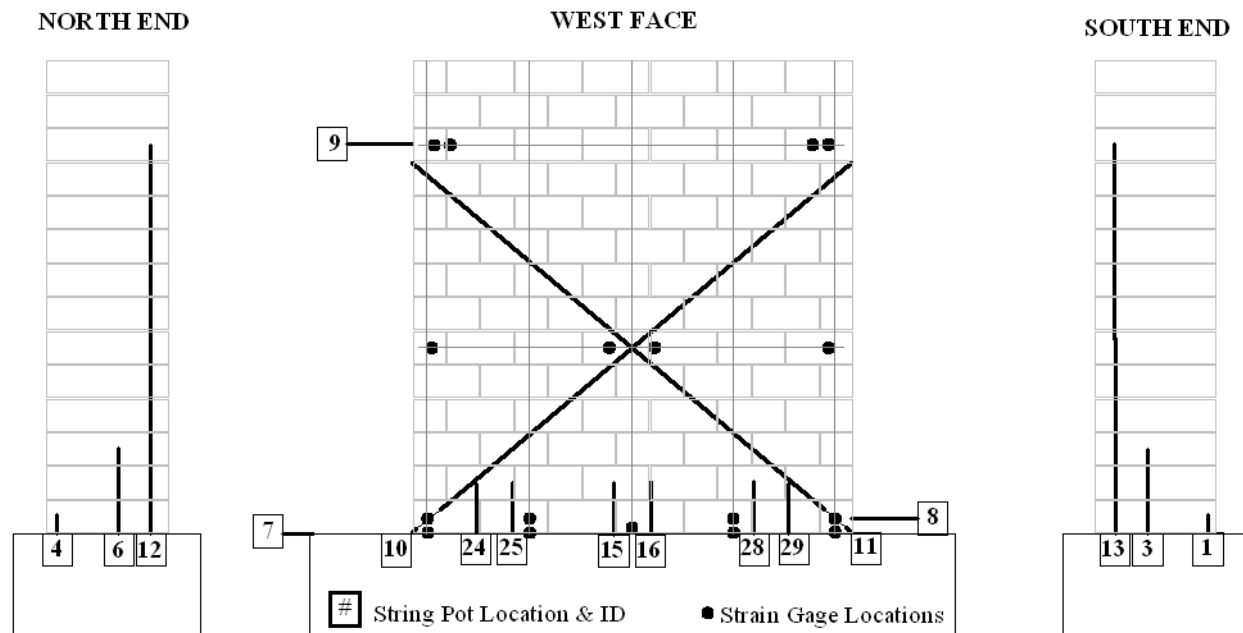
Figure D-3: Location of strain gages and location and identifier for string potentiometers on specimen PG085-24
