COMPARISON OF NUCLEAR AND NON-NUCLEAR DENSITY GAUGES FOR
DETERMINING IN-PLACE DENSITY OF HOT MIX ASPHALT

MASTER OF SCIENCE IN CIVIL ENGINEERING

WASHINGTON STATE UNIVERSITY
Department of Civil and Environmental Engineering

August 2012

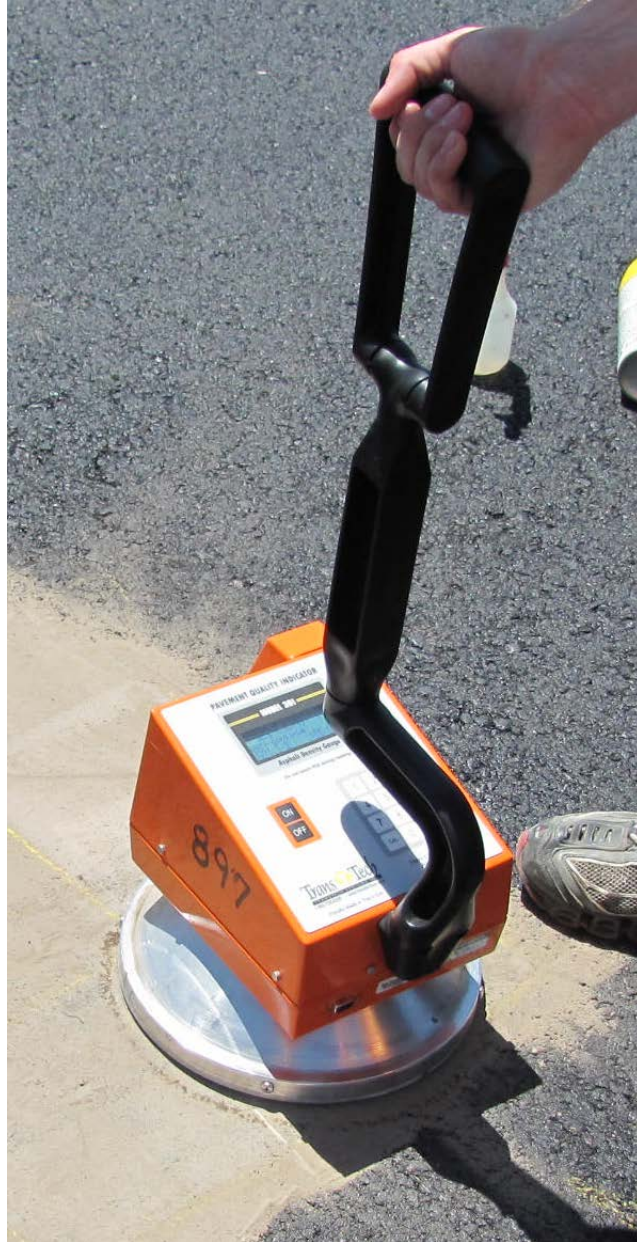
The PQI is developed by TransTech; there are 2 Models, the 300 and 301. The 301+ is the 301 with improved software in order to improve gauge accuracy. The PQI used by WSU for this study was SN 897, shown in Figure 2.1. It is significantly smaller (12 pounds) than most NDGs and requires no warm up time as well as taking much shorter measurements (around 3 seconds) than NDGs. The gauges need to be calibrated in order to correct for their bias and measure true density, or can be used right out of the case for relative density (e.g. finding locations of lower density than surrounding material) (Sully-Miller, 2000).

Figure 2.1. PQI Non-Nuclear Density Gauge.

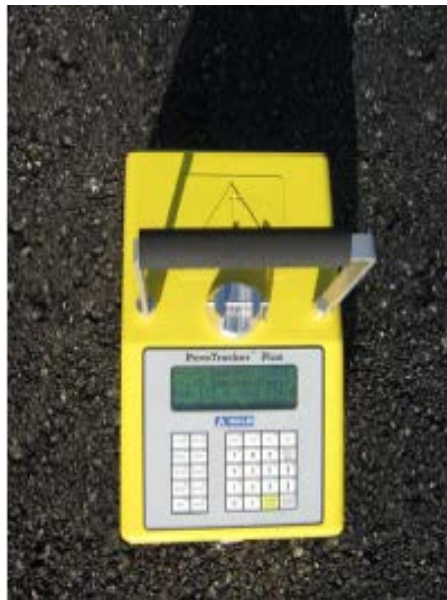
of the pavement to an alternating current. The PaveTracker used in this study was a Troxler PaveTracker Plus, Serial Number (SN) 64454.

Figure 2.2. PaveTracker Non-Nuclear Density Gauge.

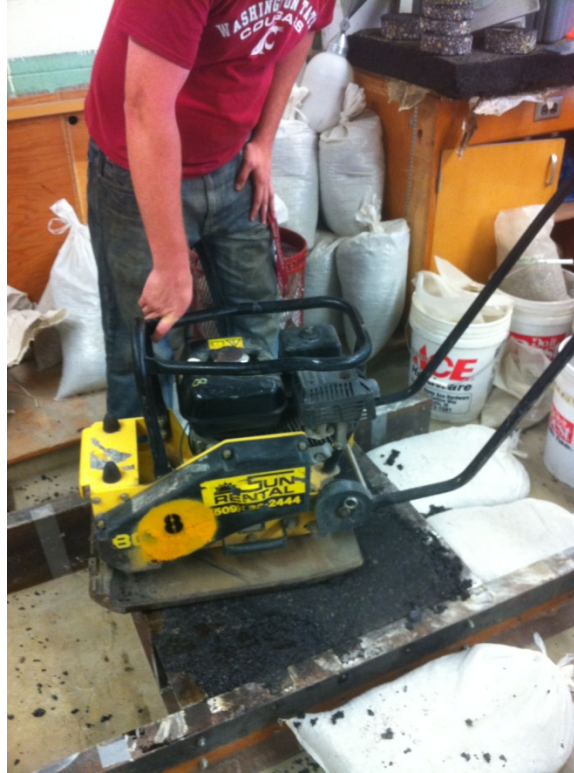
Laboratory testing was conducted in order to observe the effects of temperature as well as both surface and internal moisture on the performance of the NNDGs. The mold used to compact the HMA sample was made of four bolted together “C” shaped steel sections, with the final mold measuring 21.625 x 23.875 inches, and a slab thickness of 2 inches. The steel pieces are 8 inches in height. A 6-inch tall wooden block topped with a metal plate was placed inside of the mold to achieve the desired slab thickness. This resulted in a compacted slab volume of 0.623 ft³. A total of five laboratory samples were compacted using a vibratory plate compactor as shown in Figure 3.1. Slabs were targeted to 7% air voids.

Figure 3.1. Laboratory compaction using vibratory plate compactor.

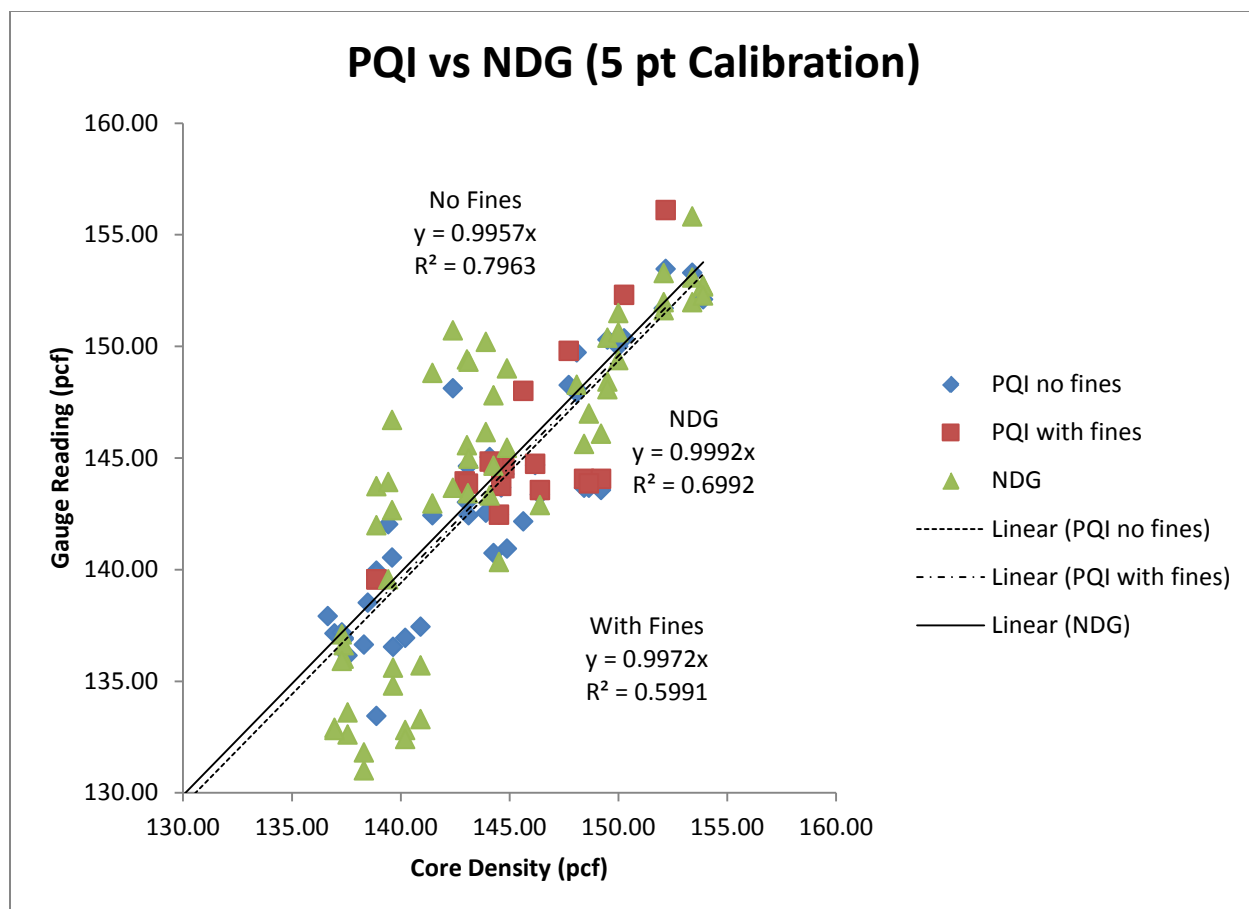
The PQI without fines and NDG readings again correlate very well with core densities for the five point correlation. Slopes of all three trendlines are 0.99. The R^2 values of PQI without fines (0.79) is greater than that of the NDG (0.70), with the PQI with fines having the lowest value at 0.60. A summary of the correlation data is shown in Table 4.2.

Figure 4.3. PQI vs NDG 5-point Calibration Correlation Results

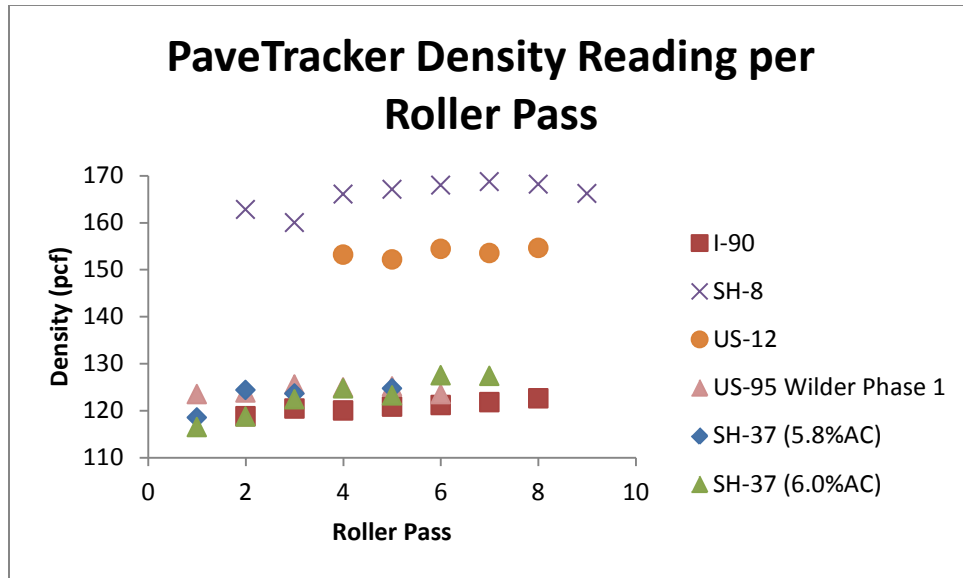
Testing was also conducted to determine if the NNDGs could accurately establish a roller pattern for field compaction. Figures 4.7 and 4.8 show the PQI and PaveTracker density readings, respectively, after each roller pass.

Figure 4.8. PaveTracker Density Reading at each Roller Pass.

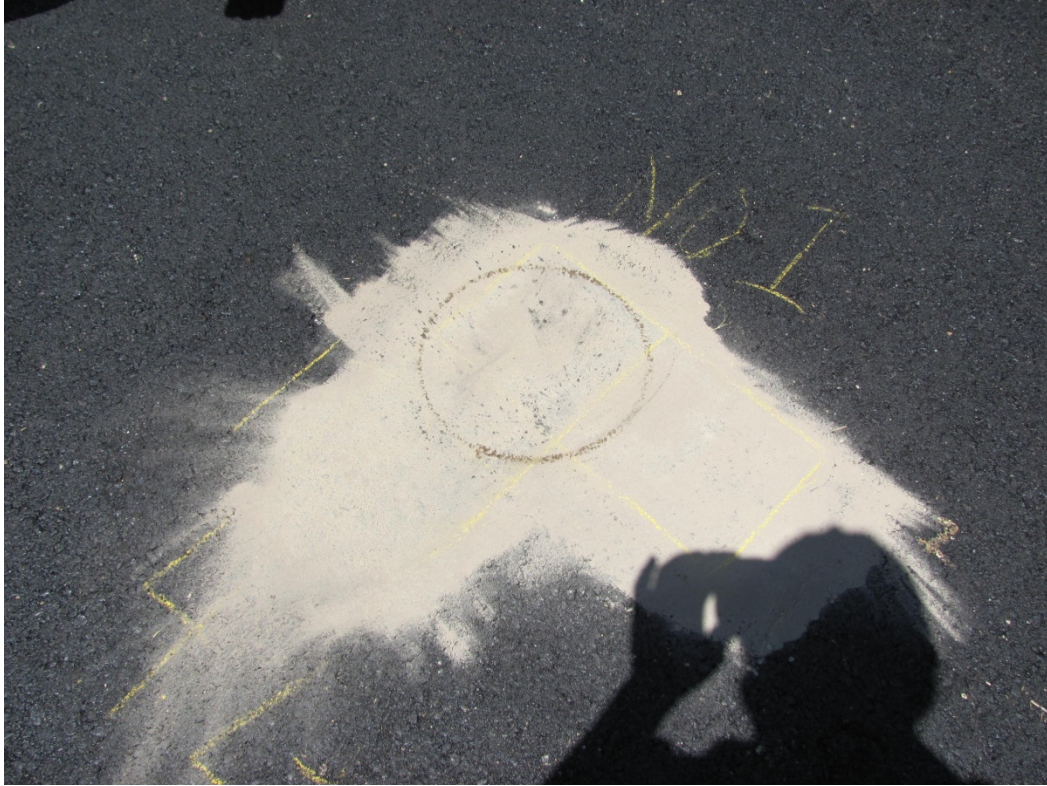
The first local factor tested was the presence of surface fines or debris. Fines were placed on the surface and spread into a thin layer filling in surface gaps, which is a standard testing procedure for NDGs. Figure 4.7 shows a test location with fines on the surface. Tables 4.6 and 4.7 show the gauge readings with and without surface fines, as well as the percent error vs core density for both sets of readings. The P-value obtained from a two-tailed, paired t-test is also shown. A P-value is less than 0.05 indicates that the local factor causes a significant difference in percent error with 95% confidence.

Figure 4.11. Test Location with Surface Fines.

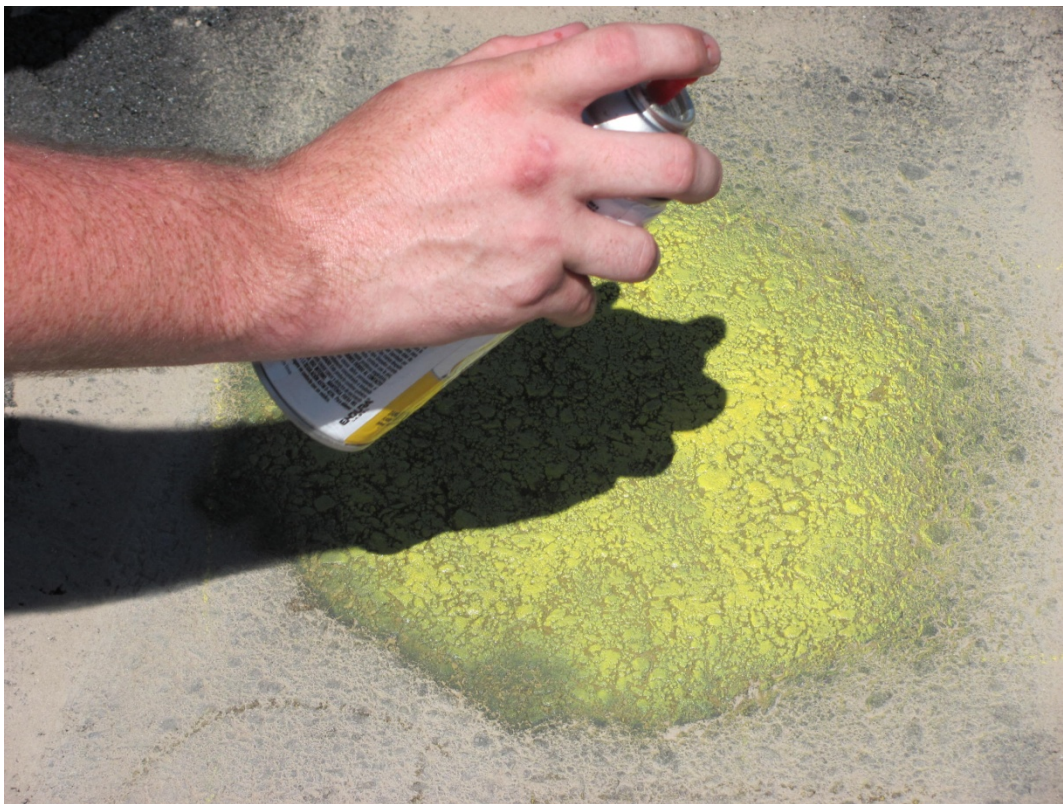
Presence of pavement markings such as paint could potentially affect NNDG readings. Therefore testing was performed with spray paint applied to the pavement surface, as seen in Figure 4.12. Results of gauge readings with and without paint on the surface are shown in Tables 4.7 and 4.8 for the PQI and PaveTracker, respectively.

Figure 4.12. Applying Paint to HMA Surface.

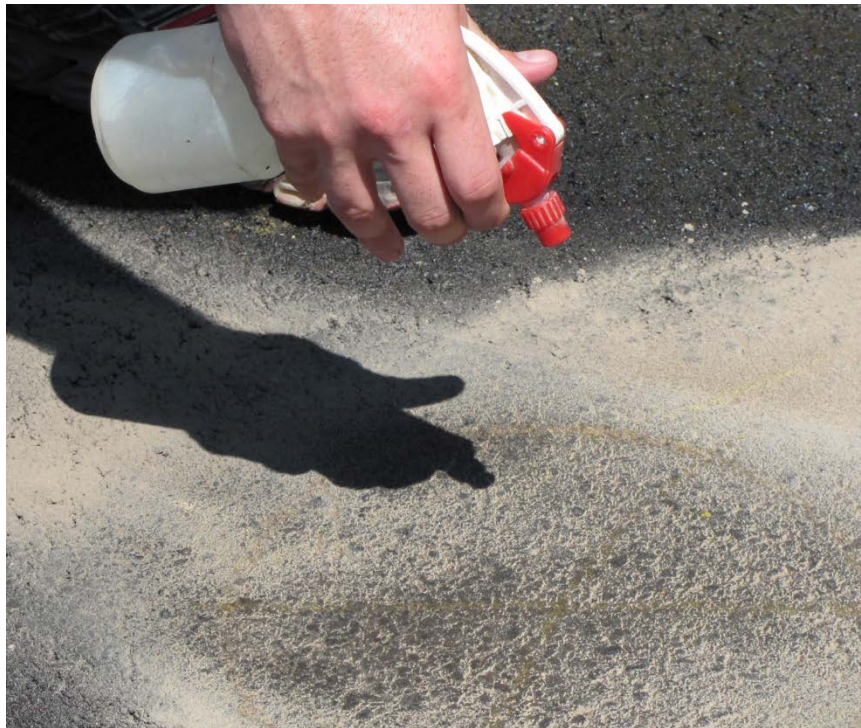
Presence of moisture has been shown to affect NNDG readings, therefore testing was performed with water applied to testing surface with a small spray bottle, as shown in Figure 4.13. Change in H₂O index was plotted vs. both change in gauge reading and change in gauge percent error as seen in figures 4.14 through 4.17.

Figure 4.13. Water Being Applied to Testing Surface.

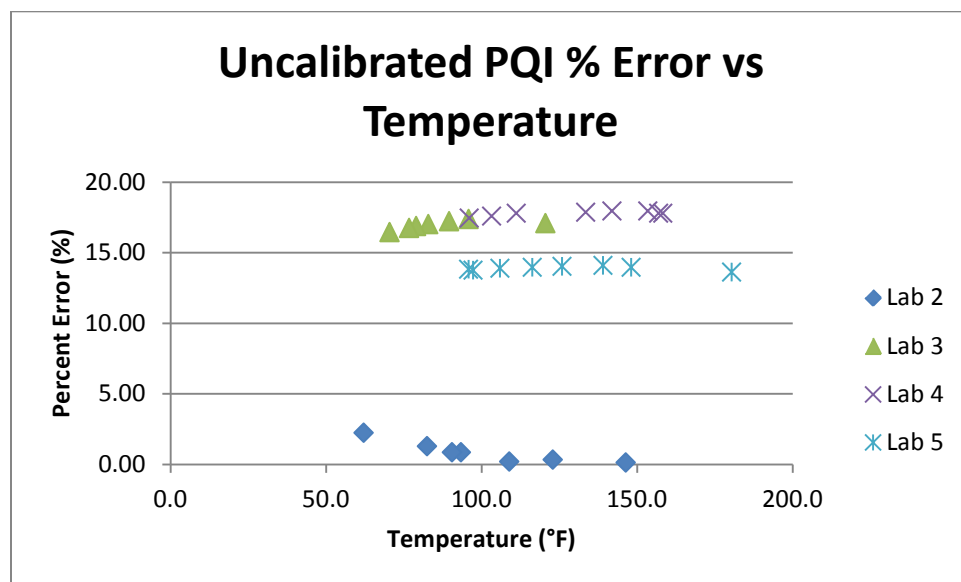
Figure 4.18 shows the percent error of the uncalibrated data plotted against the temperature for each slab. There is no visible trend in the plot, and there is very little variation within each sample. Lab 2 slab has the largest variation, with a 2.11% range of percent error, all other slabs vary less than 1%. This indicates that the error of the gauge does not vary more than roughly 2% with change in temperature. Figure 4.19 is the same plot with the calibrated data. There is again no clear trend and when calibrated to the individual mix, all data points fall between 1-2 percent error. The average percent error for the corrected data is 1.55%, which is shown as a line on the plot. Paired, two-tailed t-test shows P-values of 0.028 and 5.37E-10 for the calibrated and uncalibrated PQI data, respectively. This indicates that temperature significantly affects PQI readings with 95% confidence.

Figure 4.18. Uncalibrated PQI Percent Error vs Temperature.

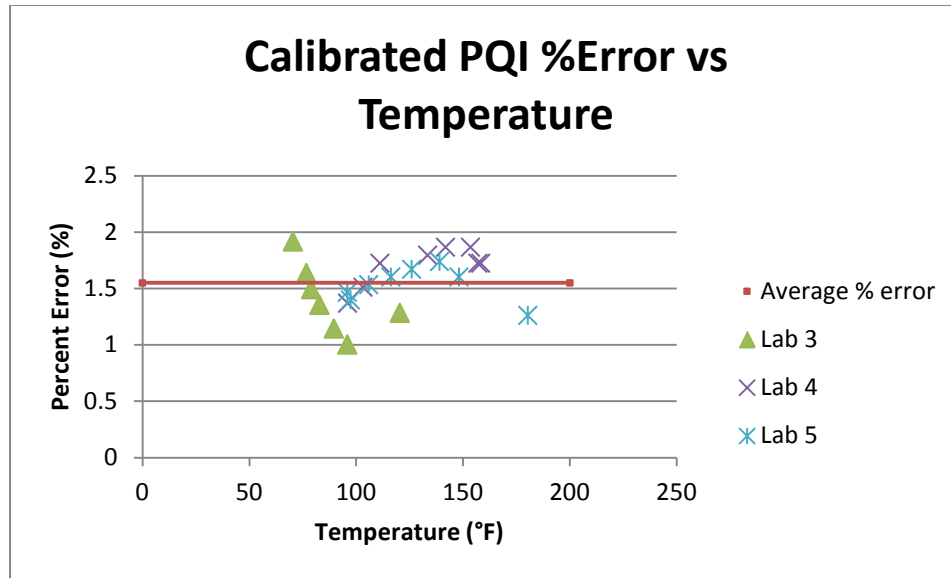
Figure 4.19. Calibrated PQI Percent Error vs Temperature.

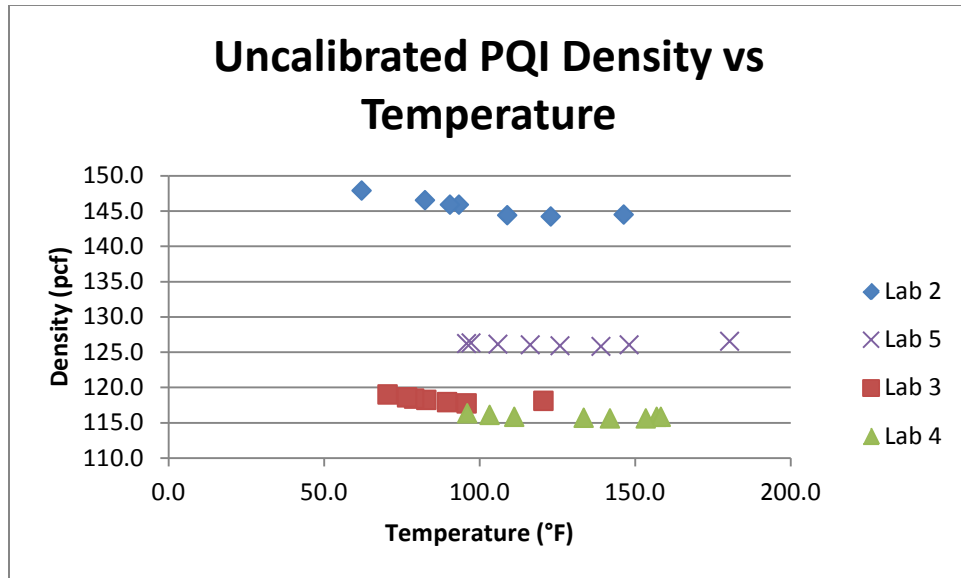
PQI density readings were also analyzed to determine any potential changes in density readings at different temperatures. Figure 4.20 shows uncalibrated PQI density readings plotted against temperature for each lab sample. There is little variation within lab samples, with laboratory slab 2 varying the most, with a 3.7 pcf difference between minimum and maximum readings. The overall data also shows no trend. Figure 4.21 is the same plot with the calibrated PQI data, and shows the same overall results. Laboratory slab 3 has the most variation with 1.3 pcf between minimum and maximum readings, there is no overall trend in the data.

Figure 4.20. Uncalibrated PQI Density vs Temperature.

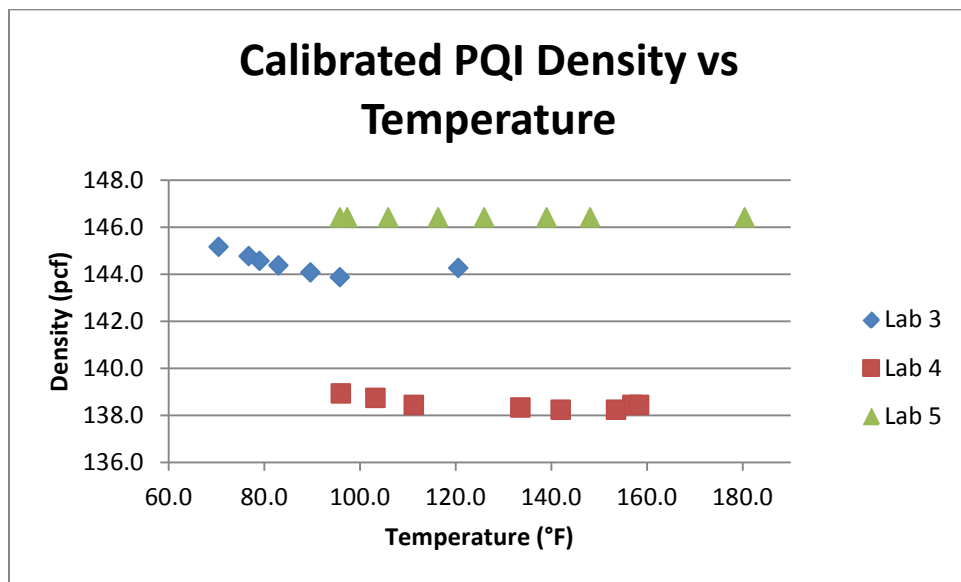
Figure 4.21. Calibrated PQI Density vs Temperature.

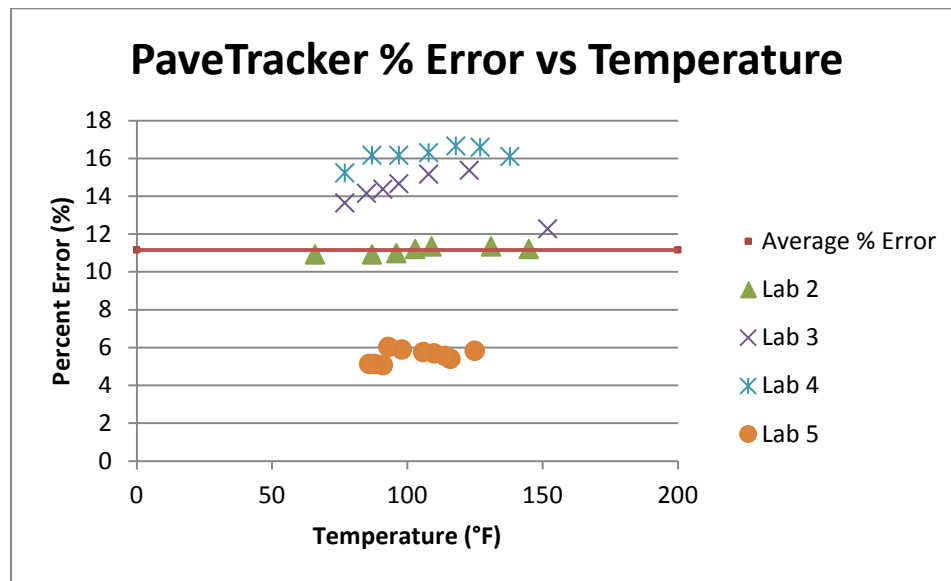
than roughly 3% with change in temperature. The average percent error for the corrected data is 11.16%, which is shown as a line on the plot. Data is spread uniformly around the average, further indicating no trend in the results.

Figure 4.22. PaveTracker percent error vs Temperature.

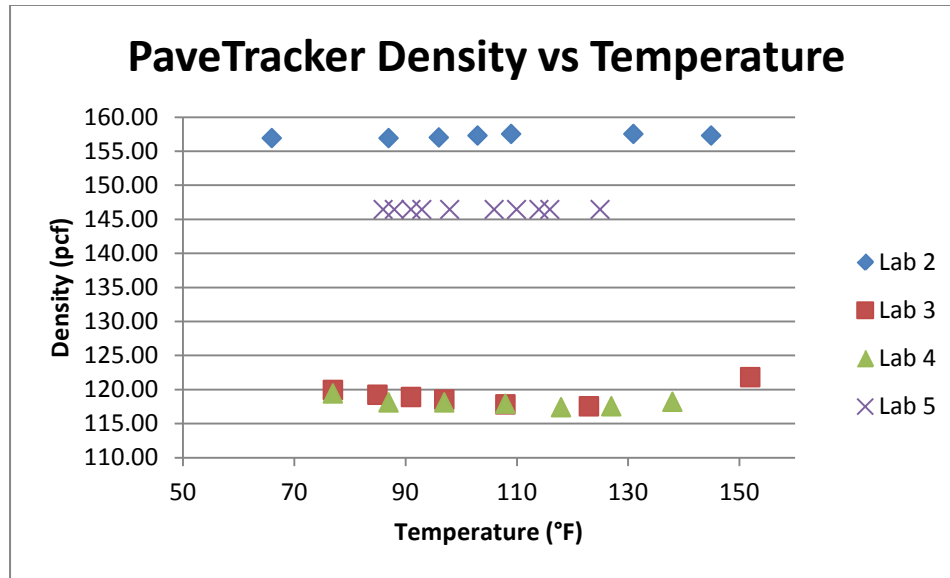
PaveTracker density readings were also analyzed to determine any potential changes in density readings at different temperatures. Figure 4.23 shows PaveTracker density readings plotted against temperature for each lab sample. There is little variation within lab samples, with laboratory slab 3 varying the most, with a 4.3 pcf difference between minimum and maximum readings. All other slabs vary less than 2 pcf. The overall data also shows no trend. Table 4.13 shows a summary of the temperature testing data for each lab sample. Core density as well as minimum and maximum temperature, density reading, and percent error are shown. The P-value obtained from a paired student t-test was 0.0025, indicating that uncalibrated PaveTracker readings at different temperatures differ significantly from core density with 95% confidence.

Figure 4.23. PaveTracker Density vs Temperature.
