EXPERIMENTAL PERFORMANCE OF CONCRETE MASONRY SHEAR WALLS
UNDER IN-PLANE LOADING

MASTER OF SCIENCE IN CIVIL ENGINEERING

WASHINGTON STATE UNIVERSITY
Department of Civil and Environmental Engineering

MAY 2012

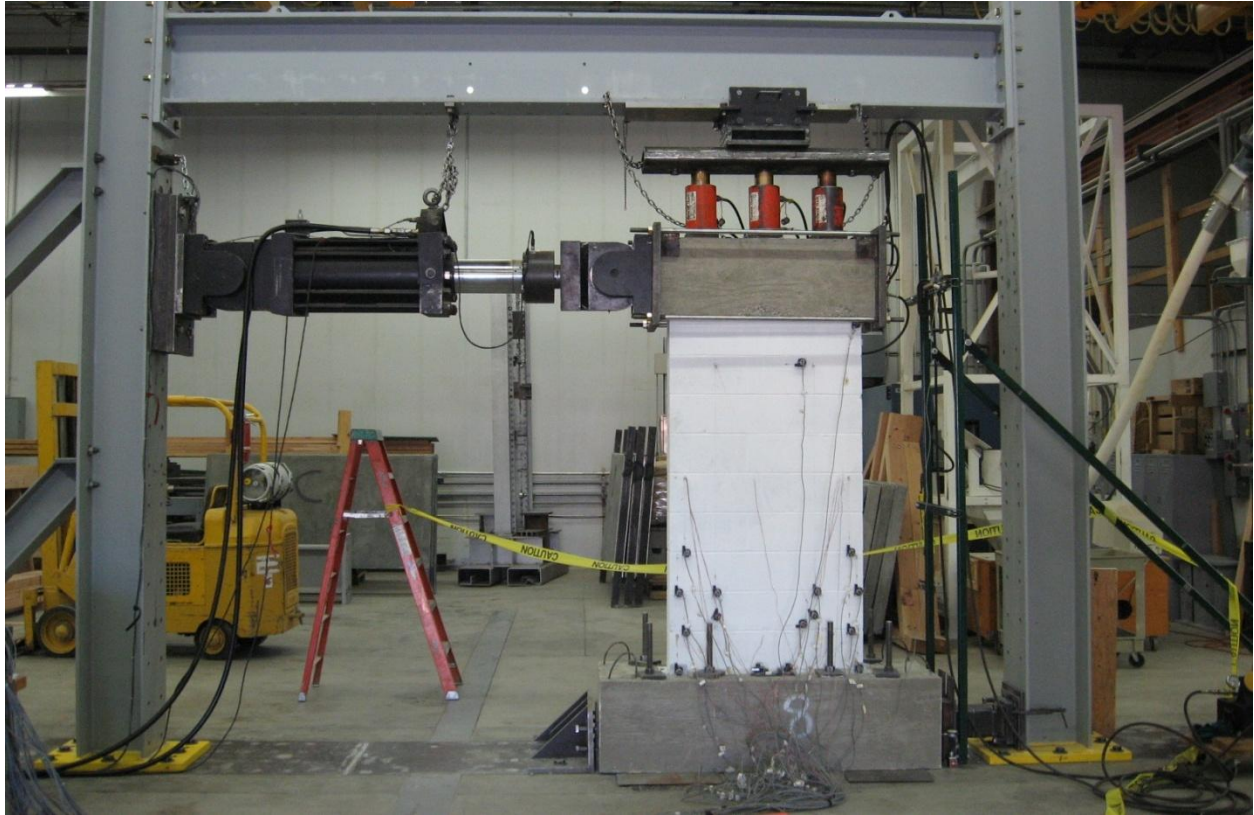
A 220-kip capacity hydraulic actuator provided the in-plane load for the wall specimens. The actuator was operated under displacement control. The actuator was connected to the main reaction frame and to a steel end-plate. The load was applied to the wall through two steel end-plates that were affixed to the North and South ends of the load beam and attached to each other by threaded rods. The test setup is shown in Figure 3.7 (North direction on the left).

Figure 3.7 Typical Wall Specimen Test Setup

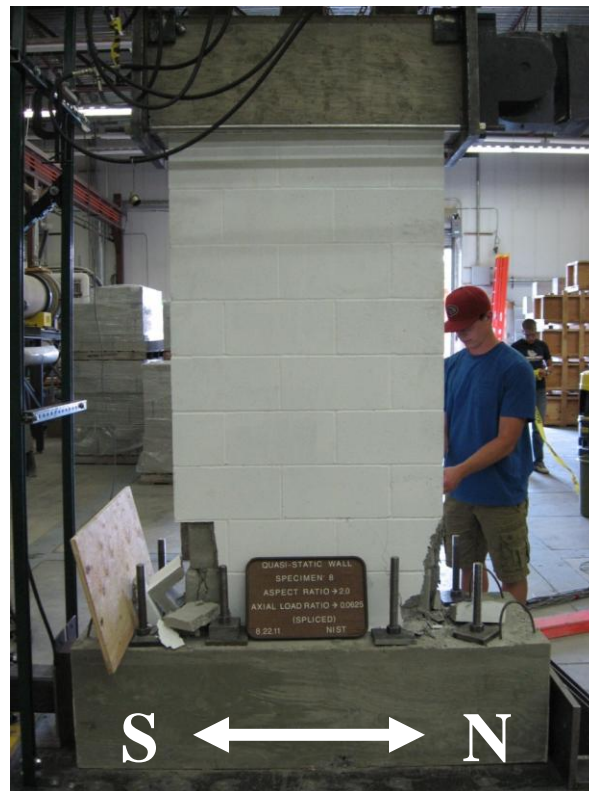
The preliminary test for Wall Specimen C2 produced a yield displacement (ΔY) of 0.23 in. In the primary test, the specimen was loaded to displacements of $\pm 1, 2, 3, 4, 6, 8, 10$ and 12 times the yield displacement. During testing, the wall behavior was dominated by flexural cracking that initiated at $4\Delta Y$ with minimal shear cracking. Separation of the mortar joints started at the base of the wall and continued along the height of the wall. Vertical splitting in both toes was observed near failure. Spalling up to the second course occurred in both toes at the last displacement level. The entire wall specimen and the North and South toe regions of the wall at test completion are shown in Figures 4.11 and 4.12, respectively. Test observations and their corresponding lateral displacements and loads are presented in Table 4.7.

Figure 4.11 Wall C2: Entire Wall at Test Completion

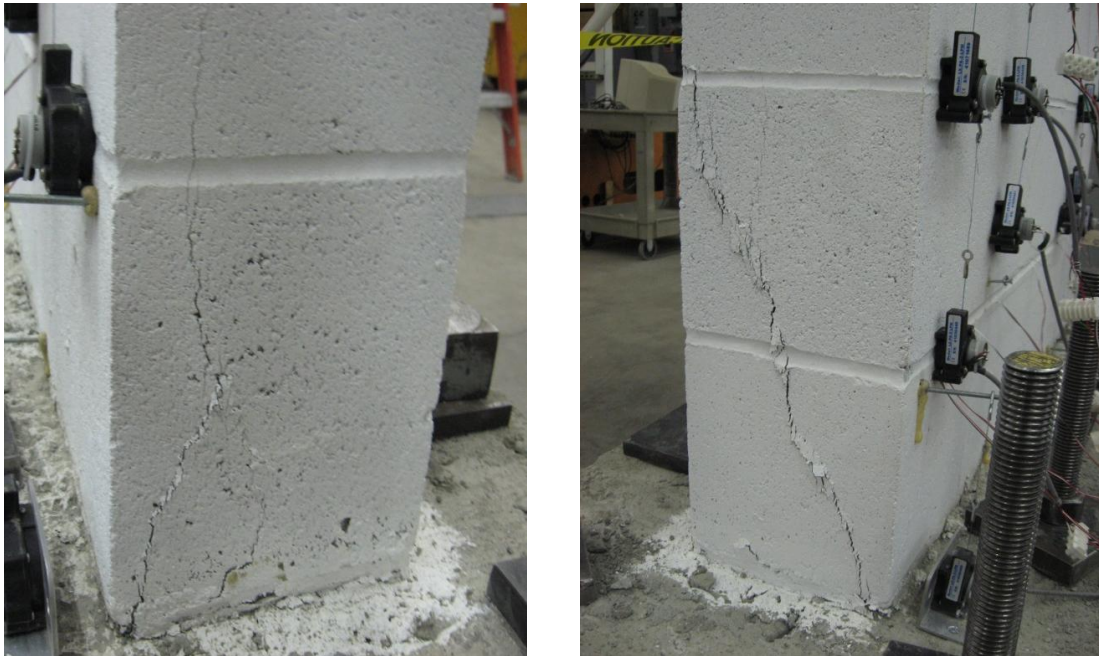
Figure 4.14 Wall C2: South Toe (Left) and North Toe (Right) at Onset of Toe Damage

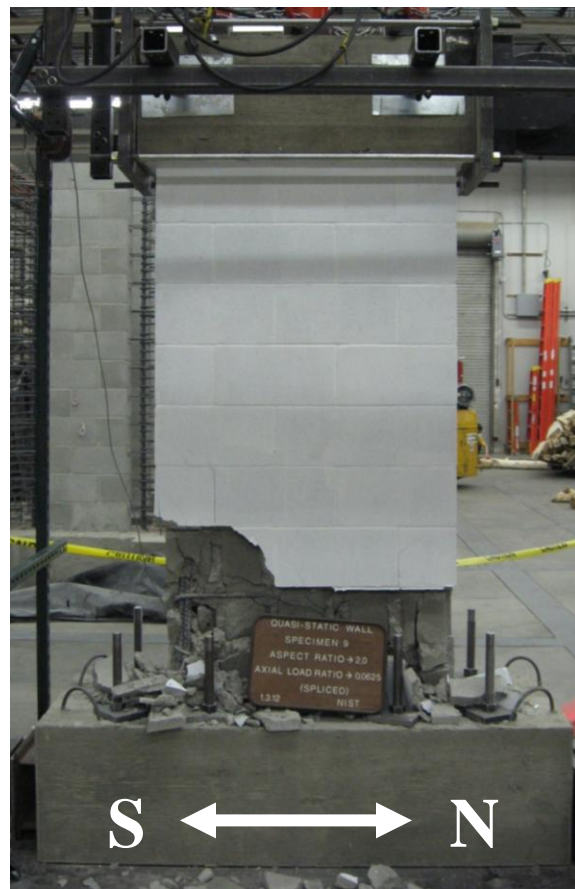
was observed near test completion. Spalling in the North and South toes at test completion extended to the second and third courses, respectively. Damage was concentrated in the lower three courses of the wall and may be attributable to a complex dowel-action behavior associated with the large amount of spliced vertical reinforcement. The entire wall specimen and the North and South toe regions of the wall at test completion are shown in Figures 4.17 and 4.18, respectively. Test observations and their corresponding lateral displacements and loads are presented in Table 4.12.

Figure 4.17 Wall C3: Entire Wall at Test Completion

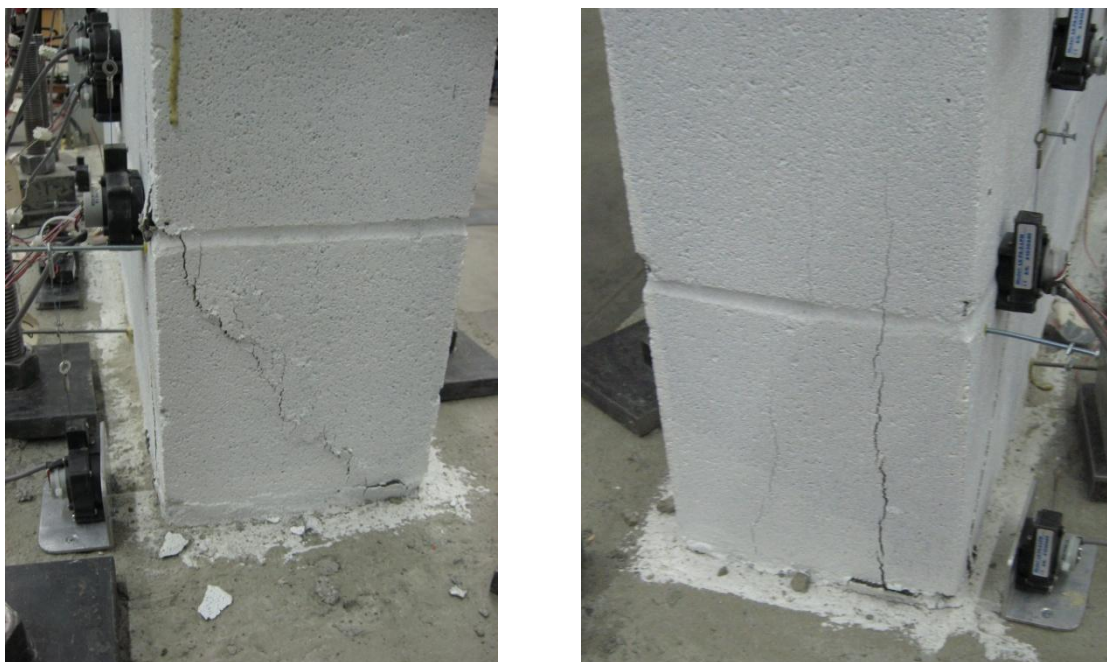
Figure 4.20 Wall C3: South Toe (Left) and North Toe (Right) at Onset of Toe Damage

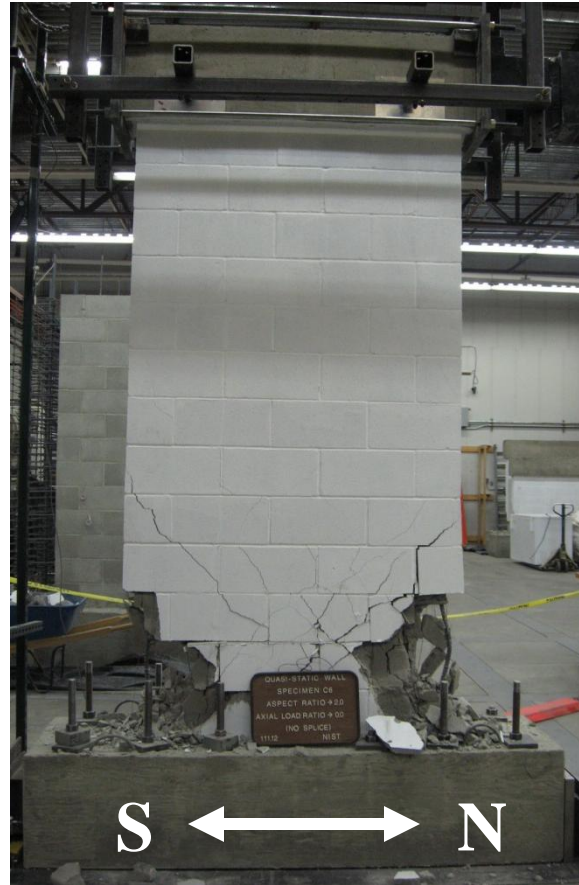
Figure 4.35 Wall C6: Entire Wall at Test Completion

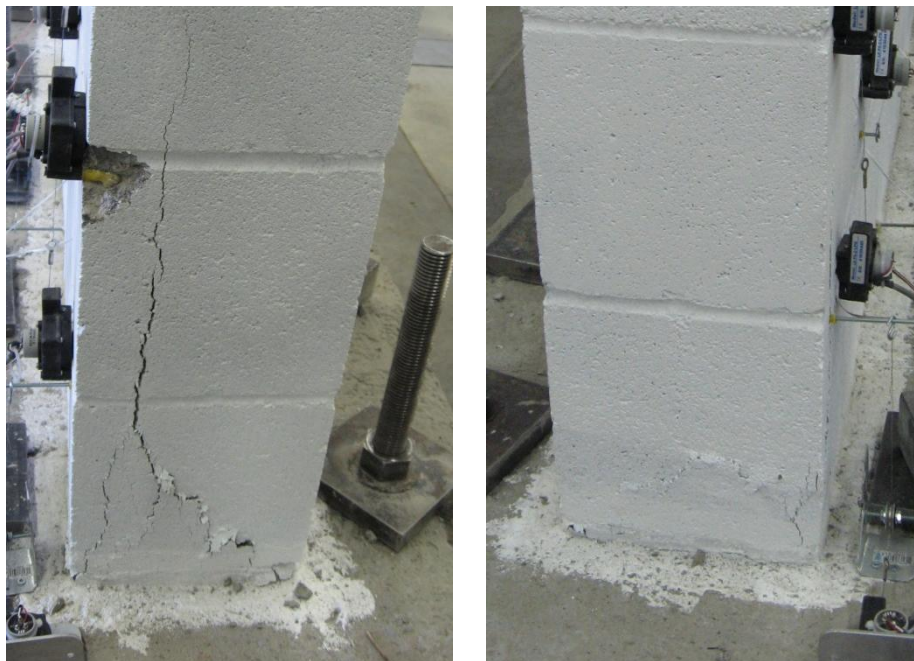
Figure 4.38 Wall C6: South Toe (Left) and North Toe (Right) at Onset of Toe Damage

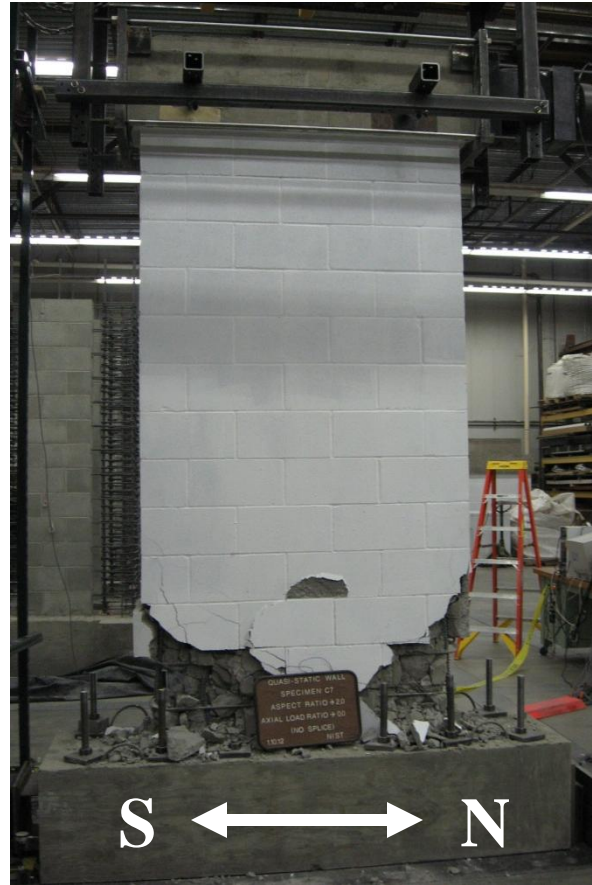
Figure 4.41 Wall C7: Entire Wall at Test Completion

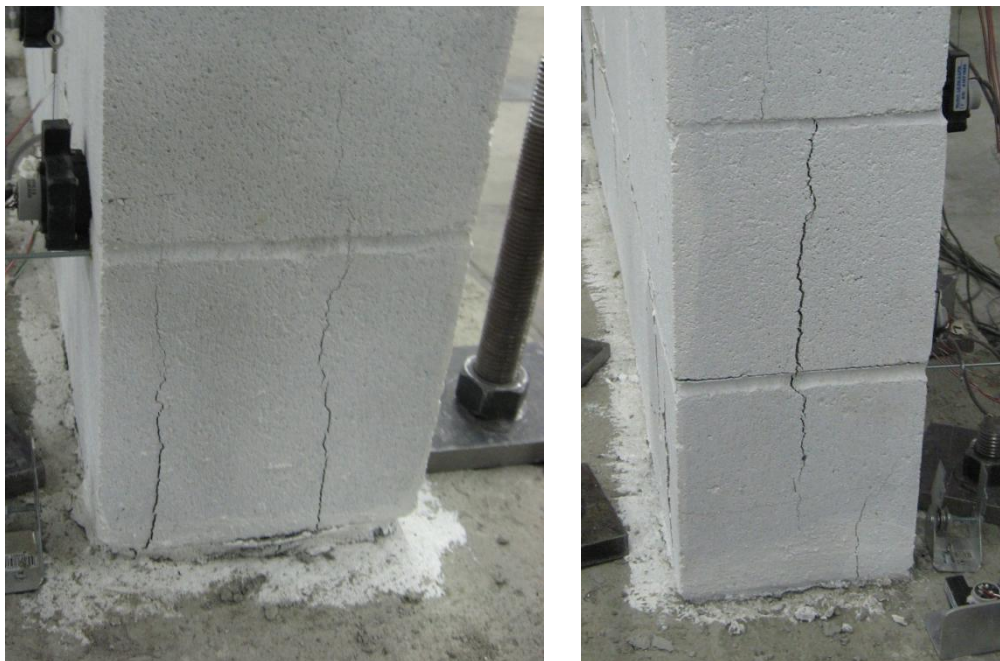
4.44 Wall C7: South Toe (Left) and North Toe (Right) at Onset of Toe Damage

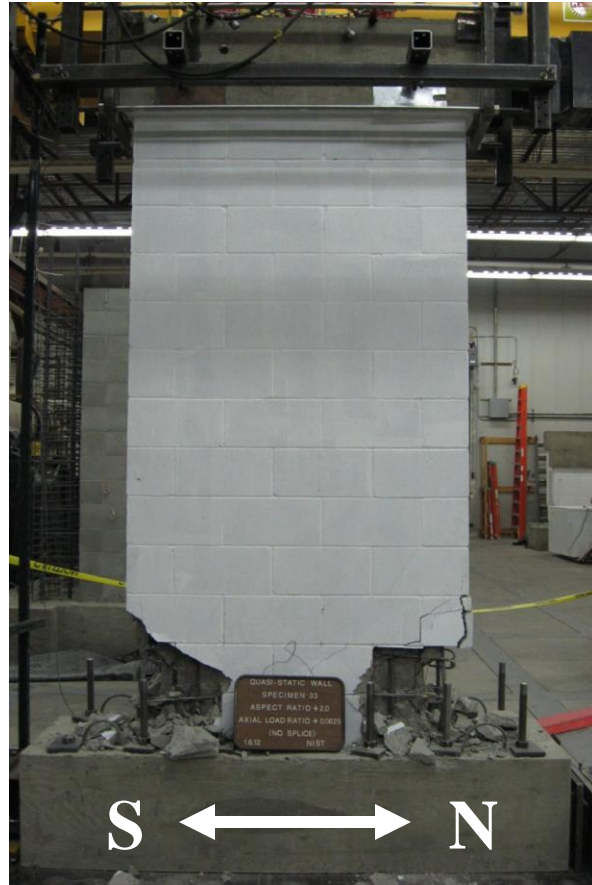
Figure 4.47 Wall C8: Entire Wall at Test Completion

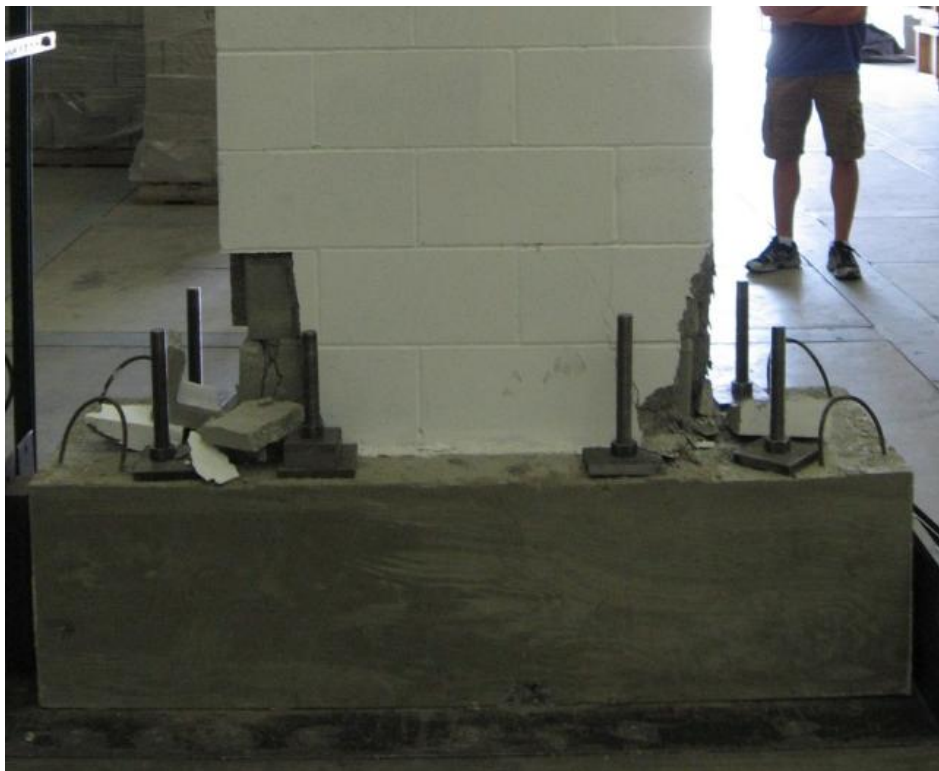
Figure 5.3 Wall C2: Toe Damage Typical of Flexural Failure

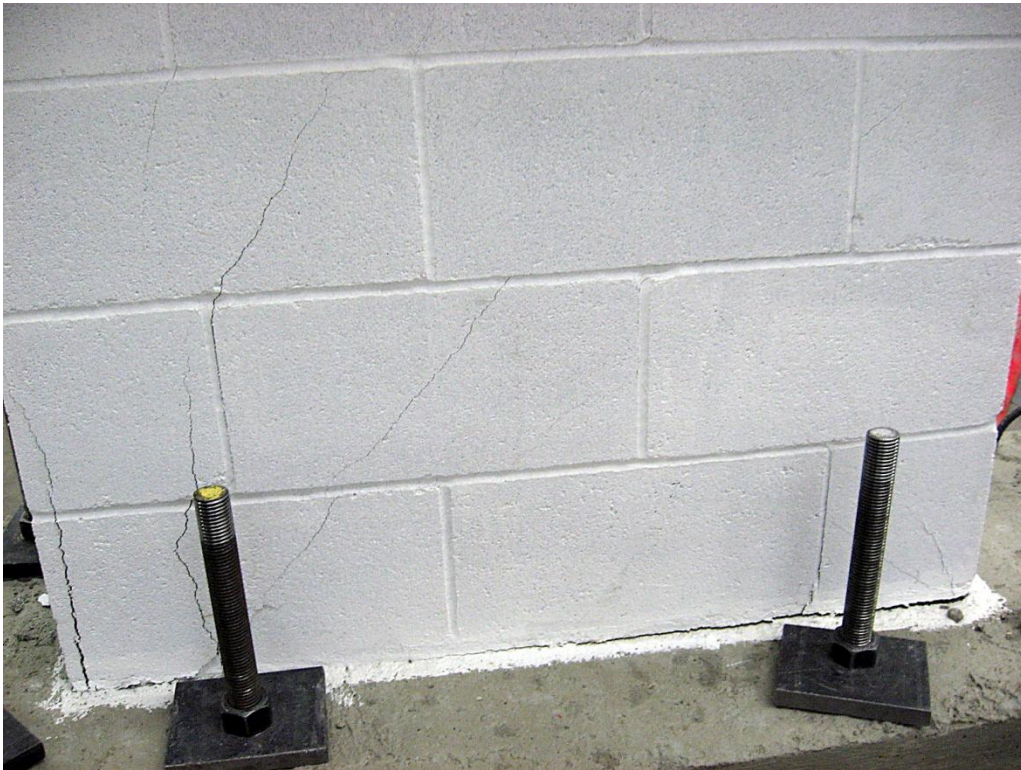
Figure 5.4 Wall C3: Development of Flexural, Shear and Splitting Cracks

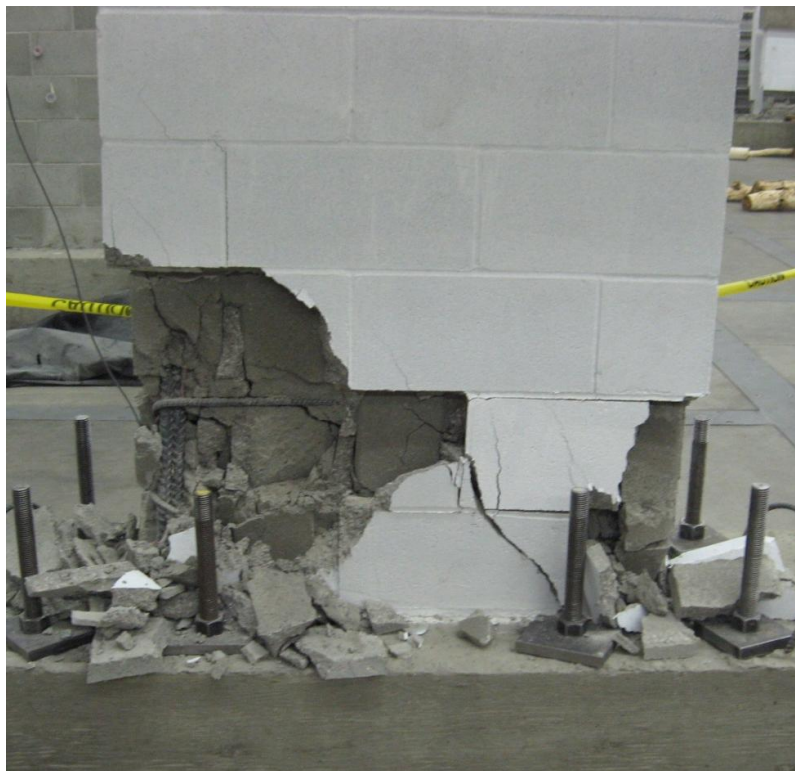
Figure 5.6 Wall C3: Crushing and Spalling of Face Shells

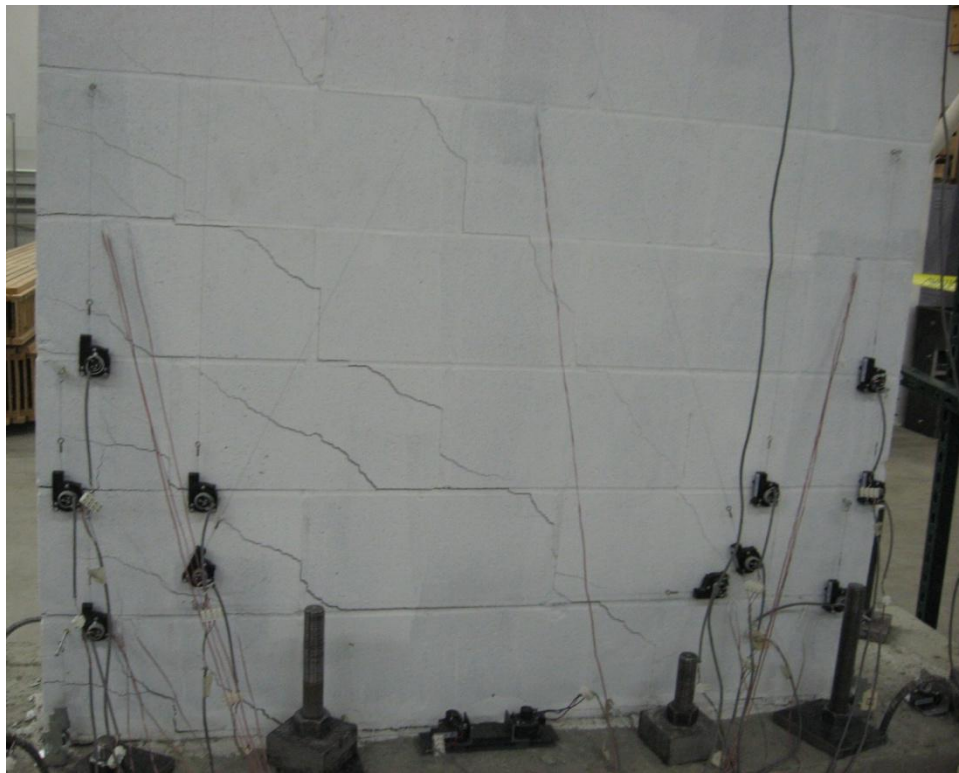
Figure 5.14 Wall C7: Progression of Failure ($3\Delta Y$ Cycle 1)

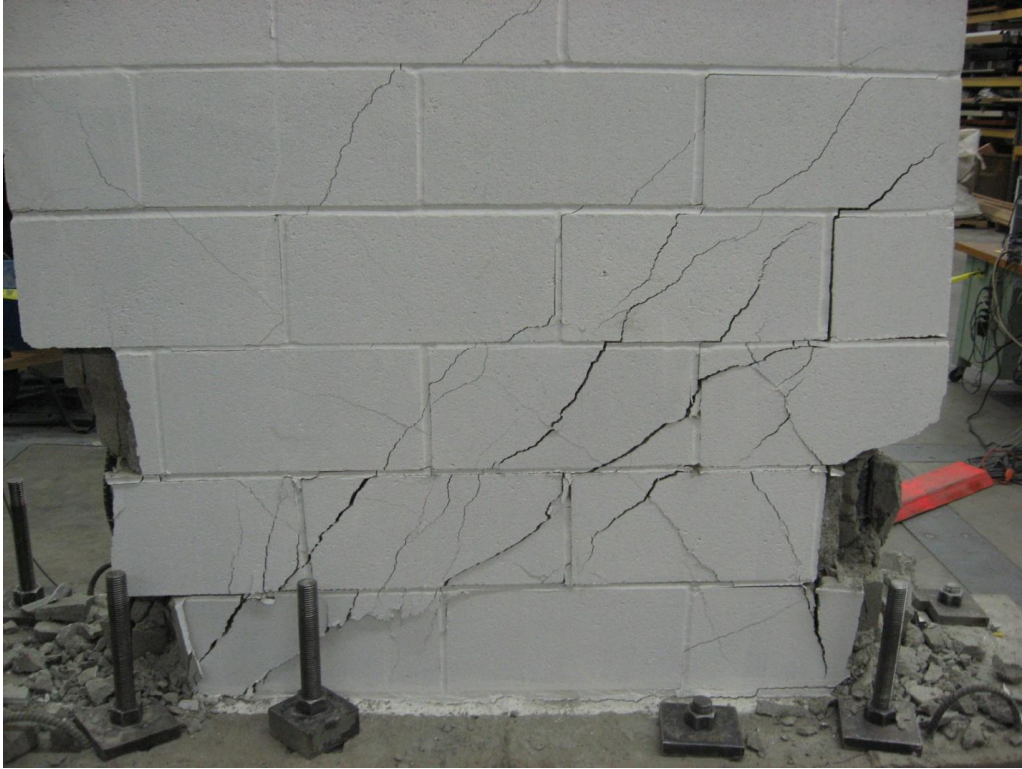
Figure 5.15 Wall C6: Progression of Failure (6 ΔY Cycle 1)
