NONDESTRUCTIVE TESTING OF CONCRETE BOX GIRDER BRIDGES USING THERMAL IMAGING

A thesis submitted in partial fulfillment of
the requirements for the degree of

WASHINGTON STATE UNIVERSITY
Department of Civil and Environmental Engineering

MAY 2008

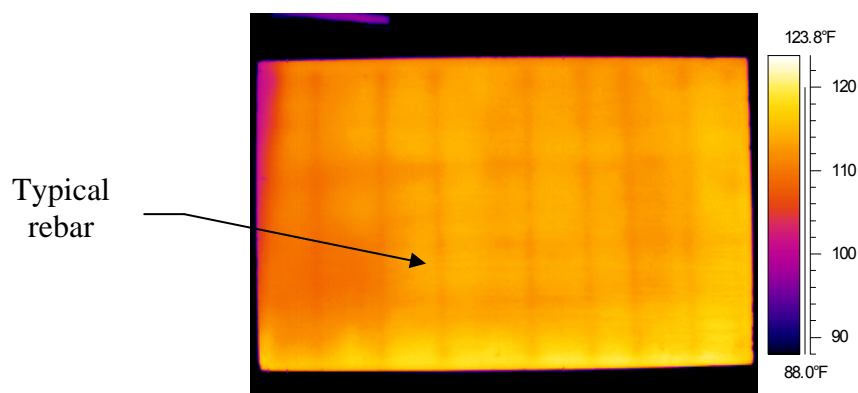
Figure 3.9 – Thermal image of Specimen 8a

The first inspection completed on Specimen 8a was on July 12th, 2007 using inspection Method 3 (sun radiation). By the end of the energy input stage, temperatures were 105.1 °F on the top face (heated surface) and 86.4 °F on the bottom face (unheated surface), for a temperature gradient of 18.7 °F (similar temperature gradients were achieved for Method 3 inspection of other 8 in. thick specimens). Although the Method 3 inspection did not reveal any PT-ducts, it did reveal some of the reinforcing steel present in the specimen, as shown in Figure 3.9. As noted in the image, the rebar is signified by the cooler lines because the reinforcing steel conducts heat at a faster rate than the concrete around it. Therefore, while taking thermal images of the heated surface, the rebar appears cooler than the concrete.

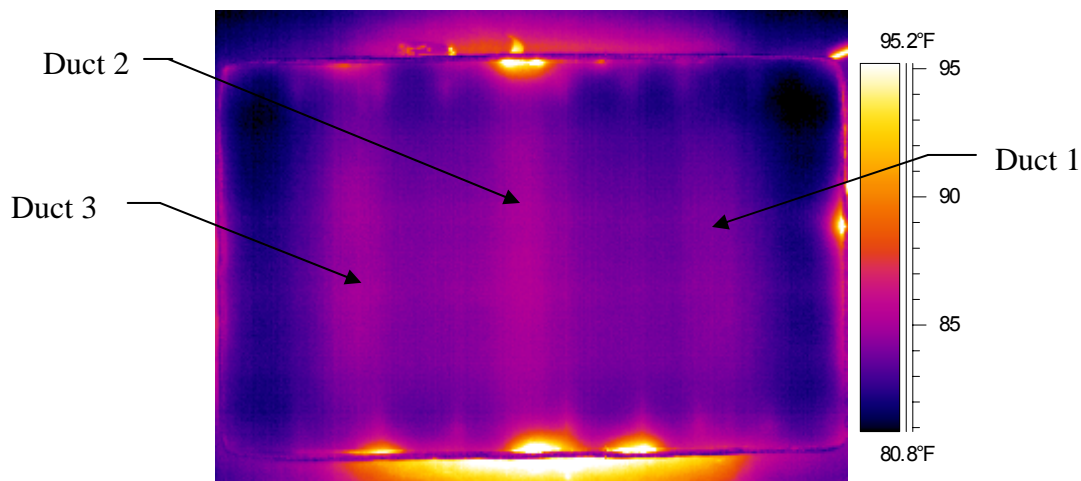
Figure 3.10 – Thermal image of Specimen 8a

The second inspection of Specimen 8a was completed on July 13th, 2007 using inspection Method 1. This inspection took images of the unheated surface, and PT-ducts were visible in thermal images after only 1:30 (hh:mm) of heat time, as shown in Figure 3.10. All three ducts are visible as hotter strips between cooler regions. This demonstrates that, since all three PT-ducts are steel, they conduct the heat through the specimen faster than the surrounding concrete. This is an indication of how steel PT-ducts should appear during field inspections of pre-stressed concrete box girder bridges when taking thermal images of the unheated surface under similar temperature conditions.

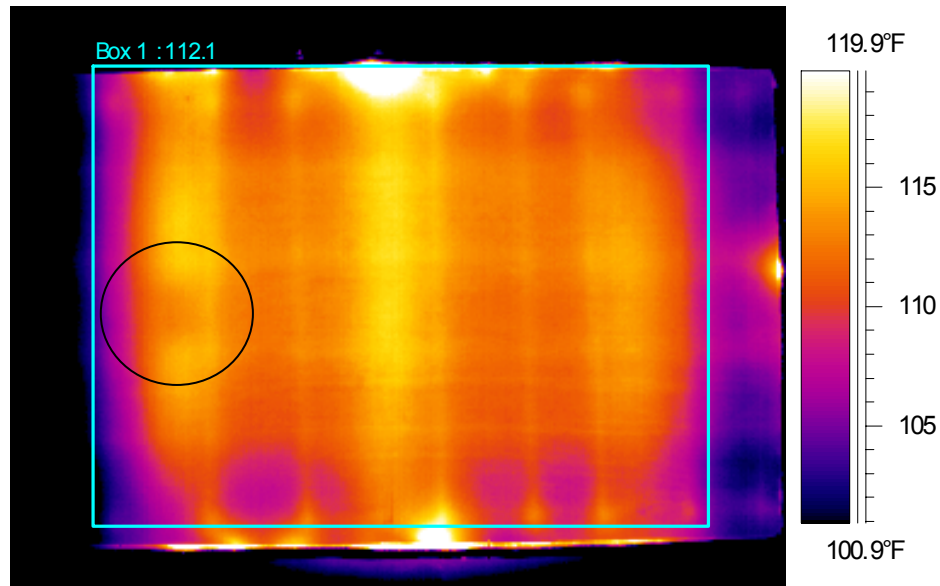
The next image, shown in Figure 3.11, is Specimen 8a at the end of heating. The PT-ducts are more clearly visible and the steel reinforcement can be seen. With surface temperatures on the unheated surface at an average of 112 °F (as shown by Box 1 in Figure 3.11), Duct 3 shows what looks like a cool spot at its center, as denoted by the circle. This is the location of the simulated air void in Duct 3. Styrofoam acts as an insulator, thus heat transfers through the simulated void at a slower rate than through the concrete or grout. In this instance,

heat flowing through the concrete reaches the unheated surface faster than heat flowing through the simulated void. The result is a cool spot on the unheated surface, as indicated on the thermal image. The area within the circle in Figure 3.11 was approximately 3 °F cooler than the regions above or below the circle.

Figure 3.11 – Thermal image of Specimen 8a showing a cool spot in the circled area

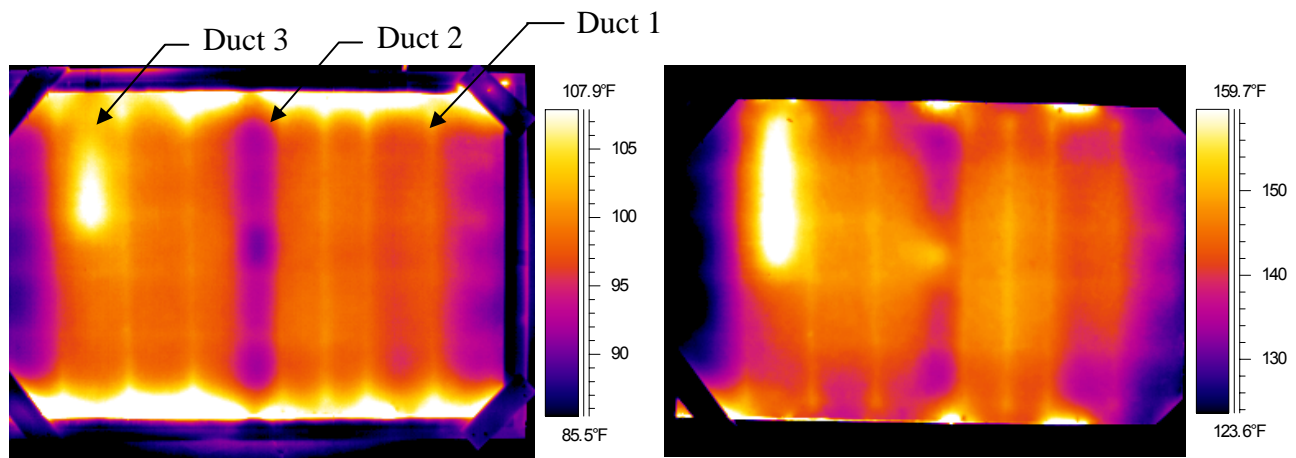
The first three inspections completed on this specimen were all done using inspection Method 1. The inspection that took place on 7/2/2007 was the very first inspection of any of the specimens, so it was primarily a learning trial to evaluate optimum heating conditions. As shown in the image on the left in Figure 3.12, the two plastic PT-ducts were detected as cooler regions and the steel duct was detected as a warmer region. A cool spot was observed in the middle of plastic Duct 2 that could represent a simulated air void. The image on the right of the Figure 3.12, however, shows a thermal image from the inspection that took place on 7/5/2007

(the inspection from 7/10/2007 provides an identical image). Here, the region in the middle of Duct 2 shows a hot spot, rather than the cool spot that was detected on 7/2/2007. The reason for this discrepancy is not clear.

Figure 3.12 – Thermal images of Specimen 8b
a) left image showing inspection from 7/2/2007
b) right image showing inspection from 7/5/2007

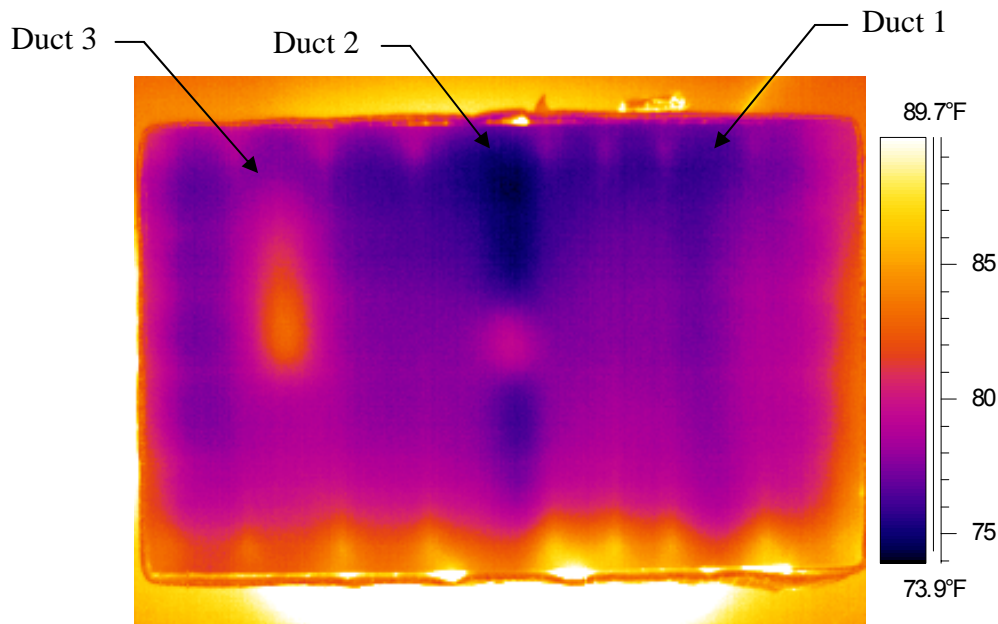
Figure 3.13 – Thermal image of Specimen 8b taken from bottom face (7/18/2004)

Figure 3.13 shows a thermal image of the bottom face of Specimen 8b from an inspection conducted on 7/18/2007. This inspection intentionally had much less heat time than the other inspections (only two hours, see Table 3.4). The reason for the shorter heat time was to see what difference it made in the thermal image when compared to other inspections with longer heat times. The resulting images were similar to images obtained from longer heat times, except that hot spots did not reach quite as large temperature differences with respect to the regions around them. For example, the hot spot in Duct 3 was approximately 4 °F warmer than the rest of Duct 3 with the inspection from 7/18/2007, whereas other inspections of Specimen 8b obtained an almost 20 °F temperature difference.

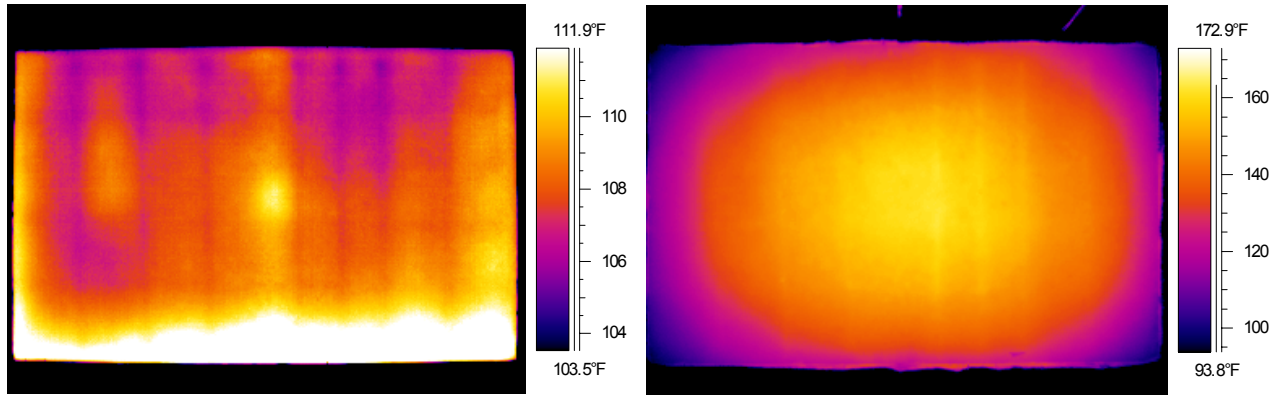
Figure 3.14 – Thermal images of Specimen 8b

Inspections of Specimen 8b on 7/12/2007 and 9/24/2007 used inspection Method 3 and Method 2, respectively. The inspection on 7/12/2007 used only sun radiation as the input energy source. It yielded the same types of thermal images as inspections on 7/5, 7/10, and 7/18, but with smaller temperature differences. For example, the hot spot located in the middle of Duct 2 was approximately 2 °F warmer than adjacent regions of solid concrete, whereas temperature differences from the other three inspections were approximately 10 to 15 °F. This inspection also weakly showed some reinforcing steel. The inspection completed using Method 2 did not reveal anything regarding the internal characteristics of the specimen. Inspection Method 2 was effective for detecting near-surface characteristics during field inspections of bridges, but Method 2 was not effective for inspecting PT-ducts at depths of 5 cm (2 in.) or greater below the concrete surface. Images from both inspections can be seen in Figure 3.14.

- a) left image showing Method 3 inspection from 7/12/2007
- b) right image showing Method 2 inspection from 9/24/2007

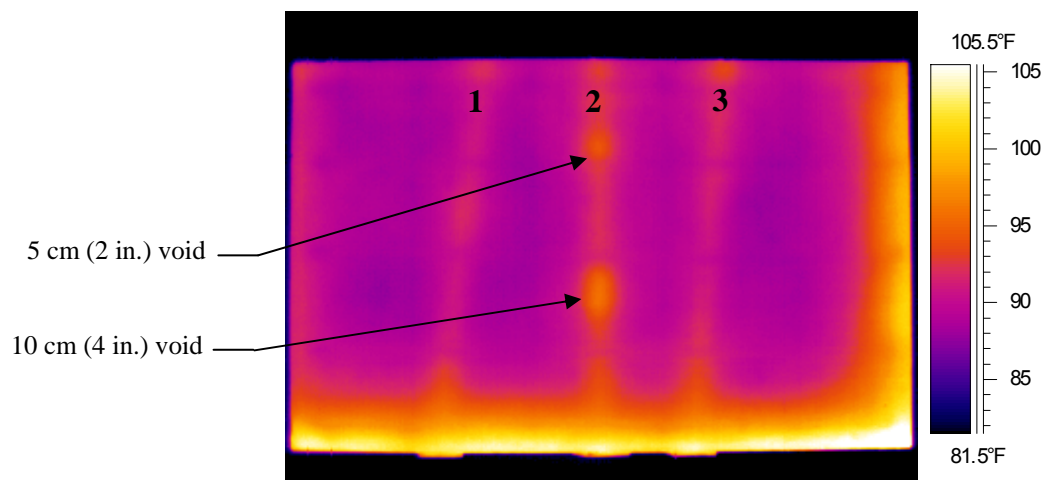
Figure 3.15 – Thermal image of Specimen 8c from solar radiation

The first inspection of Specimen 8c was completed using Method 3, where solar radiation was the only source of heat input. Figure 3.15 shows a thermal image taken after bringing the specimen indoors. The three PT-ducts are clearly visible (numbered 1, 2, and 3), as are the two simulated voids in Duct 2 (hot spots). Temperature differences between the simulated voids and the rest of the duct are approximately 2.5 to 4 °F. This image shows that, with a temperature gradient of 13.2 °F between the top and bottom faces due to ambient exposure to solar radiation, PT-ducts and simulated voids located within approximately one inch of the heated surface are discernable from the rest of the specimen.

The simulated voids appear as hot spots in Figure 3.15 because the image was taken of the heated surface. The radiant heat from the sun propagated through the concrete until it reached the simulated voids. At this point, the simulated voids slowed the rate of heat transfer, keeping more heat closer to the heated surface and making the simulated voids look like hot spots. As shown in Figure 3.15, the ducts (all plastic) also show up as warmer areas. This is

because the plastic acts as an insulator, slowing the rate at which heat flows through the specimen compared to surrounding concrete.

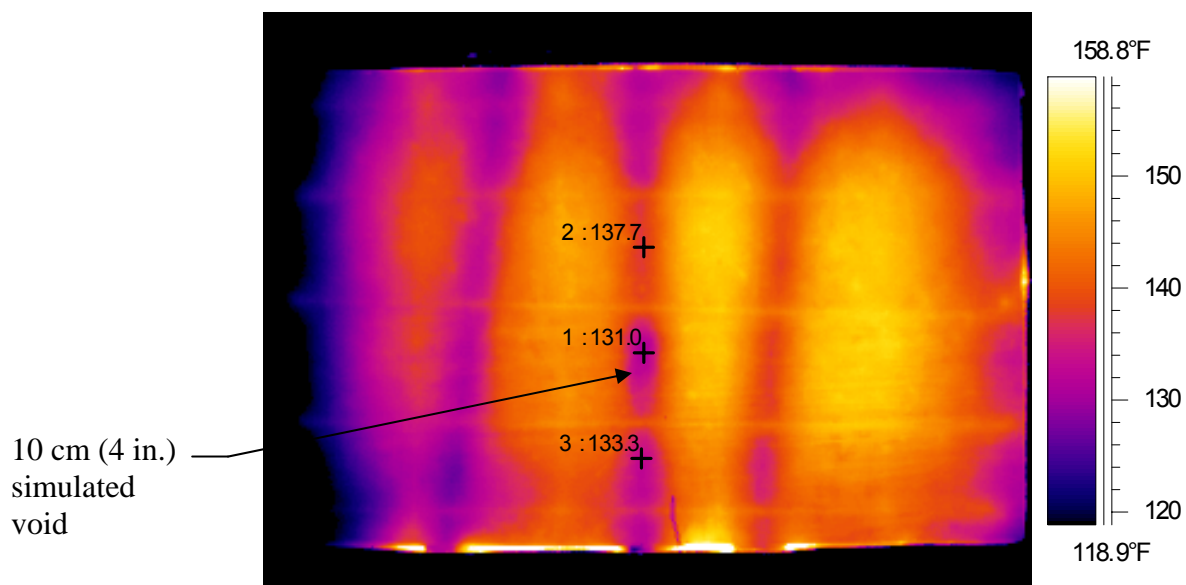
Figure 3.16 – Thermal image of Specimen 8c taken on 7/11/2007

The second inspection of Specimen 8c was conducted using inspection Method 1. The inspection took place approximately one hour after the first inspection ended, and instead of heating the top face, the bottom face of the specimen was heated and thermal images were taken of the top face. The heat transfer that took place was now due to energy input from the infrared heater, instead of solar radiation. The ducts and one of the simulated voids were detected as cooler areas. The 10 cm (4 in.) simulated void was visible, with a 2 to 7 °F temperature difference from the rest of Duct 2 (as shown by points 1, 2, and 3 in Figure 3.17). The 5 cm (2 in.) simulated void was not visible, but this may be due to rebar interference or to the fact that the 5 cm (2 in.) long simulated void has less effect on heat flow than the 10 cm (4 in.) long simulated void (as a result of its smaller size). The rebar (warmer lines), ducts, and simulated void can be seen in Figure 3.16.

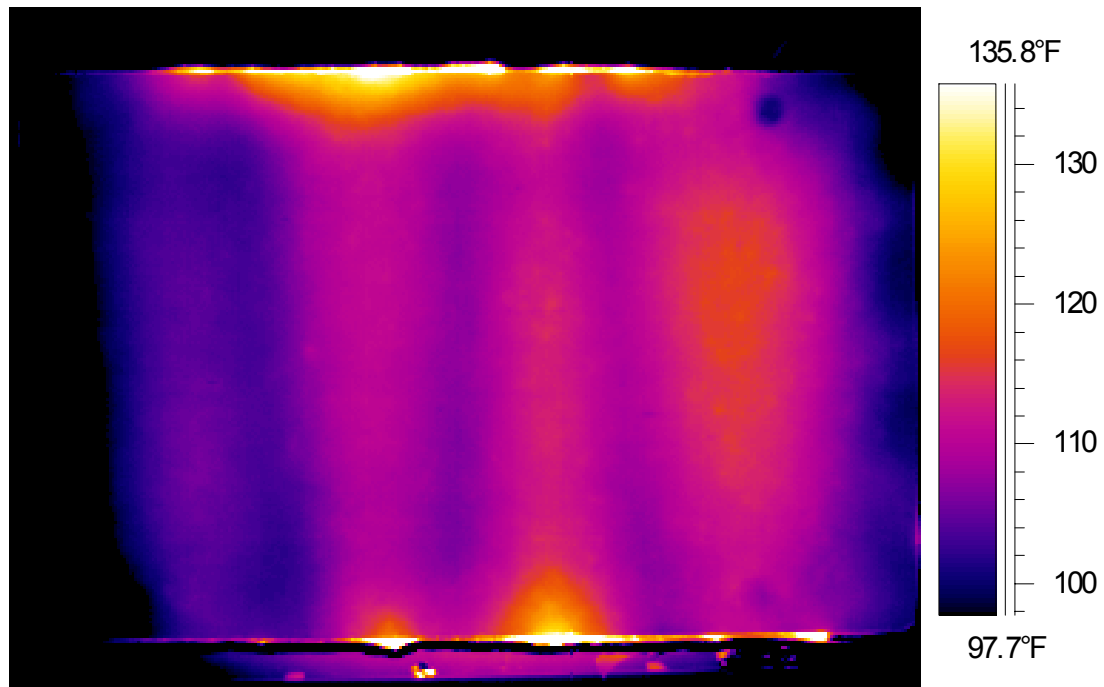
Figure 3.17 – Thermal image of Specimen 8c from 7/17/2007

The last inspection of Specimen 8c was completed on 7/17/2007. Method 1 was used, so the top face was heated and thermal images were taken of the bottom face. Thermal images showing the PT-ducts were obtained after only 3.5 hours of heat time, as shown in Figure 3.17. The thermal image does not show any sign of the two simulated voids present in Duct 2. This may be a result of the fact that the voids were oriented underneath the tensioning strands inside the duct. The strands conduct heat better than concrete or air, so they are more likely to be at consistent temperatures throughout their length. In other words, all the strands increase in temperature at a rate that is not affected by the simulated voids, thus the thermal image shows ducts with uniform temperatures. Figure 3.18 further illustrates why the simulated ducts were not detected.

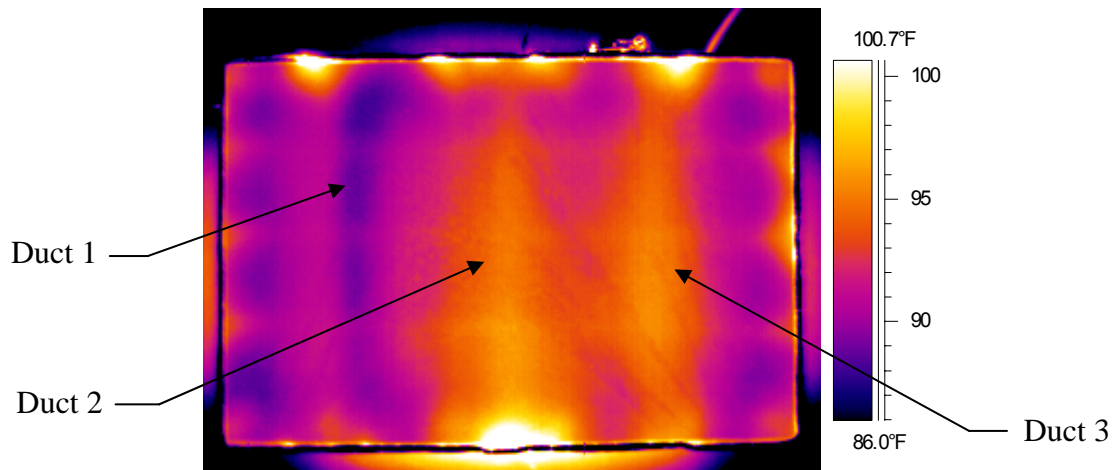
Figure 3.19 – Thermal image of Specimen 8d taken 7/24/2007

The first inspection of Specimen 8d took place on 7/24/2007 using Method 1. At this point, it was concluded that a 20 cm (8 in.) thick specimen required between three and four hours of radiant heat input to produce thermal images showing PT-ducts, thus Specimen 8d was heated for 3:15 (hh:mm). Figure 3.19 shows a thermal image from this inspection, where the two steel

ducts (Ducts 2 and 3) are displayed as warmer regions and the plastic duct (Duct 1) is cooler. The thermal image, however, does not reveal the simulated air voids.

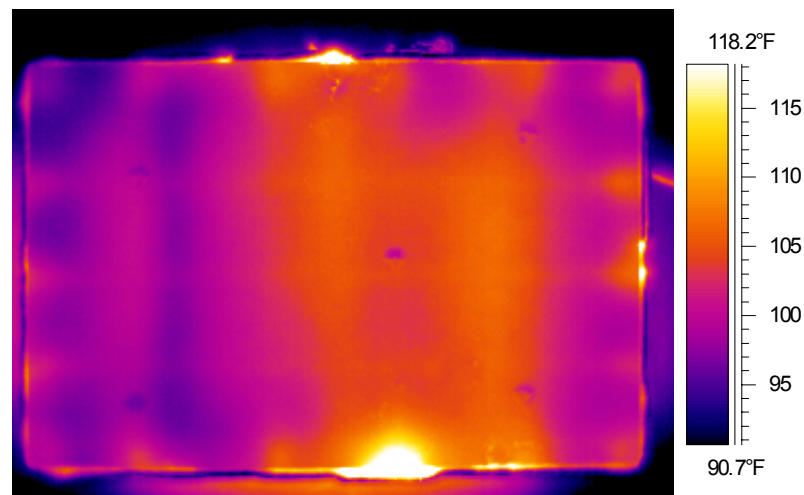
Figure 3.20 – Thermal image of Specimen 8d taken 9/10/2007

The second inspection of Specimen 8d was completed on 9/10/2007 using Method 1 to inspect the bottom face. The thermal image, provided in Figure 3.20, was much like the previous inspection where the two steel ducts were detected as warmer regions and the plastic duct as cooler. However, as with the prior inspection, no simulated voids were visible.

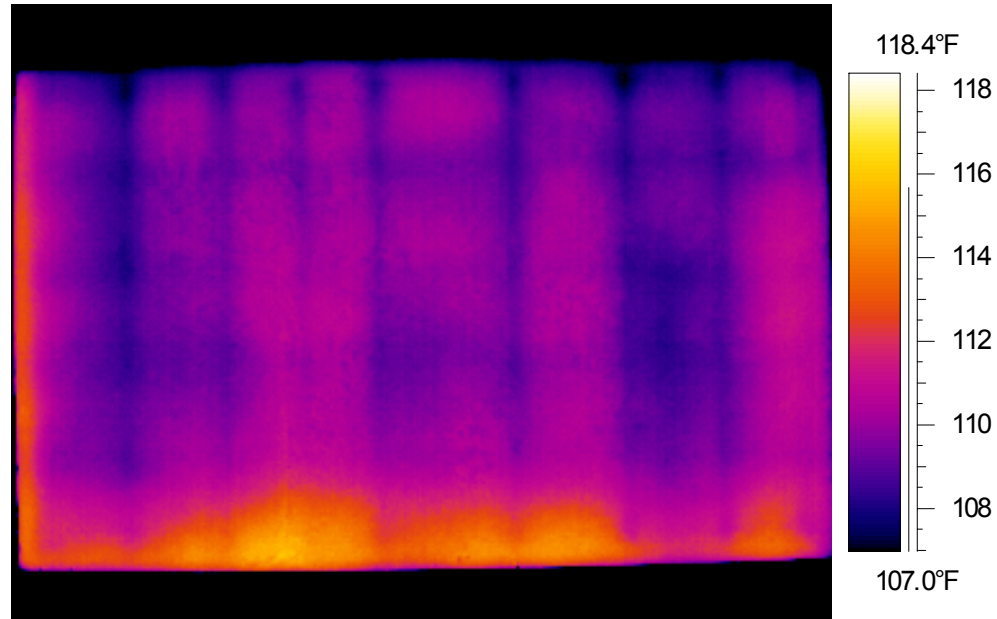
Figure 3.21 – Thermal image of Specimen 12a taken 7/13/2007

The first inspection of Specimen 12a was completed on 7/13/2007 using Method 3 with sun radiation as the only source of heat. Specimen 12a was left outside under solar radiation for 7:30 (hh:mm) and then taken indoors. At this point, Specimen 12a had a temperature gradient of 14.1 °F between the top and bottom faces. The thermal images from this inspection only show the steel reinforcement closest to the heated surface. The rebar is visible as cooler lines in Figure 3.21 because the steel conducts heat from the heated surface faster than the concrete around it. So when the heat input is stopped, the surrounding concrete has retained more heat than the steel reinforcement.

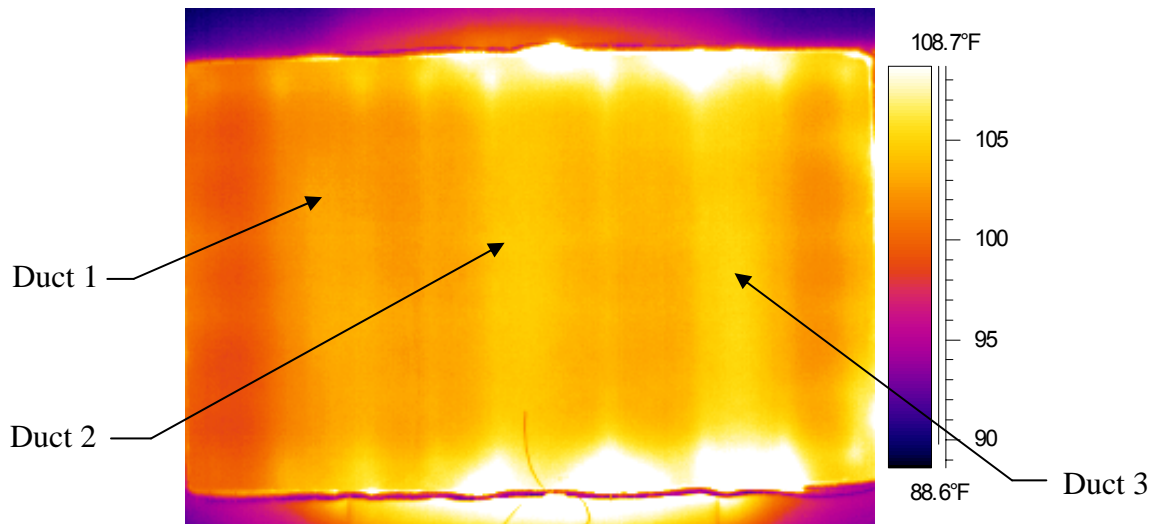
Figure 3.22 – Thermal image of Specimen 12a taken 7/16/2007

The second inspection of Specimen 12a was conducted on 7/16/2007 using inspection Method 1 procedures. Specimen 12a was heated for 8:15 (hh:mm) because, at the time, it was not clear how long a 30 cm (12 in.) thick specimen needed heat input to produce thermal images showing PT-ducts. The steel PT-ducts could be identified in thermal images after approximately four hours of heat time, but the best image was taken after approximately 6:30 (hh:mm). The thermal image of Specimen 12a did not show the crisp differences between the ducts and the solid concrete visible in thermal images of the 20 cm (8 in.) specimens. Temperature differences between the ducts and surrounding concrete were only approximately 2 °F with Specimen 12a, whereas temperature differences were roughly 7 to 10 °F with the 20 cm (8 in.) thick specimens. Figure 3.22 shows a thermal image from this inspection.

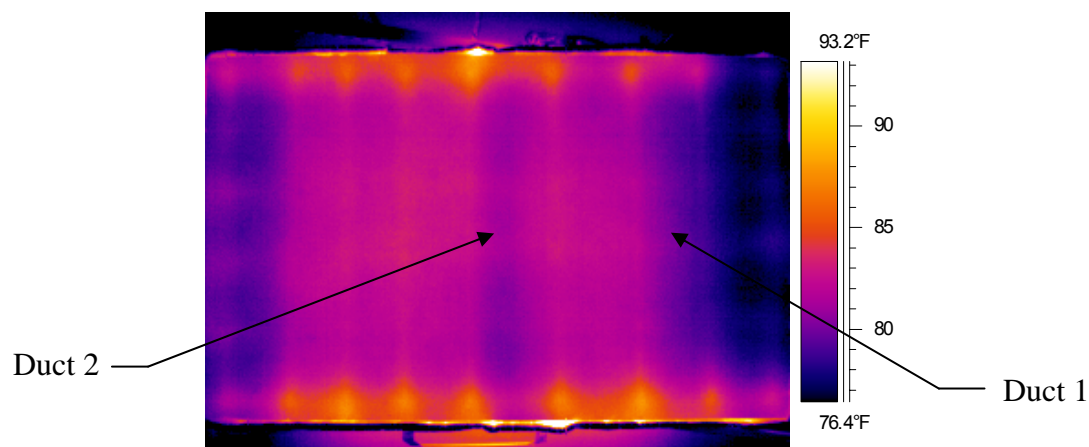
Figure 3.23 – Thermal image of Specimen 12b taken 9/17/2007

The second inspection of Specimen 12b was conducted on 9/17/2007 using inspection Method 1. Specimen 12b was heated for approximately six hours while taking thermal images throughout the test. A thermal image of the specimen taken after seven hours is provided in Figure 3.23. In the image, the two plastic ducts (Ducts 1 and 2) show up as cooler areas than the concrete around them, but the steel duct (Duct 3) is not clearly visible.

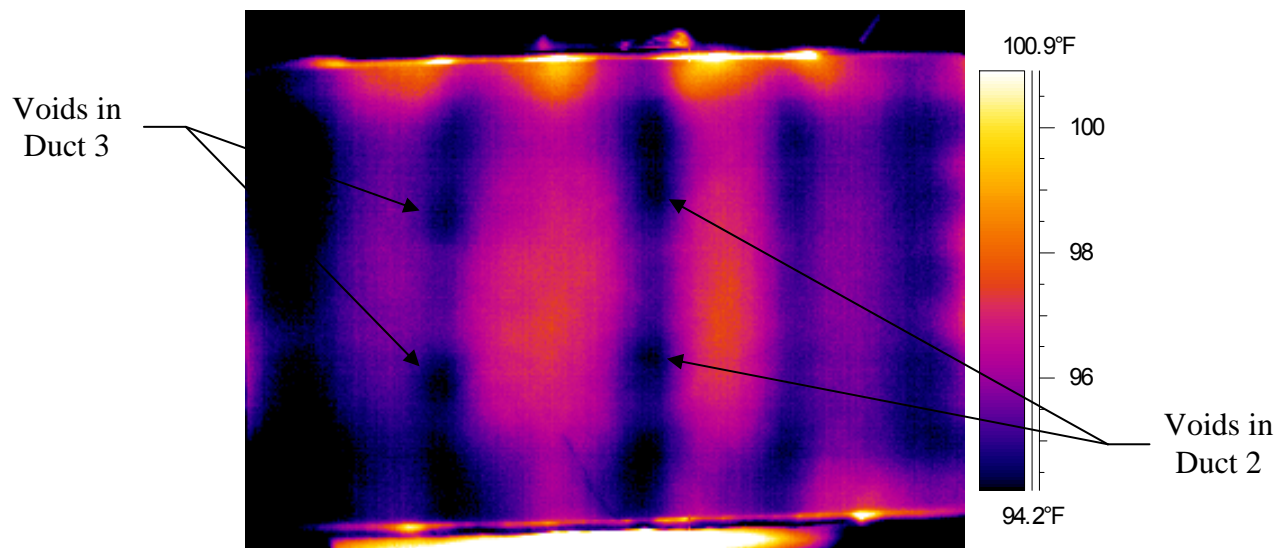
Figure 3.24 – Thermal image of Specimen 12c taken 7/23/2007

The first inspection of Specimen 12c took place on 7/23/2007 using inspection Method 1. Since Specimen 12c contained four simulated voids in plastic ducts, thermal images were promising. The simulated voids in Ducts 2 and 3 were all visible, as denoted in Figure 3.24. Temperature differences between simulated void locations and their surrounding regions were only approximately 0.5 to 1.0 °F. This temperature difference is an unusually small value compared to other inspections, but the simulated voids show up clearly because the image temperature range was only about 6 °F. The voids are represented as cool spots in the thermal image, which follows the heat theory presented in prior inspection analysis.

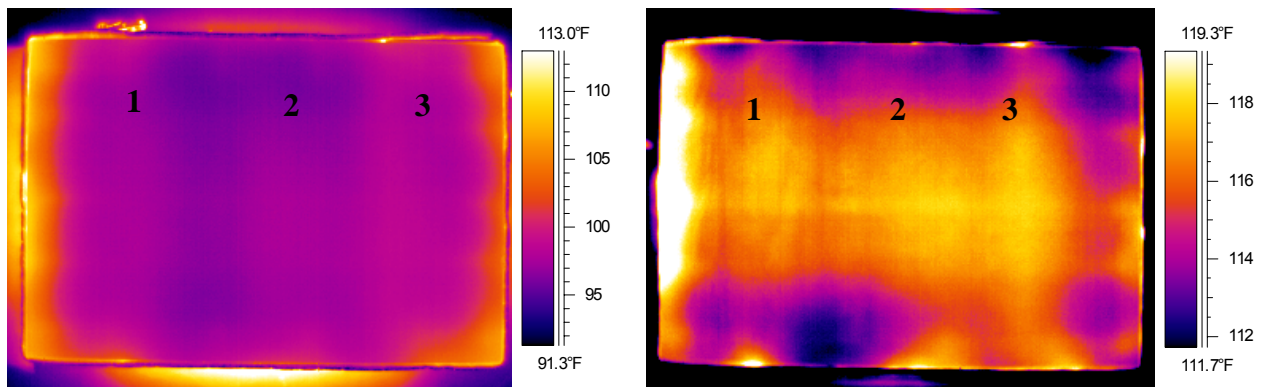
Figure 3.25 – Thermal images of Specimen 12d

The first inspection of Specimen 12d was conducted on 7/26/2007 using inspection Method 1. Even though Specimen 12d was heated for almost seven hours, the thermal images did not show the steel PT-ducts very clearly. One such image can be seen in Figure 3.25 (left side), where the PT-ducts are distinguishable as slightly warmer strips between cooler regions. The reason for this lack of visibility in a 30 cm (12 in.) thick specimen isn't clear. Older 30 cm (12 in.) thick specimen inspections showed PT-ducts more clearly when heated for approximately the same length of time. The absence of temperature difference at duct locations in the thermal image of Specimen 12d may be due to the fact that it was much newer and thus had more moisture in the concrete. Older specimens had cured for over three years, whereas Specimen 12d had only cured for about two months before being inspected.

The inspection of Specimen 12d conducted on the very next day (7/27/2007) did not reveal anything more about the specimen than the previous inspection. Due to the increased initial unheated surface temperature, the thermal image taken on 7/27/2007 looks different, but the PT-ducts are not clearly visible. A thermal image from this inspection can be seen in Figure 3.25 (right side). The numbers on each thermal image signify the locations of Ducts 1, 2, and 3.

- a) left image taken 9/26/2007 (initial unheated surface temp. of 75 °F)
- b) right image taken 9/27/2007 (initial unheated surface temp. of 105 °F)

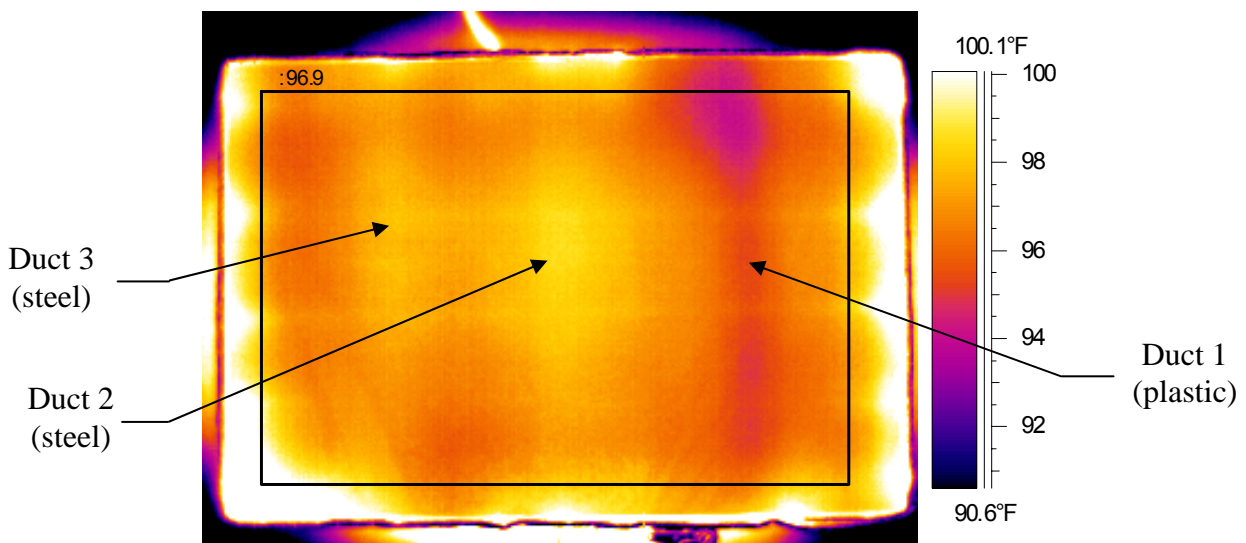
Figure 3.26 – Thermal image of Specimen 12e taken 7/25/2007

The inspection of Specimen 12e was conducted on 7/25/2007. The bottom face of the specimen was heated for almost eight hours, and thermal images were taken of the unheated top face throughout the inspection. Thermal images began revealing PT-ducts after about 4:30 (hh:mm). The clearest images, however, were not obtained until the end of heating because that was the point when temperature variations at specimen edges were at a minimum in the thermal image. Minimum temperature variations result in smaller temperature ranges on thermal images (the range of Specimen 12e was about 10 °F in Figure 3.26), thus smaller temperature differences are easier to detect. Figure 3.26 shows a thermal image taken near the end of heating. The two steel ducts are shown as warmer areas and the plastic duct as a cooler region. The image also shows that the average unheated surface temperature was almost 97 °F. A few rebar are displayed as well, but there are no clear, visible signs of any of the simulated voids located at the middle of each PT-duct.

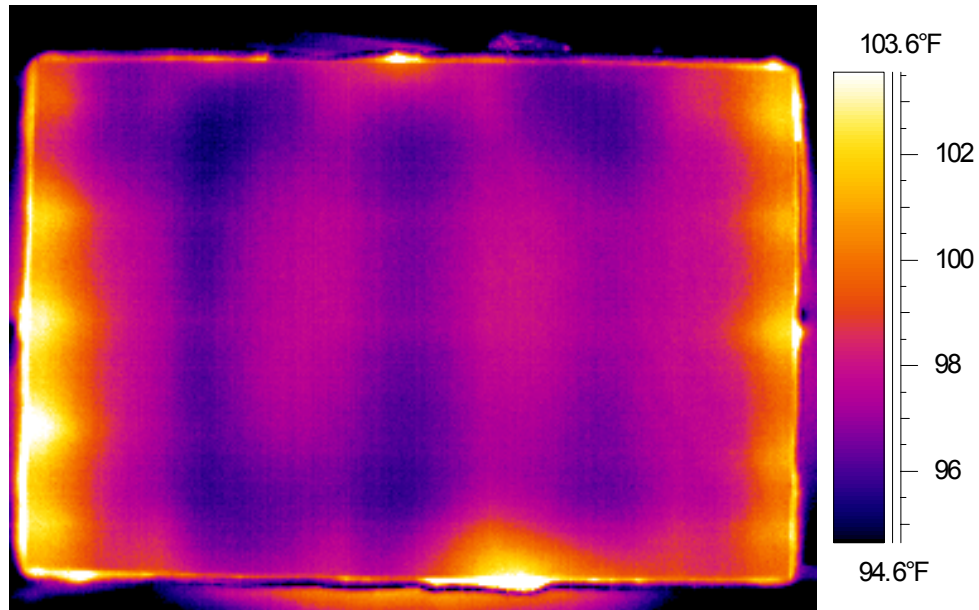
Figure 3.27 – Thermal image of Specimen 12f taken 9/12/2007

The first inspection of Specimen 12f took place on 9/12/2007 using inspection Method 1. Specimen 12f was heated for approximately six hours, and thermal images of the unheated surface were taken throughout. Since Specimen 12f contained three plastic PT-ducts, the thermal image showed three cooler strips between warmer regions. Figure 3.27 shows a thermal image of the inspection conducted 9/12/2007. Even though two of the ducts (Ducts 2 and 3) had 5 cm (2 in.) more concrete cover to the top face than Duct 1, the ducts in the thermal image look similar. There are no simulated voids visible in the thermal image.

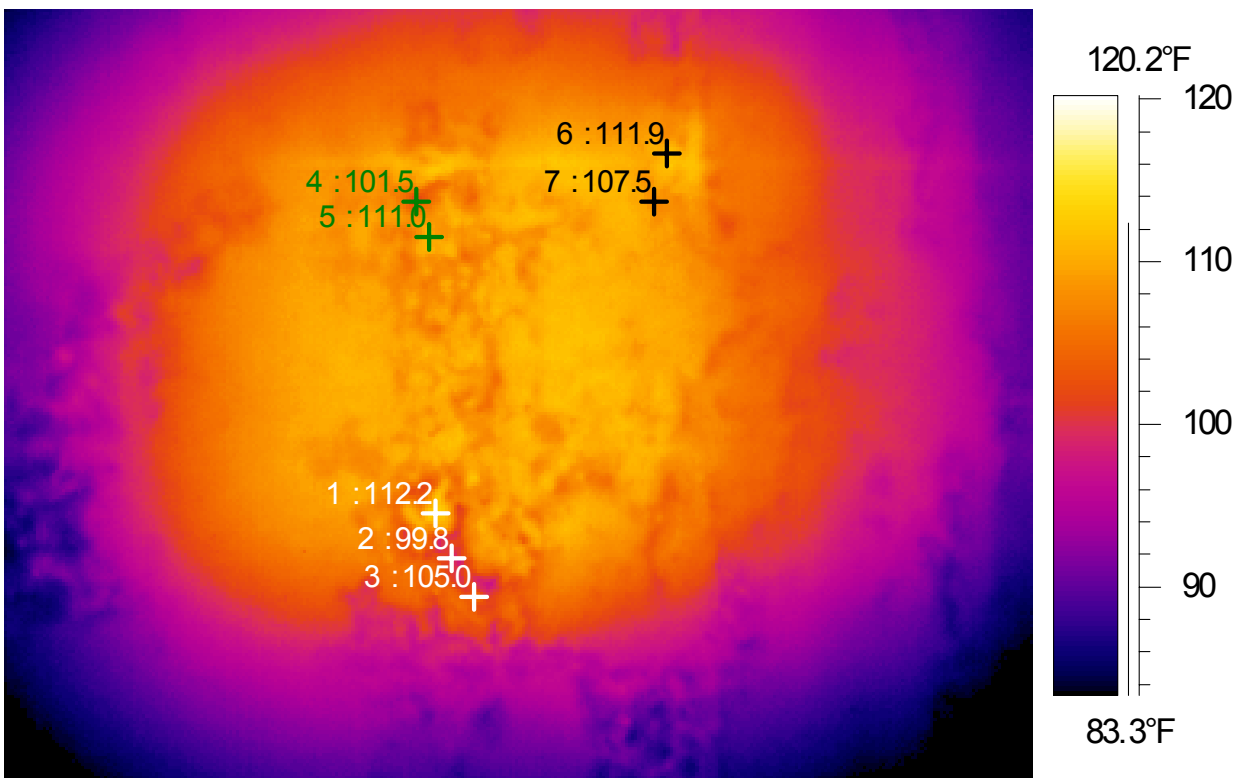
Figure 4.4 – Thermal image of Heating Location # 1

The irregularities from Heating Location #1 can be seen more clearly if the thermal image in Figure 4.3 is enlarged, as in Figure 4.4. The points denoted with a white symbol (points 1, 2, and 3 in Figure 4.4) display different surface temperatures within fairly close proximity to each other. From the center of the heated area, point 1 is hottest at 112.2 °F and point 2 is lower at 99.8 °F, as expected (the center of the heated area should be the hottest, with surface temperatures decreasing farther away from the center). However, it is evident that point 3 is hotter than point 2, even though it is farther away from the heated center. This shows that there was an irregularity at this location.

The green and black colors in Figure 4.4 also indicate areas where there were noticeable temperature differences within close proximity. There was roughly a 10 °F difference between

points 4 and 5, which were only a few inches apart. Also, points 6 and 7 show a surface temperature increase at distances farther away from the heated center, replicating the effect at points 2 and 3. These irregularities could be a sign of many things. From the photo in Figure 4.3, there are some areas with discoloration. As this is reproduced in the thermal images, these may be locations of poorly consolidated concrete or delamination.

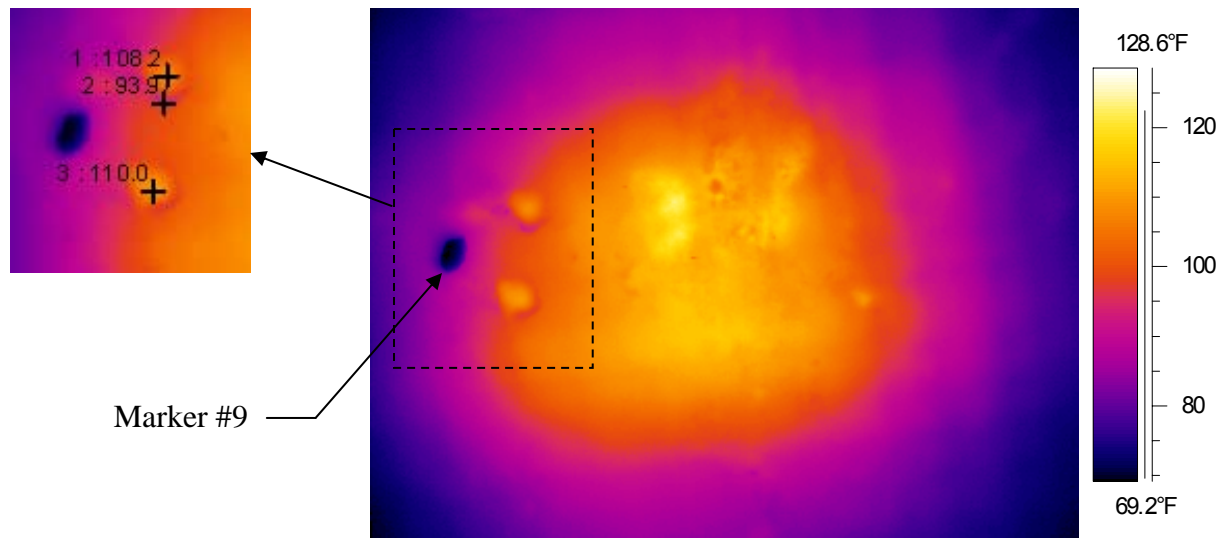
Figure 4.5 – Thermal image and enlarged area showing spot temperatures of Heating Location # 2

Figure 4.5 shows a thermal image of Heating Location # 2. The black mark on the left side of the image is marker # 9, and marker # 7 would be on the right side if it were within the viewing range. This image is a very good example of delamination, as indicated by the two “spots” located to the right of the marker # 9. These two areas look like hot spots because of the delamination (separated layers within the concrete) that keeps the heat from propagating farther into the floor of the box girder. The heat propagates at a slower rate due to a layer of air present at the delamination interface. The air acts as an insulator, keeping more heat within the layer of concrete nearest the heat source. The delaminations in the thermal image were confirmed by WSDOT inspectors through tapping the surface with a hammer after thermal imaging was completed. Figure 4.5 also shows three points that demonstrate the temperature differences in

the vicinity of hot spots. The temperature difference between points 1 and 2 is approximately 14 °F and can be attributed to the delamination occurring between the two points.

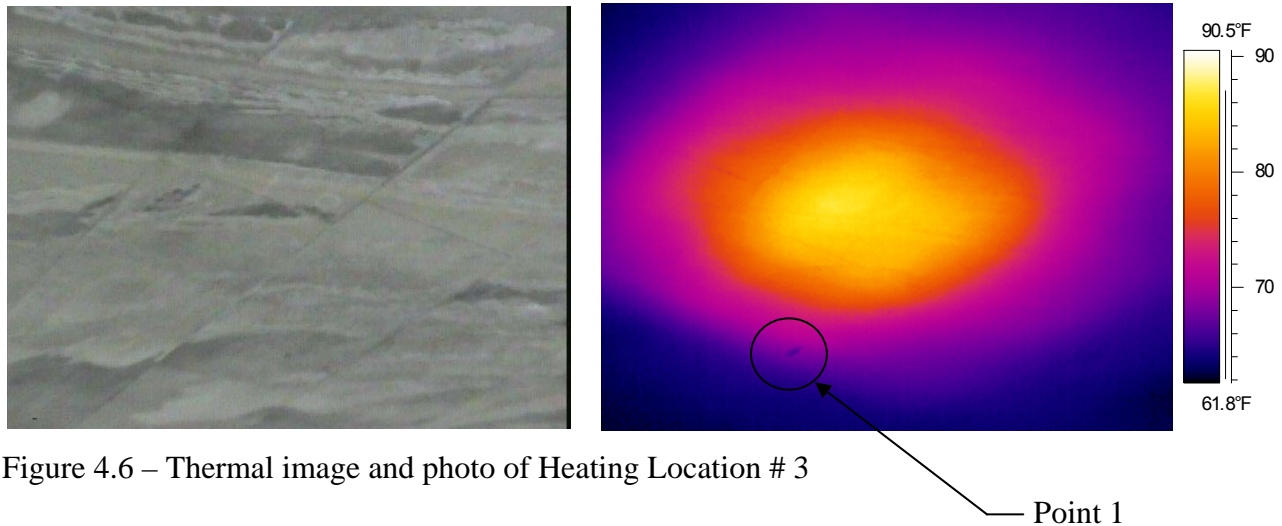
Heating Location # 3 did not reveal very many irregularities. A thermal image of this location is provided in Figure 4.6, and it only shows one small irregularity denoted by the circle. Using the thermal imaging software, temperatures at the irregularity and at a location just to the right of it were 66.3 °F and 68.5 °F, respectively. This is a 2.2 °F difference, which is not very

big considering the temperature range of the image is approximately 28 °F. Due to the relatively small temperature change and the lack of other irregularities around the point, it would probably not be classified as a point of significance. Heating Location # 3 would therefore be a good example of a surface with no apparent problems after inspection.

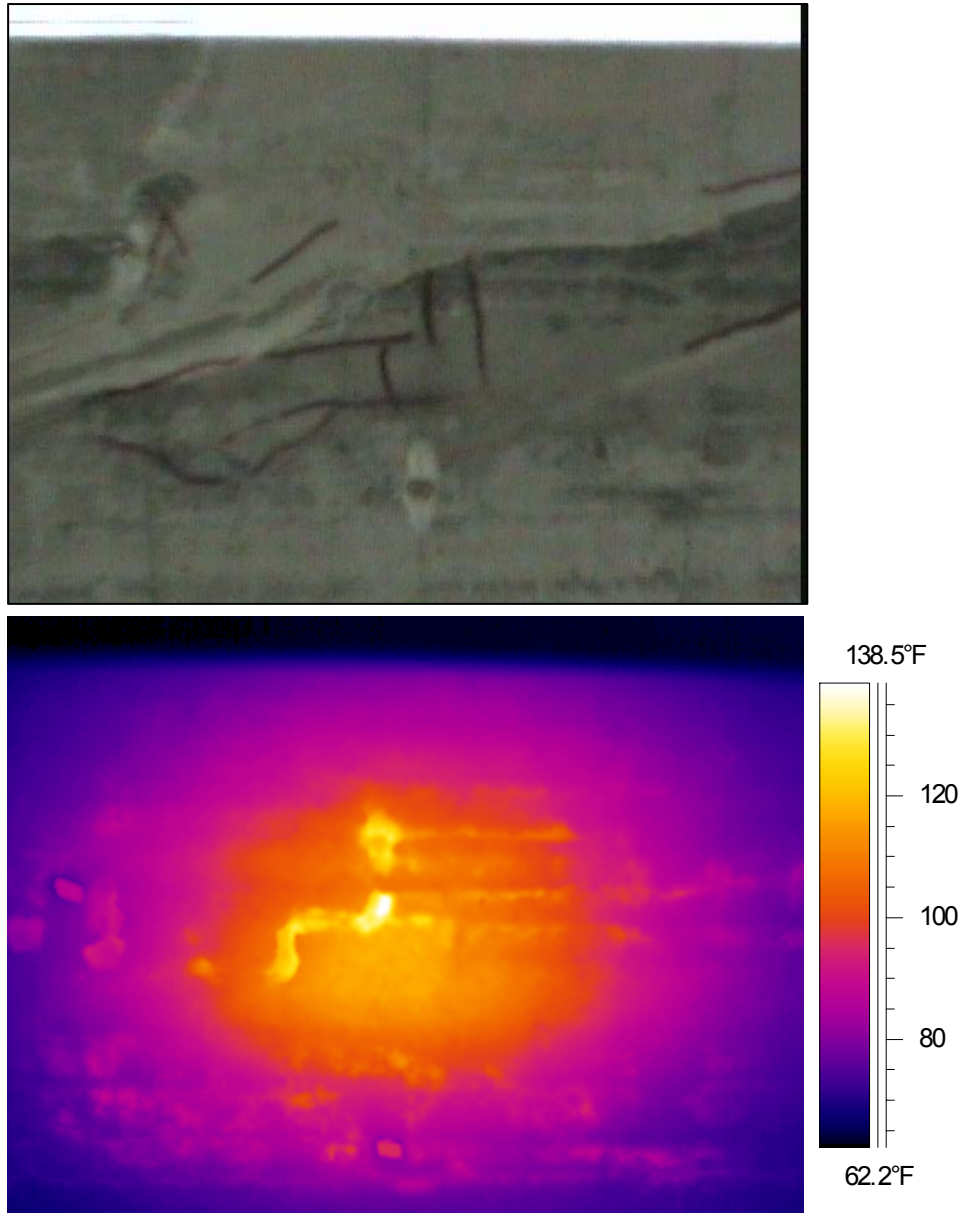
Figure 4.12 – Thermal image and photo of Heating Location # 8

Figure 4.12 shows a photo and thermal image of Heating Location # 8. From the photo, one can see that the surface had been marked during previous WSDOT inspection. The markings were somewhat unclear, or at least they did not match up with anything in the thermal image. The image, however, does show a great deal about the surface. In the middle of the heated surface area were a few flaws that varied greatly from the areas around them. Temperature differences ranged from approximately 12 °F to 24 °F between the irregularities and the surrounding concrete. The left side of the image revealed some flaws as well, but they were not very clear because heat was not directly applied to that area. The flaws on the left side of the thermal image do demonstrate, however, that a lot of direct heat is not necessary for flaws to be detected.

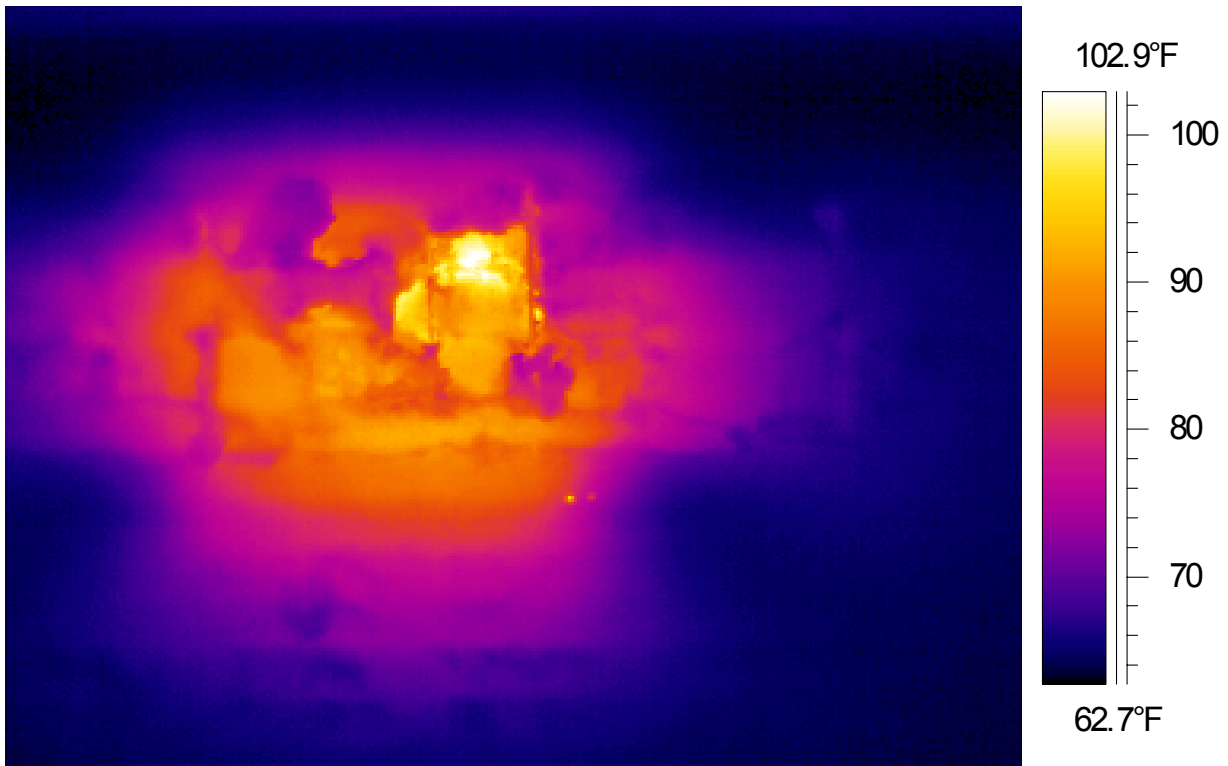
Figure 4.13 – Thermal image of Heating Location # 9

Figure 4.13 shows a thermal image of Heating Location # 9. There is great thermal variation in this image with temperature differences between 10 °F and 25 °F in the middle of the heated area. With Method 1 heating, irregularities like delamination appear as cool regions because the images were taken of the unheated surface. At delaminations, heat propagates at a slower rate than through a section of concrete with no irregularities, and thus a cool spot occurs on the unheated surface of a delaminated region.

The thermal image in Figure 4.13 was taken near the end of the heating process, at approximately 1:55 (hh:mm) after heating began. When heat propagates through a material as in Method 1, thermal images may still be obtained after the heat input has been removed. Even with no heat source, the heat already within the concrete will still propagate toward regions of lower temperature. During this inspection, thermal images were taken for two hours following the removal of the heat source.

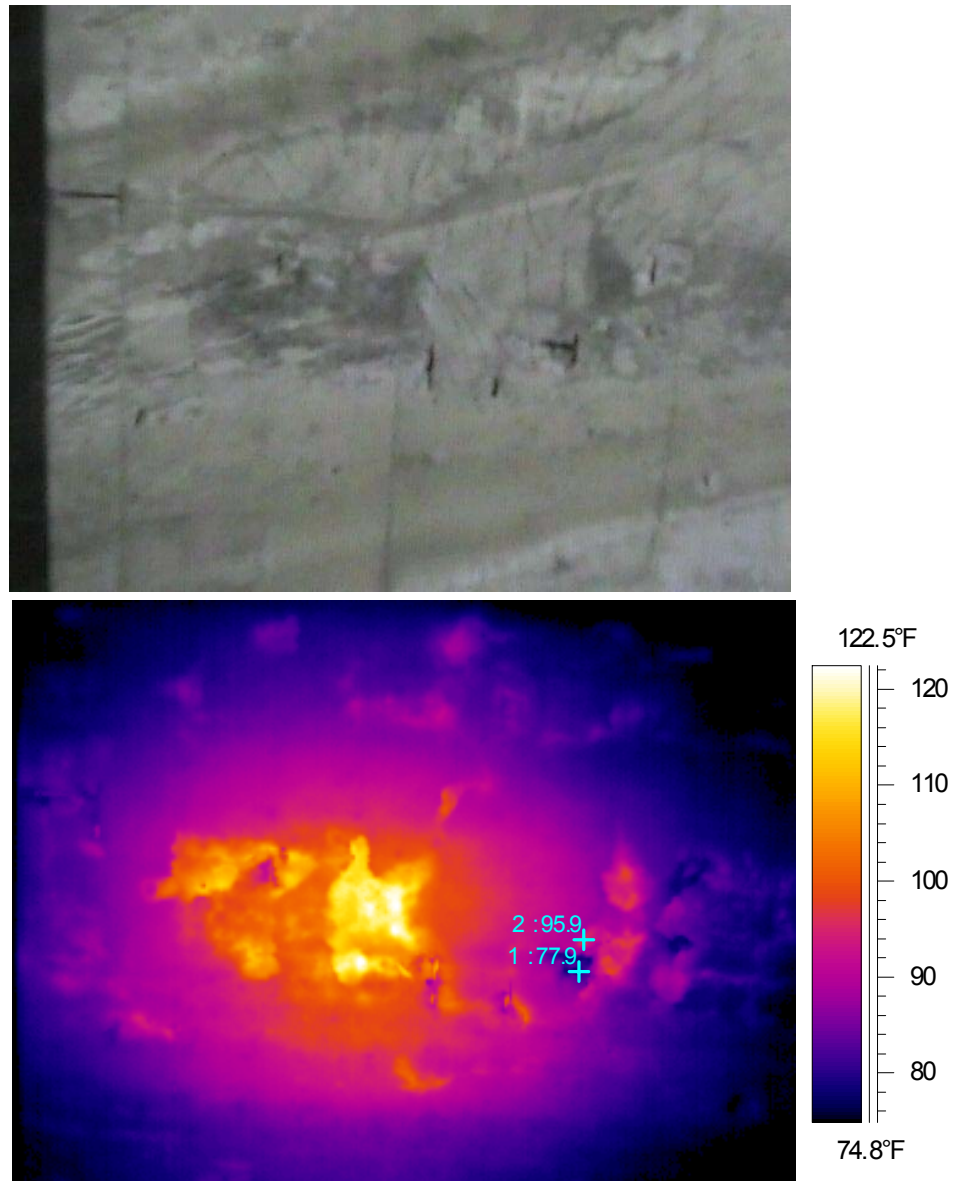
Figure 4.14 – Thermal image and photo of Heating Location # 10

Figure 4.14 shows a thermal image and photo of Heating Location # 10. This image exhibits a lot of temperature variation. An example exists with points 1 and 2 on the right side of the image. Point 1 is located on a cool spot at 77.9 °F, while just a few inches above, point 2 is warmer at 95.9 °F. This is a temperature difference of 18 °F. There are more variations like this

throughout the image, thus indicating that near-surface irregularities are present. Also, around the edges of the heated area, discolorations are visible indicating inconsistencies in the concrete surface. When looking at both the thermal image and photograph, it appears that temperature differences occur where visual discoloration is present.
