NONDESTRUCTIVE TESTING OF CONCRETE BOX GIRDER BRIDGES USING THERMAL IMAGING

A thesis submitted in partial fulfillment of
the requirements for the degree of

WASHINGTON STATE UNIVERSITY
Department of Civil and Environmental Engineering

MAY 2008

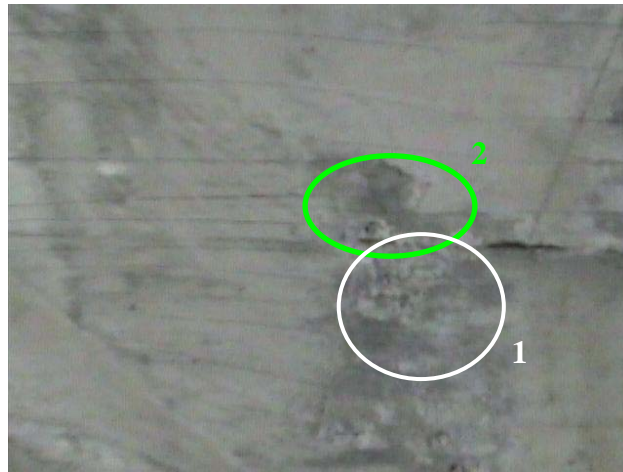
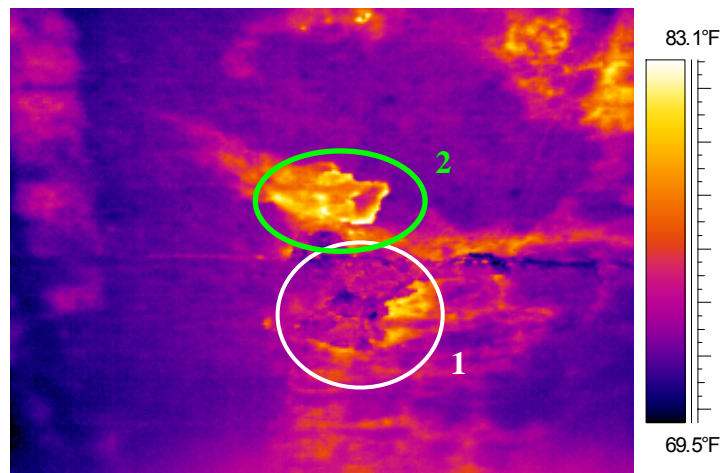
Figure 4.15 – Thermal image and photo of Heating Location # 11 approx. 10 min. after heating began

Figure 4.15 shows a thermal image and photo of Heating Location # 11 that were taken approximately 10 minutes after heating began. Visible flaws were present on the heated surface and temperature differences between warm and cool areas were approximately 7 °F. The thermal image shows that not much heat time is needed to detect surface irregularities and obtain a significant temperature variation. Figure 4.15 also shows what looks like spalled concrete (denoted by circle 1) and an area of delamination (denoted by circle 2).

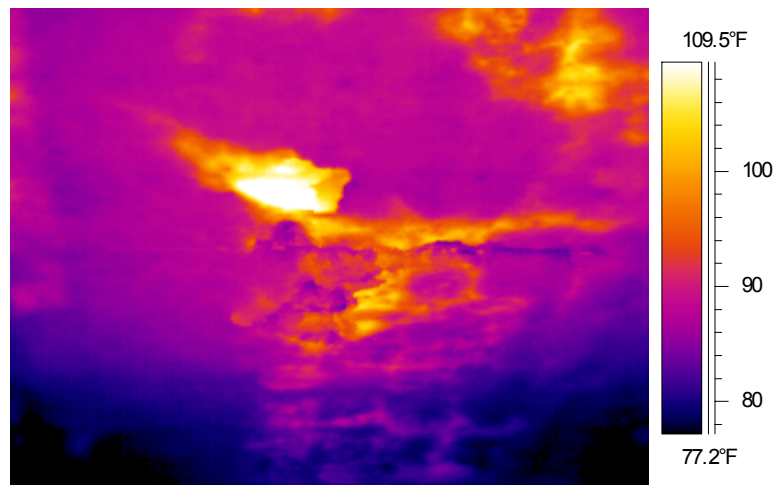
Figure 4.16 – Thermal image of Heating Location # 11 approx. 40 min. after heating began

Figure 4.16 shows a thermal image of Heating Location # 11 taken approximately 40 minutes after heating commenced. When comparing Figures 4.15 and 4.16, it is evident that a lot of surface detail was lost as the heating time increased. This is likely due to the camera's automatic adjustment to a broader temperature range. Broader temperature ranges result in less detailed images.

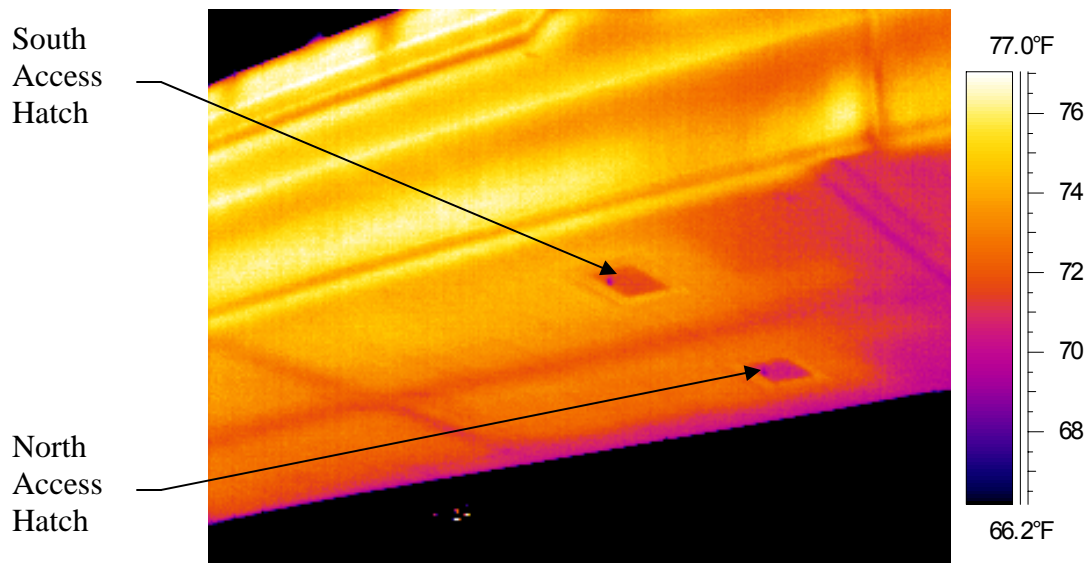
Figure 4.17 – Thermal image of Span 4 under ambient conditions

Before any inspections took place, thermal images of the bottom surface of the box girder under ambient conditions were analyzed to see if problem areas could be identified. Figure 4.17 shows a thermal image of the bridge (Span 4) under ambient conditions that encompasses most of the span. This thermal image displays the access hatches used during one inspection (Heating Location # 2). However, it does not reveal any specific problem areas. Without thermal identification to locate problem areas, visual analysis was used in conjunction with access limitations to determine heating locations. The positioning limits were based on access provided

by WSDOT lane closures on I-5. In Figure 4.17, only the area from the right side of the image to approximately the two hatches was available for inspection. This allowed for two inspections, one using Method 1 and the other using Method 2. The two heating locations were then chosen based on what regions presented the most visible irregularities. It is important to note that inspection of this box girder bridge took place at night. Setup started around 10:00 pm on August 13th, and the final inspection ended at about 2:00 am on August 14th, for a total inspection time of four hours.

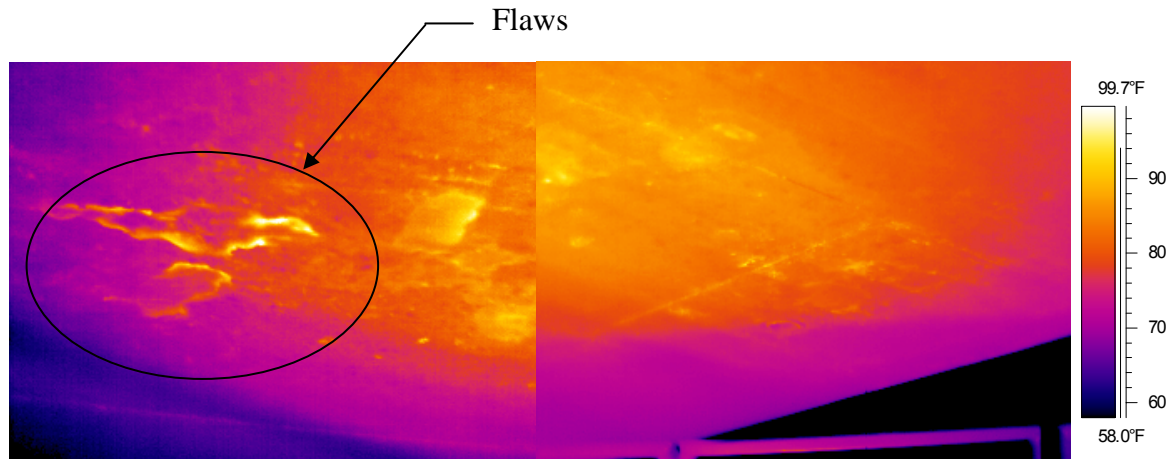
Figure 4.19 – Thermal images of Heating Location # 1, side by side

With this inspection, thermal images were taken throughout the heating process. The camera was placed on the lift platform approximately 3 m (10 ft.) to one side of the heater. Figure 4.19 shows two thermal images side by side that were taken approximately four minutes after heating began. Each image shows one half of the heated surface. The circled region demonstrates that after a fairly short heat time, surface characteristics and flaws were visible in thermal images. There were also other visible irregularities in the middle of Figure 4.19.

The thermal images in Figure 4.19 were taken in order to help locate areas that, with further heat input, might reveal sub-surface flaws. The circled region shows what looks like a flaw, so the heater was moved so that its center was directly underneath this region, and then heating commenced again. From here, thermal images were taken every two minutes. Figure 4.20 shows a single image from the progression of images. Figure 4.21 shows a typical image progression during heating, or what one would see from the camera display.

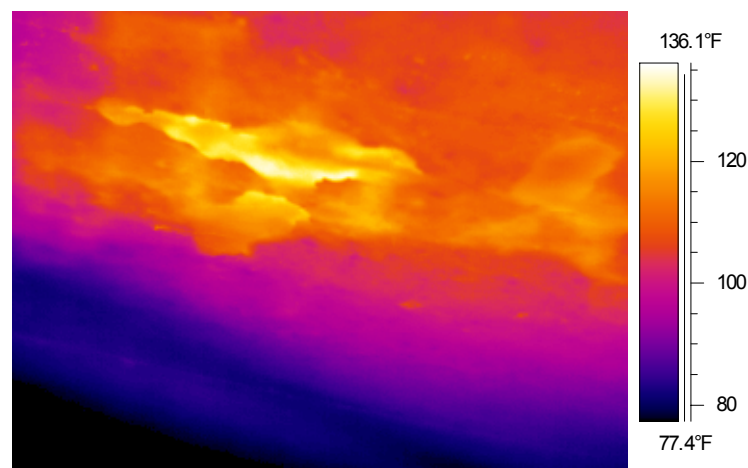
Figure 4.20 – Thermal image of Heating Location # 1 at middle of heating interval

Heating Location # 1 was a very important inspection because, after heating was stopped, the surface was examined with a rock hammer. Tapping confirmed what was seen in the thermal images. A WSDOT inspector tapped part of the surface that had no apparent flaws (either visually or thermally) and then tapped at suspected locations. Sound differences were easily discernable between the two locations and then the pick end of the hammer was used to remove surface concrete and excavate the flaw. Delamination and poorly consolidated concrete (small air voids) were discovered. Figure 4.22 shows a thermal image of a WSDOT employee excavating the delaminated concrete at the flaw location shortly after thermal imaging inspection. This was the first inspection location where flaws discovered thermally were confirmed using physical means (tapping and excavation).

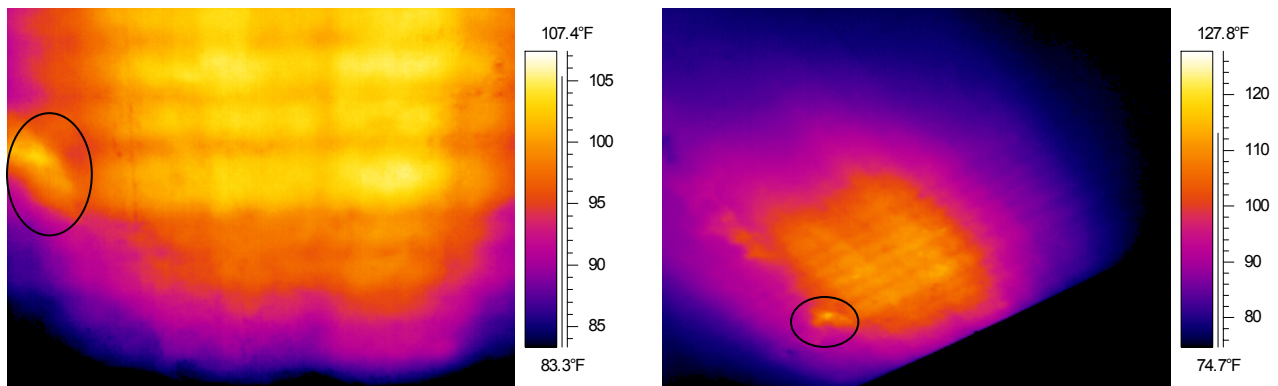
Figure 4.23 – Thermal images of Heating Location # 2

Thermal images from Heating Location # 2 do not reveal anything about the leaching or the unheated surface. Steel reinforcement inside the concrete and one hot spot are shown in the

images. Figure 4.23 is comprised of two thermal images that show the reinforcing steel as cool lines between warmer regions. The hot spot, which is located inside the circled region in both thermal images, may be a delamination.

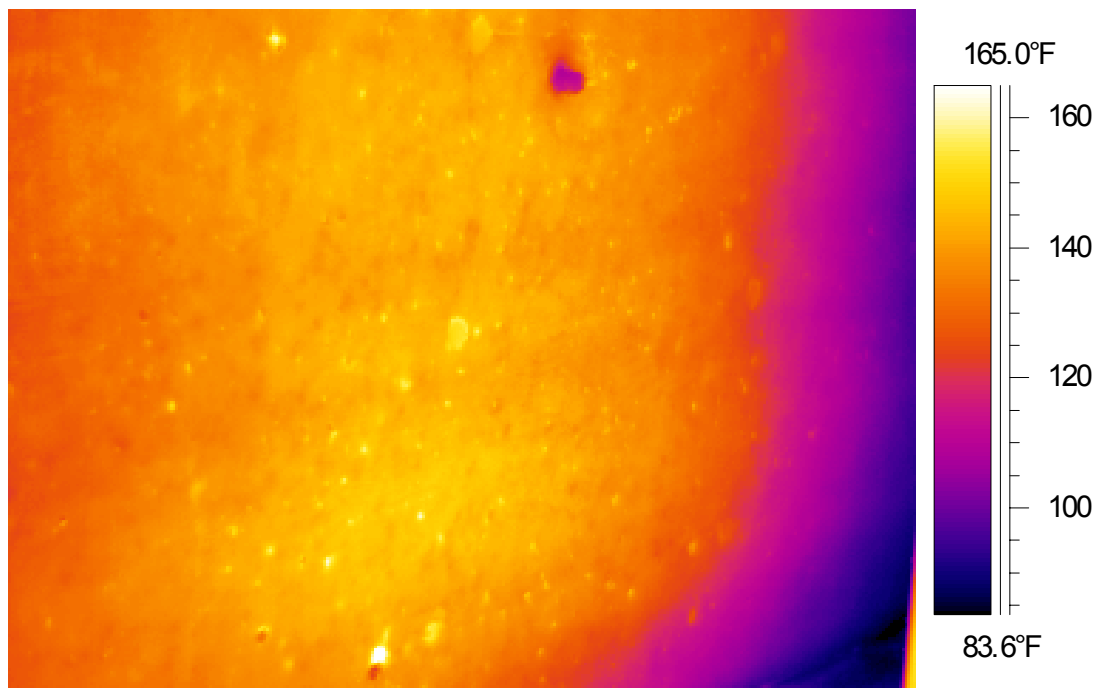
Figure 4.25 – Thermal image of Heating Location # 1 (30 minutes after heating began)

Figure 4.25 shows a thermal image of Heating Location # 1 taken approximately 30 minutes after heating commenced. This image illustrates the state of the concrete surface and its characteristics. A few hot and cool spots can be seen, but this image primarily reveals surface characteristics of the concrete

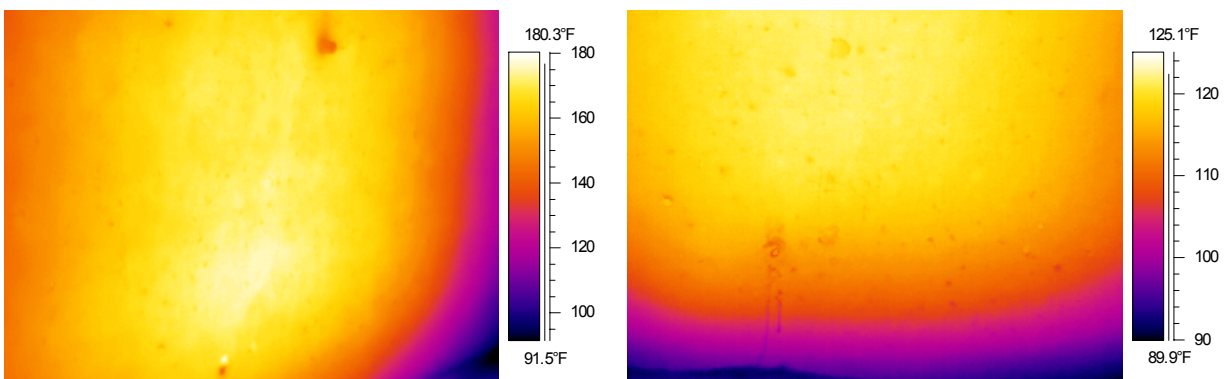
Figure 4.26 –Thermal images of Heating Location # 1:

The next two thermal images, shown in Figure 4.26, do not reveal anything regarding materials embedded in the concrete box girder web. The first image on the left was taken after 2:55 mark (hh:mm) of heating. The second image on the right was taken after the camera was moved directly in front of the heated surface, about 0:45 (hh:mm) after heating ended. There are no PT-ducts visible in any of the thermal images, which indicates a couple of different things. First, three hours of heat input may not be enough to provide thermal images showing PT-ducts embedded in 30 cm (12 in.) thick concrete. Second, it is likely that the inspection setup was not

ideal for detecting the ducts. Inspection Method 2 involves taking thermal images from the same side as the heat input, and specimen inspections conducted in the lab indicated that Method 2 does not yield images showing inner-surface characteristics. Also, due to the confined area inside the box girder, the camera could not be placed as far from the heated surface as desired. Thus the camera lens could not capture the entire heated surface area. Unfortunately, since the opposite face of the box girder web was not accessible, inspection Method 2 was the only option available.

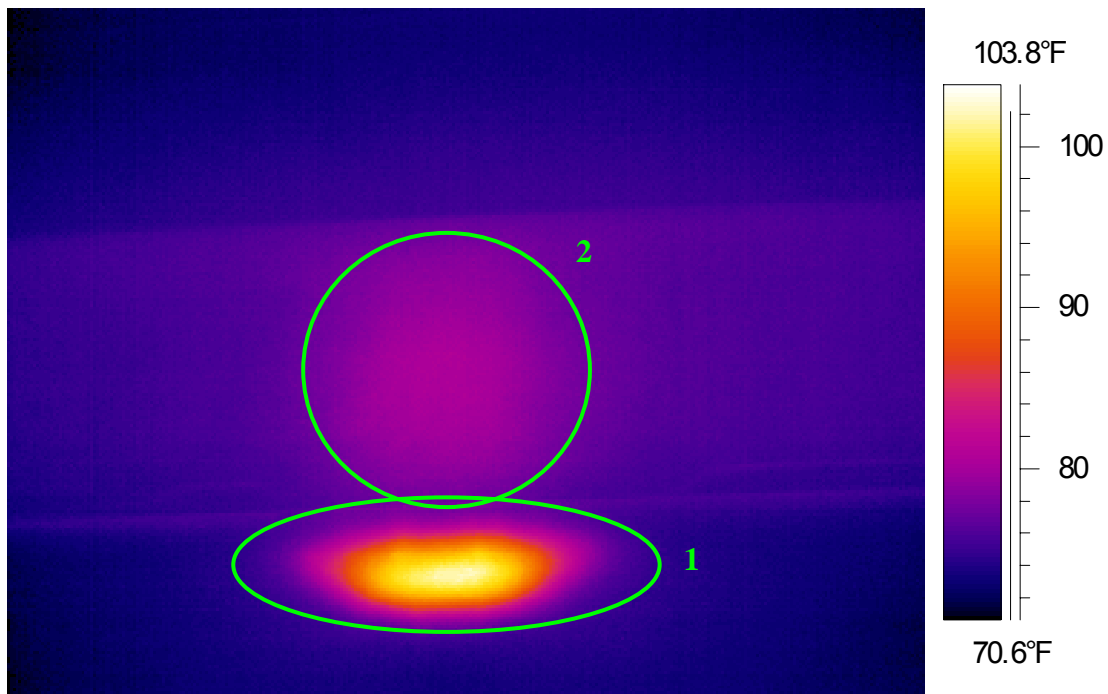
Figure 4.28 – Thermal image of Heating Location # 2 taken of the unheated surface

The inspection setup for this location allowed for two kinds of thermal images to be obtained. The first kind of image was of the unheated surface, taken from ground level outside the box girder (Method 1). The heated surface was approximately 9.1 m (30 ft.) above the camera, and due to this large distance, images had less detail and a large viewing window. Figure 4.28 shows one such image taken about three hours after heating began. From the image, one can see that the heated surface (wall) was not as warm as the floor of the box girder. This is due to the fact that the wall is thicker than the floor (12 in. versus 8 in.), and it takes longer for heat to propagate through thicker concrete. After only three hours of heat input, there were no PT-ducts or flaws visible in the thermal image. In Figure 4.28, circled area 1 shows the floor,

while circled area 2 shows the wall of the box girder. Thermal images taken of the unheated surface after five hours of heating did not reveal the PT-ducts in the box girder wall.

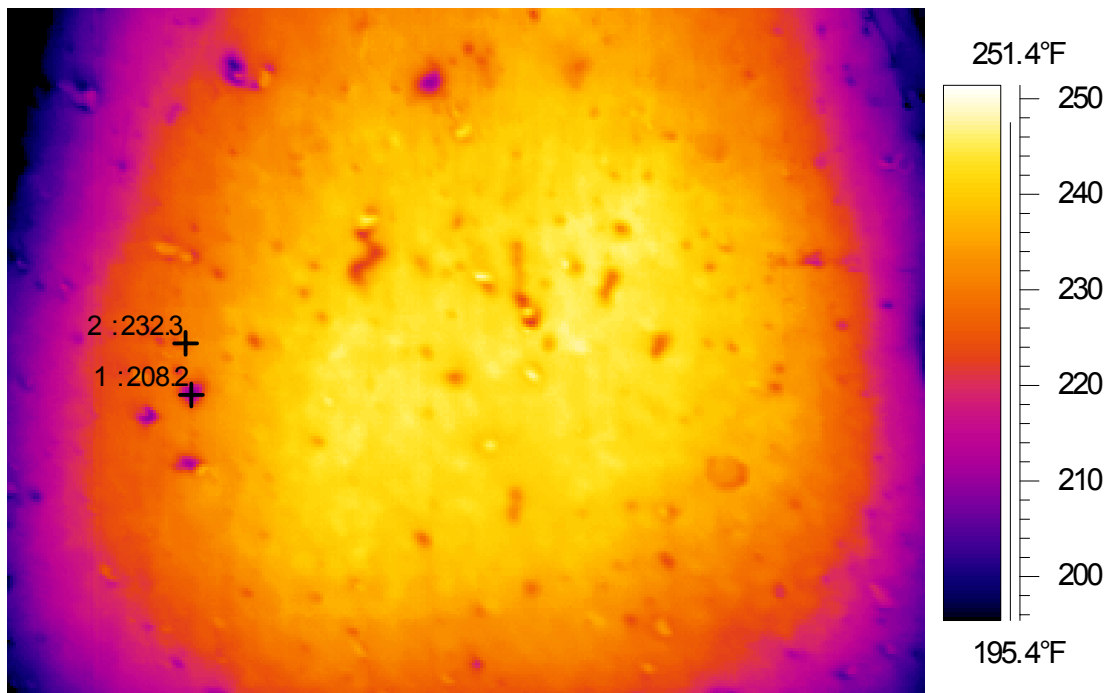
Figure 4.29 – Thermal image of Heating Location # 2 taken of the heated surface

Images of the heated surface were also obtained from inside the box girder after heating ended. Figure 4.29 displays one such image where surface characteristics are visible. However, as with Figures 4.27 and 4.28, the image does not show any PT-ducts. The flaws shown are mostly surface irregularities and or small surface voids. Points 1 and 2 in the Figure 4.29 show a temperature difference of approximately 24 °F in a span of only a few inches.
