**SEISMIC RETROFIT OF CRUCIFORM-SHAPED COLUMNS
IN THE AURORA AVENUE BRIDGE USING FRP WRAPPING**

A thesis submitted in partial fulfillment of
the requirements for the degree of

WASHINGTON STATE UNIVERSITY
Department of Civil and Environmental Engineering

MAY 2010

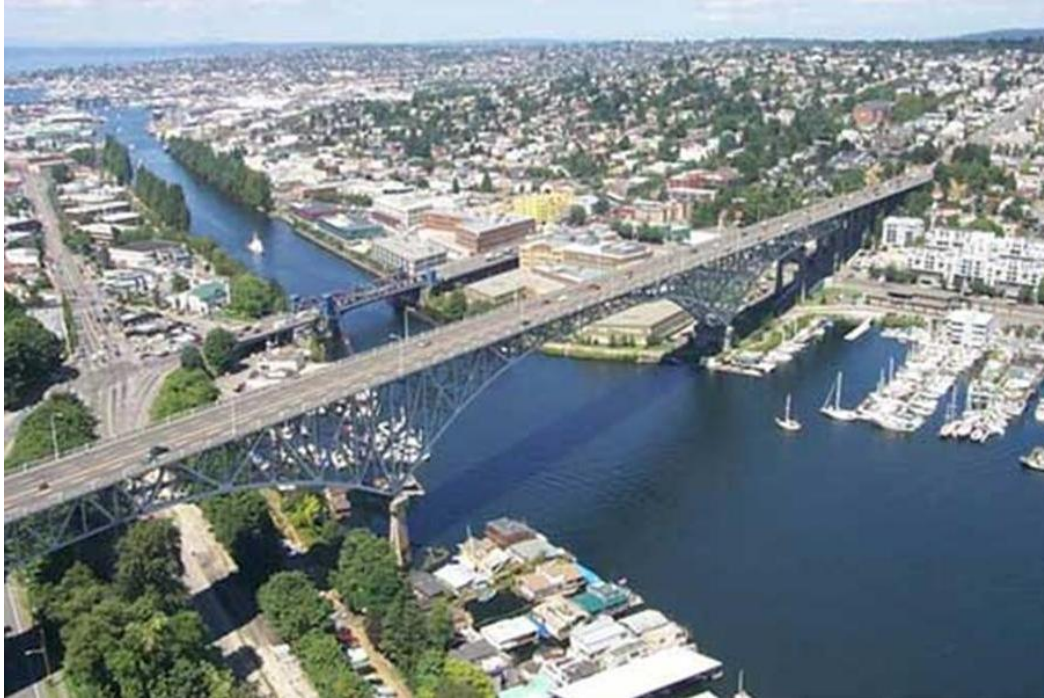
Figure 2.3.1 – Overall Layout of the Aurora Avenue Bridge

The layout of the Aurora Avenue Bridge can be broken down into three distinct sections: the south approach, the main span, and the north approach. Figure 2.3.1 shows the overall layout of the bridge.

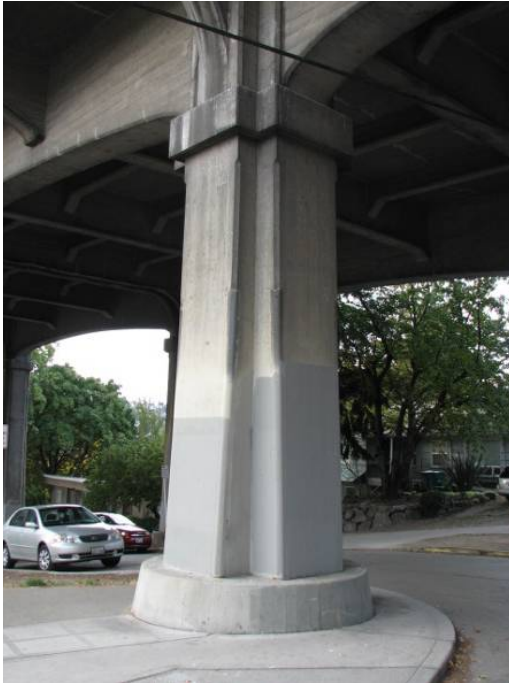
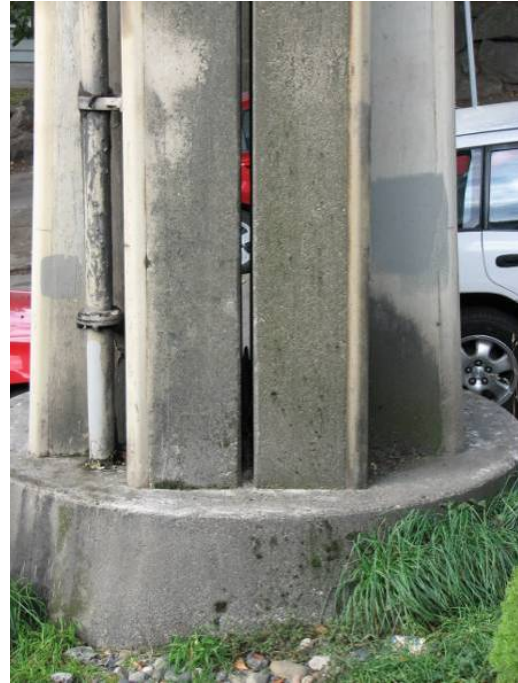
Figure 2.3.3 – Typical Solid and Split Columns in the North Approach

The north approach features twelve spans of reinforced concrete construction. These twelve spans are separated into five independent frames by split columns which allow for expansion and contraction of the bridge due to temperature and shrinkage effects. Figure 2.3.2 shows the layout of the north approach. The piers themselves are unusual in that they are in the

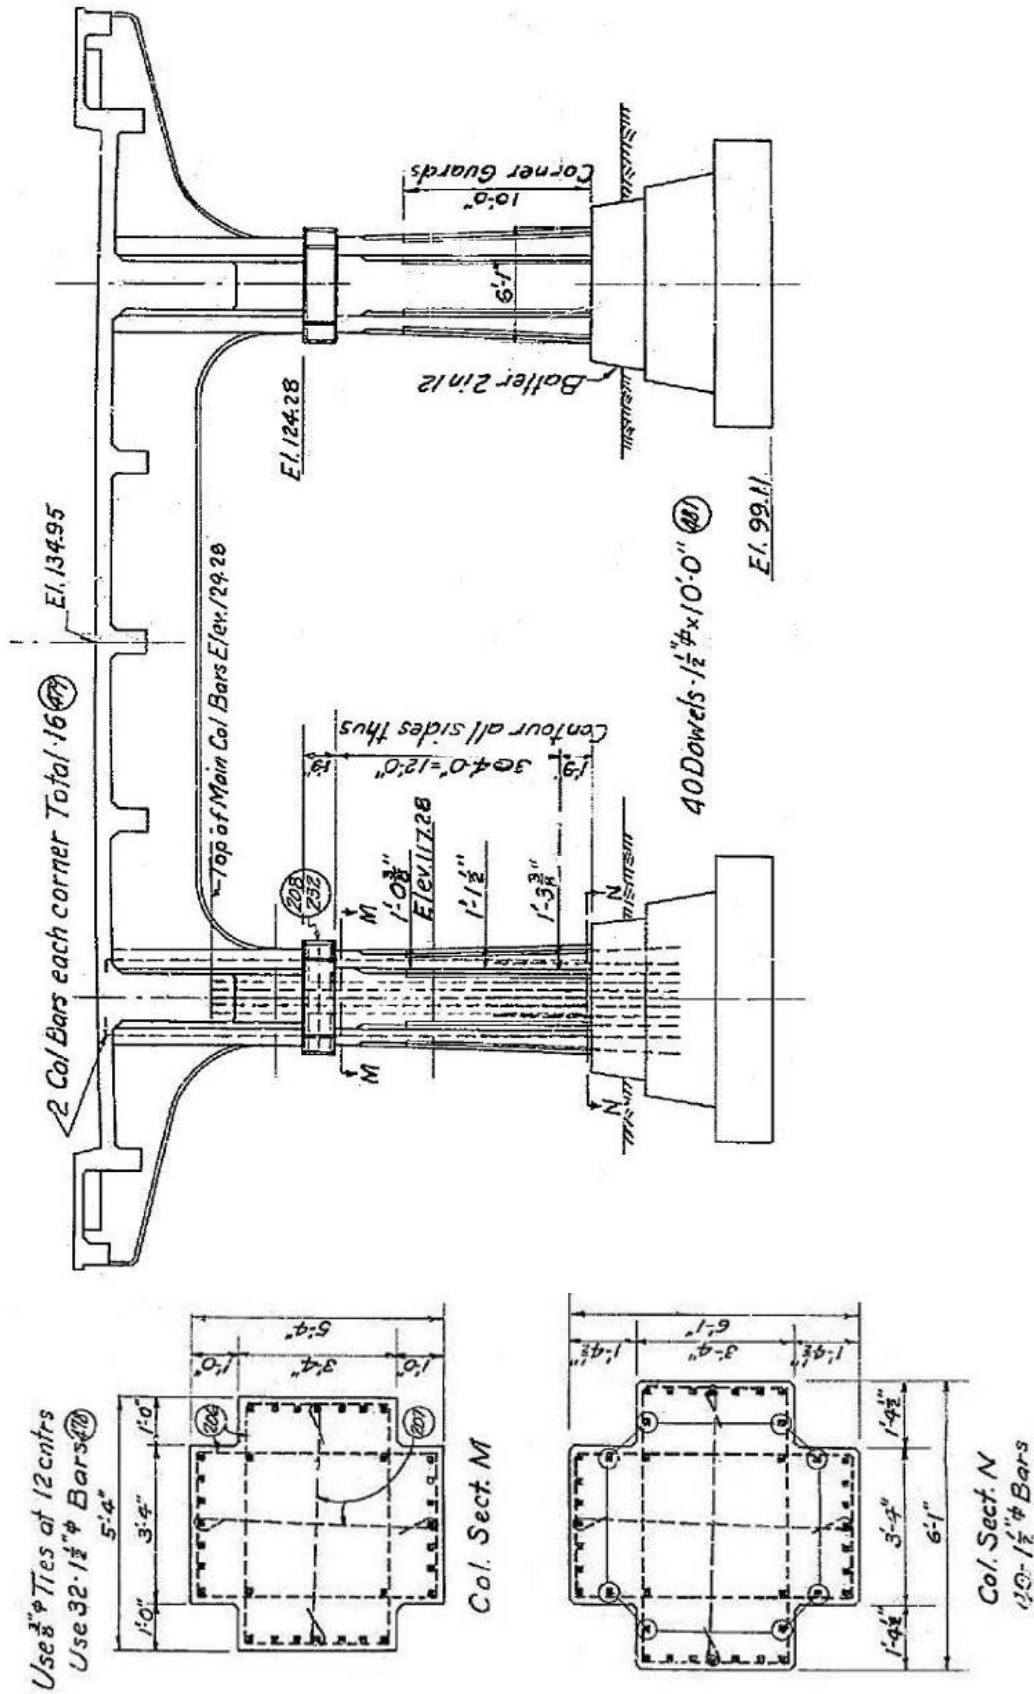
Figure 4.2.1 - Column As-Built Details (1 in. = 25.4 mm)

Details for the column specimens were modeled after columns in Bent N13 in the as-built plans. Figure 4.2.1 shows the column dimensions and reinforcement details for Bent N13.

As-built column details for the test specimens were based on “Bridge 99-560 Approach Span As-Built Plans” provided by the WSDOT. Material properties for the bridge construction were not available, so material properties were obtained from the 1931 *Standard Specification for Highway Bridges* (AASHTO, 1931). This standard required all concrete to have a minimum compressive strength at 28 days of 3500 psi (24 MPa) and steel reinforcement conforming to ASTM A15-30. Due to the strength gain of concrete with time, it was estimated that the concrete strength of the in-place concrete in the bridge would now be about 5000 psi (34 MPa). Information on ASTM A15-30 steel was found in “FEMA 356 – Prestandard for the Seismic Rehabilitation of Buildings”, which lists the yield strength of A15, Intermediate Grade steel as 40 ksi (276 MPa).

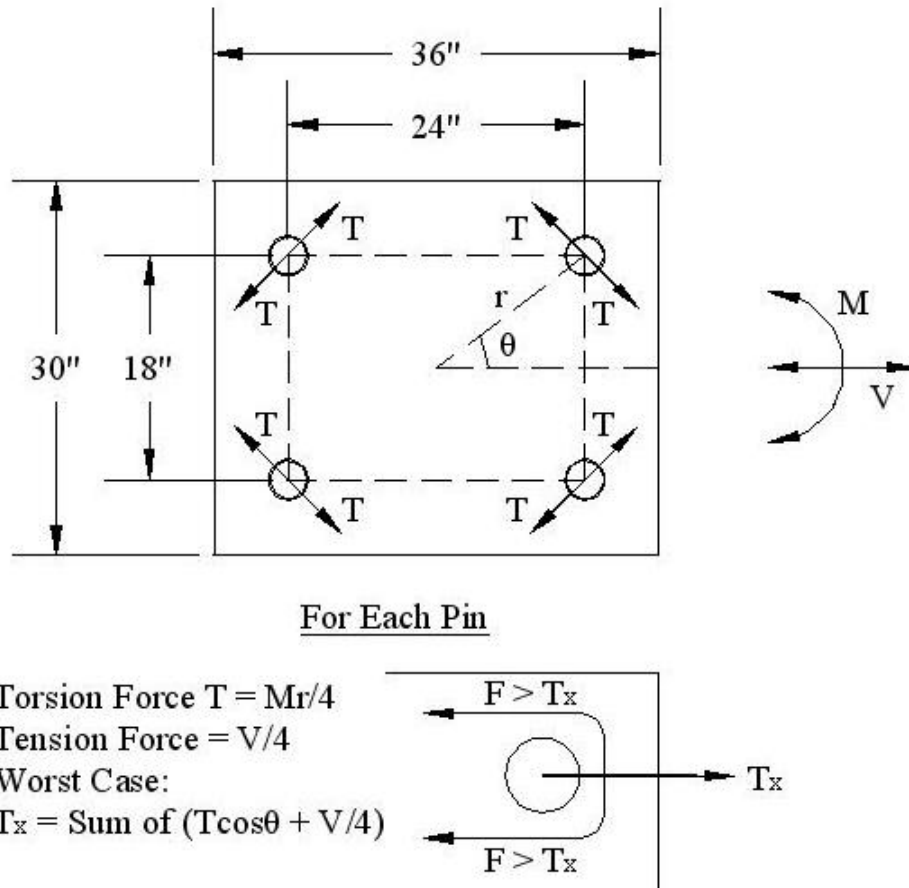
Figure 4.4.3 – Torsion Design in Top Load Stub (1 in. = 25.4 mm)

A heavily-reinforced load stub was constructed at the top of the column specimen in order to attach the loading frame to the specimen. Figure 4.4.1 shows the layout of reinforcement in the loading stub. The top load stub contained (30) No. 5 Grade 60 straight bars with 90° hooks running in the horizontal direction and evenly distributed around the top load stub. (8) No. 5 Grade 60 hoops and (16) No. 5 Grade 60 crossties were provided in the vertical direction. (4) 3-in. (76 mm) diameter standard steel pipes were cast into the load stub to connect the load stub to the load frame. (3) No. 6 Grade 60 hairpins were provided between each of the four steel pipes to resist the design shear and the torsion force developed at the four steel pipe locations due to the column top moment and applied shear forces, as shown in Figure 4.4.3. These hairpins were provided in both the horizontal and vertical directions for a total of (12) hairpins, which provided a lateral tension capacity of 158 kips (703 kN) at each bend. This was considered to be adequate to resist the worst possible case shown in Figure 4.4.3, where a maximum likely shear force, V , equal to 120 kips (534 kN), and an equivalent moment, M , equal to 427 k-ft (579 kN-m) at the center of the load stub, resulted in a maximum possible value of T_x equal to 98 kips (436 kN) at each bend.

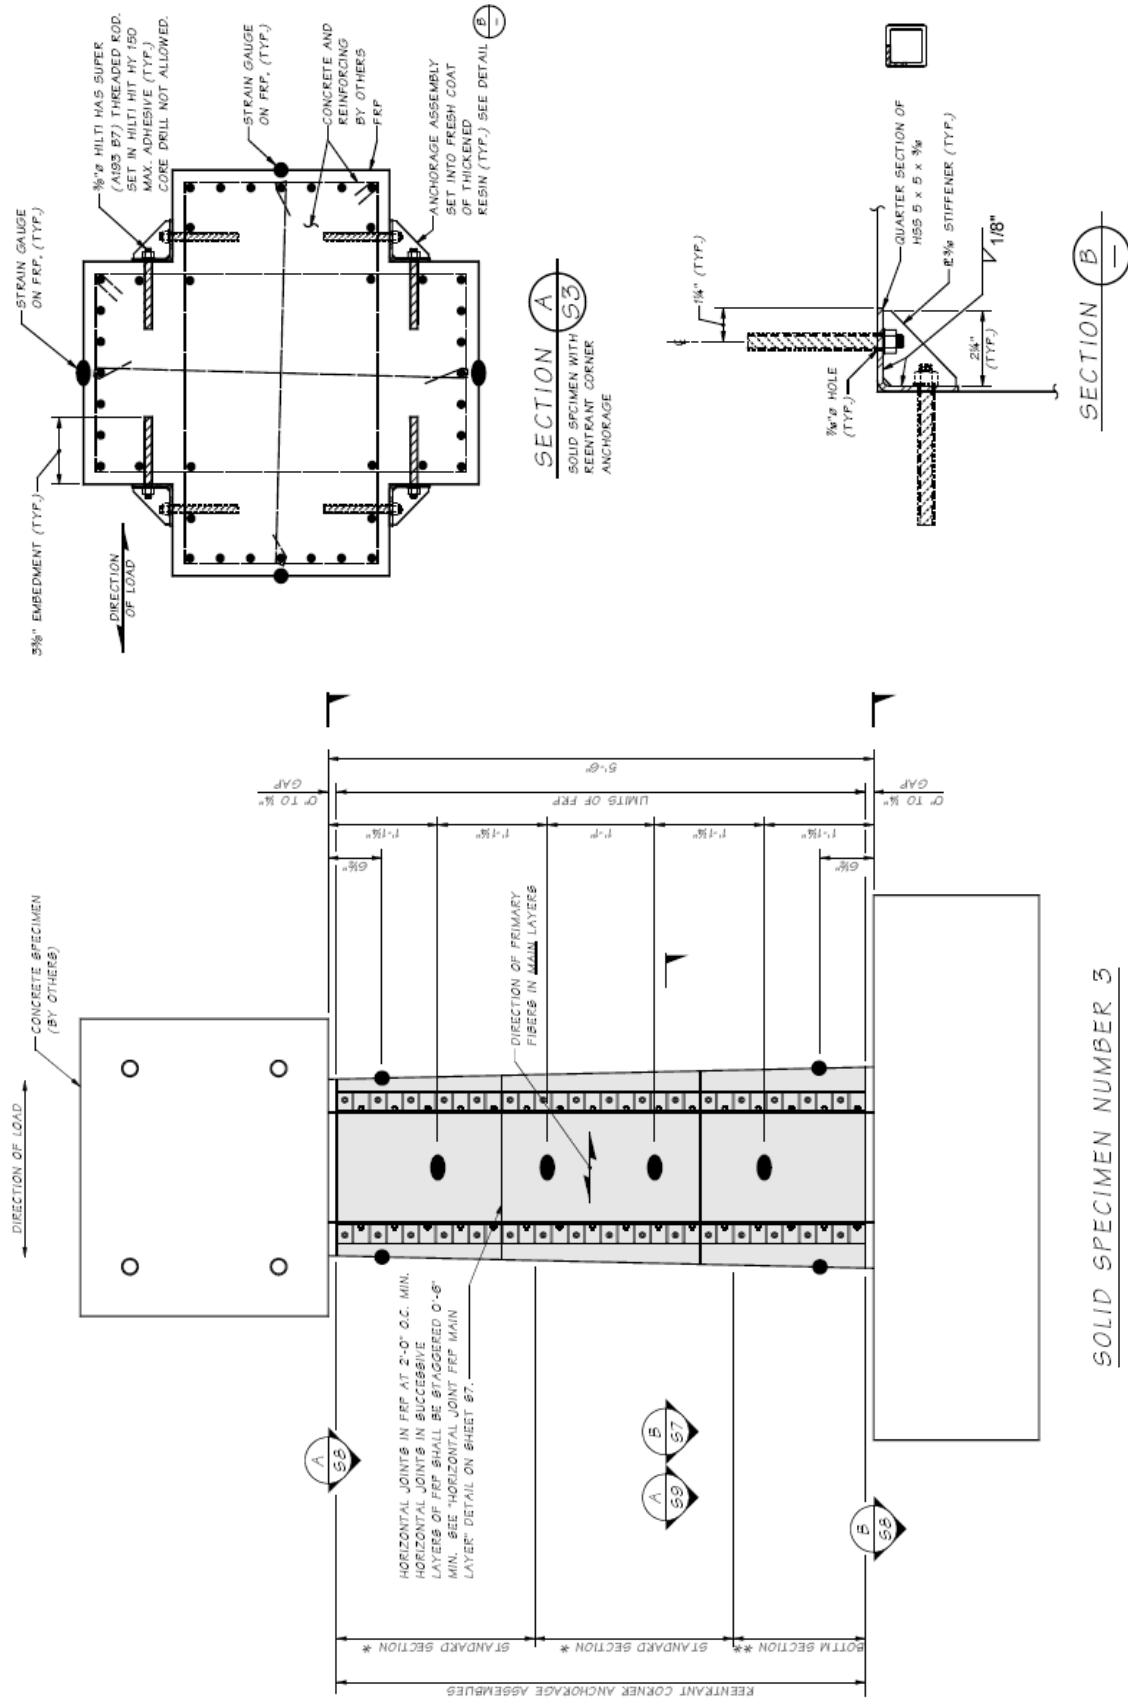
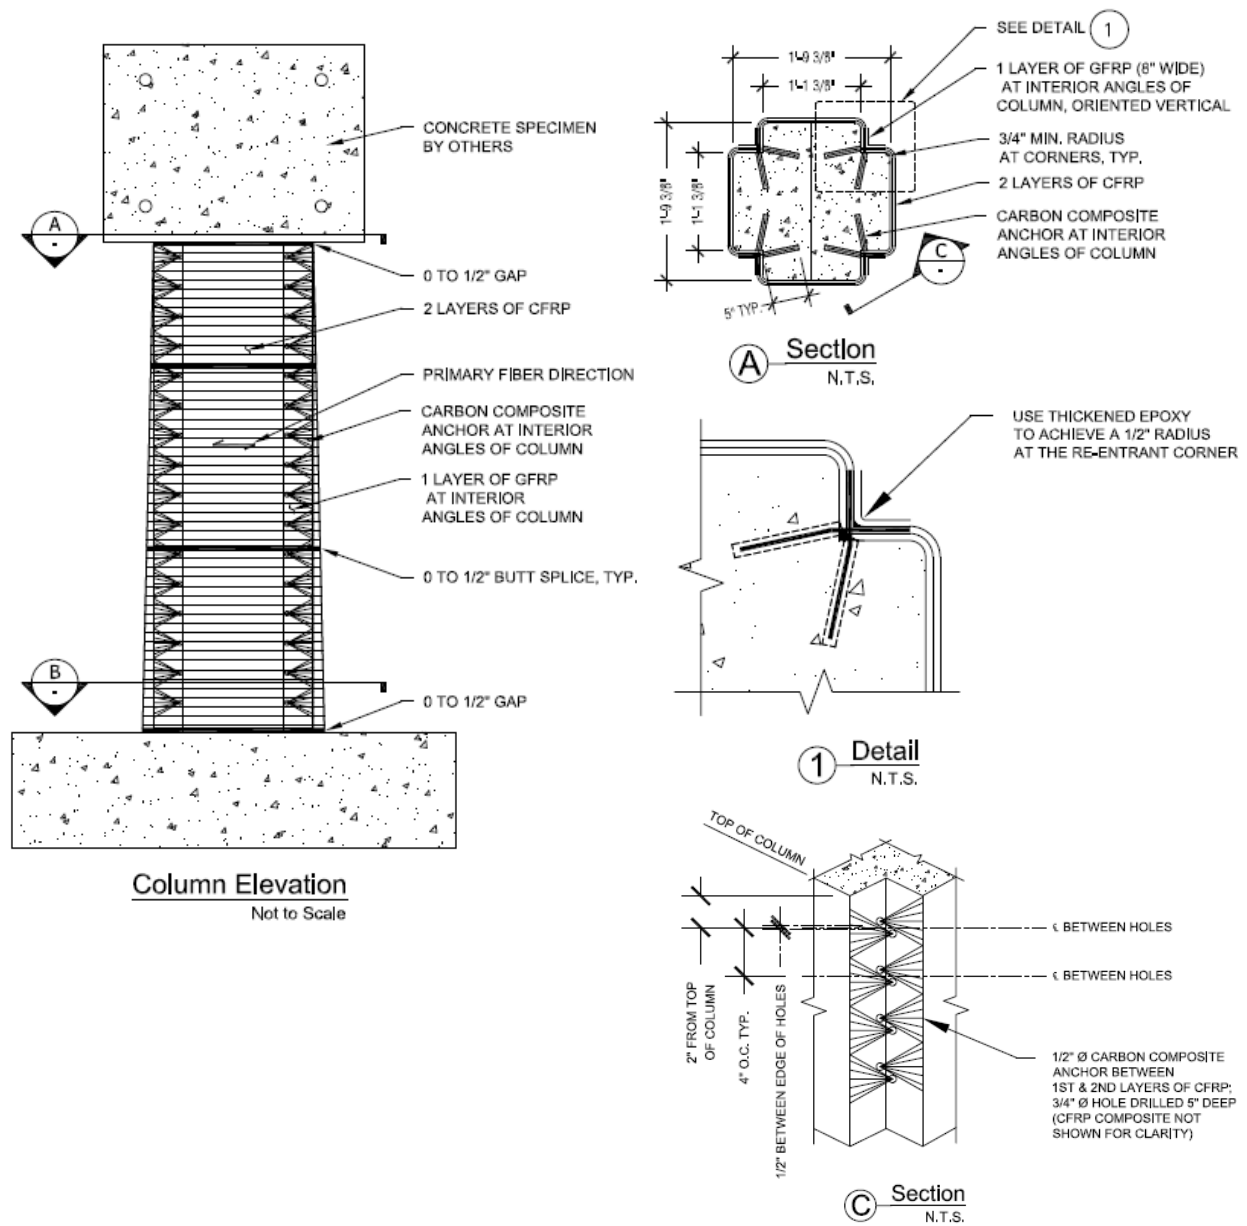
Figure 4.4.5 – FRP Anchor Retrofit Details (1 in. = 25.4 mm)

The reentrant corner anchorage for Column 4 consisted of ½-in. (13-mm) diameter FRP anchors as shown in Figure 4.4.5. These anchors were installed at 4 in. (0.1 m) on center up each face of the reentrant corners. The anchors were designed assuming they were effective only in tension (Ozbakkaloglu et al. 1996). Shear strength of the FRP anchors was neglected, and thus anchors were proportioned to carry the full anchorage demand in tension on one face of the reentrant corner. Prior to installation of the first layer of FRP, 7/16-in. (11-mm) diameter anchor holes extending 5 in. (0.13 m) into the concrete column were drilled and filled with epoxy and the reentrant corner of the column was filled with epoxy to a minimum ¾-in. (19-mm) radius. After installation of the first FRP jacket layer, the dry FRP anchors were soaked in epoxy and then pushed through a small cut in the FRP jacket. The end fibers of the FRP anchors were then splayed out and laid flat onto the surface of the FRP jacket as shown in Figure 4.4.6. After the FRP anchors were installed, a coating of epoxy was applied over the top of the anchors to fill any voids between anchor locations. The second FRP jacket layer was then applied. Following installation of the FRP jacket, a ¼-in. (6-mm) thick by 6-in. (0.15-m) tall A36 steel collar was installed at the top and bottom of the column and filled with high-strength non-shrink grout. A 1-in. (25-mm) gap was provided between the collars and the footing and top loading blocks.

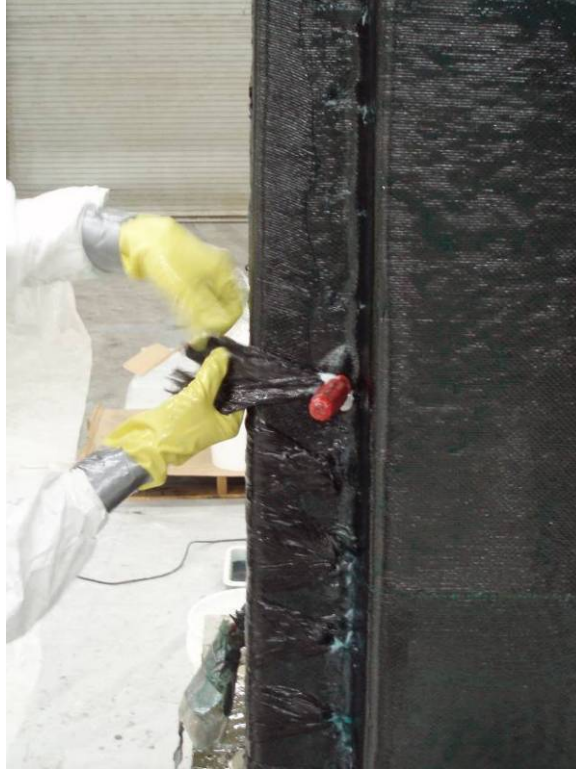
Figure 4.4.6 – FRP Anchor Installation

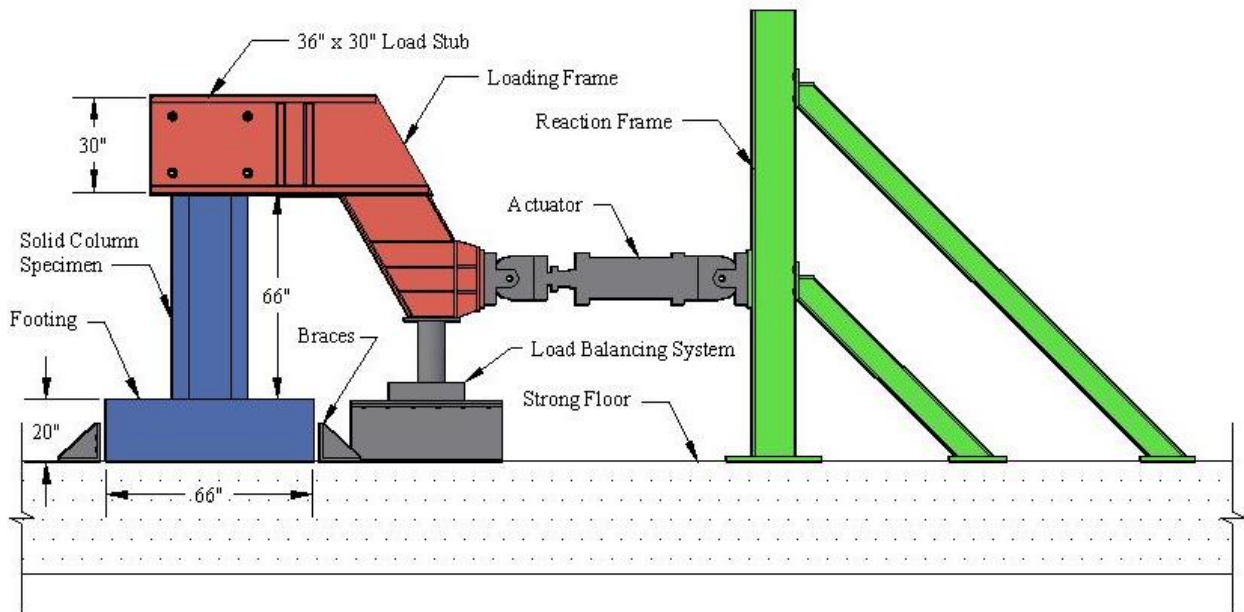
Figure 4.8.1 – Test Setup (1 in. = 25.4 mm)

The test setup for the column specimens was adapted from testing performed at the University of California at San Diego. Figure 4.8.1 shows the overall shear test setup, which was designed to load the test columns in double bending.

A moment-curvature analysis of the top and bottom cross sections of the column was used to locate the point of zero moment in the test column. A stiff loading frame connected the column top block to a horizontal double-acting actuator aligned at the point of zero moment, inducing double bending in the column specimen. An articulating clevis provided the connection between the loading frame and the actuator through a 220 kip (980 kN) load cell. The actuator was then fixed to a strong reaction frame at the other end, which was bolted to the strong floor. The force capacity of the actuator was 330 kips (1470 kN) in compression, and 220 kips (980 kN) in tension, with an available stroke of 20 in (0.5 m). The columns framed into a 32 in. (0.8

m) x 20 in. (0.5 m) x 66 in. (1.7 m) strong footing at the base and into a 30 in. (0.8 m) x 36 in. (0.9 m) x 30 in. (0.8 m) heavily reinforced load stub at the top. Moment was transferred through the loading frame into the top load stub by means of the 3-in. (76-mm) diameter steel pipes located in the load stub. The footing was bolted to the strong floor using (8) 1¼-in. (32-mm) diameter bolts to prevent any overturning from occurring. Sliding of the footing base was prevented by two stiff brackets which were bolted to the floor, each using (4) 1¼-in. (32-mm) diameter bolts. Load stub eccentricity was compensated for by a load balancing system which included a load-follower jack with a 6-in. (0.15-m) travel in each direction, which balanced the extra bending moment transmitted to the load stub and column due to the self-weight of the large loading arm and half of the weight of the actuator.

The loading frame (see Figure 4.8.1) was made up of two steel plates extending horizontally from the top load stub and connected by a double I-beam extending downwards. The double I-beam was inclined to the vertical at an angle of thirty degrees and reinforced with web stiffeners. The inclined beams framed into the load cell and the actuator aligned with the neutral axis of the column. No buckling was allowed in any part of the loading frame, this being achieved by the use of several stiffener plates. Details of the design of the loading frame are provided in Appendix A.

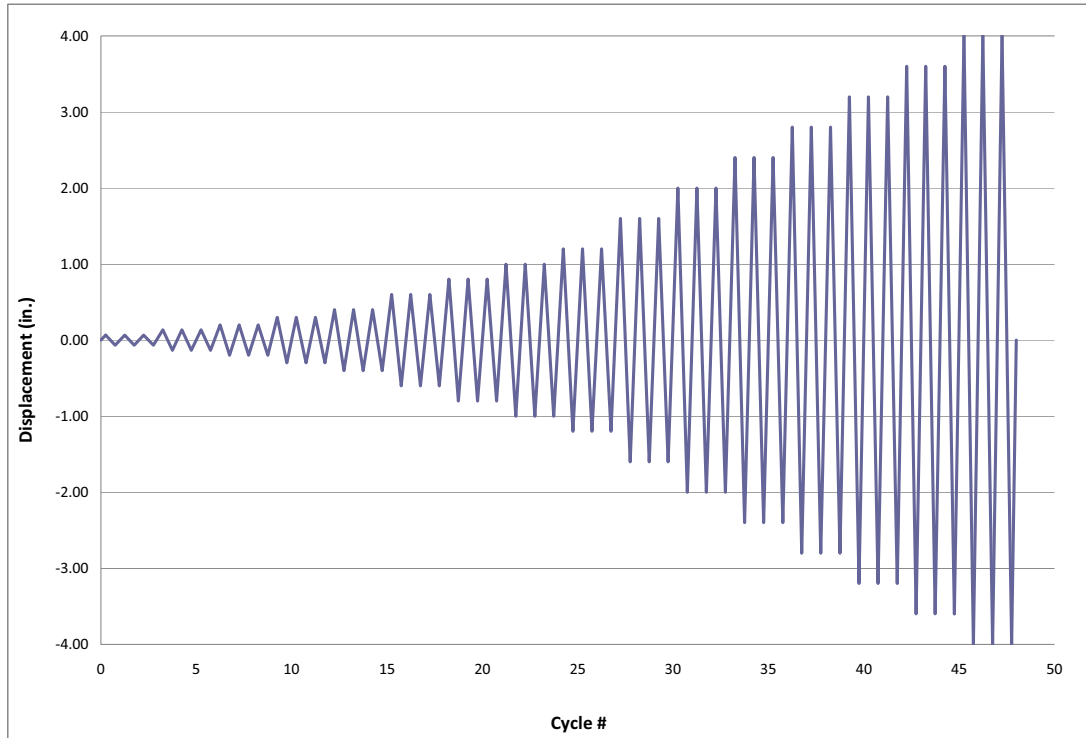
Figure 4.10.1 – Loading Protocol: Sequential Displacements (1 in. = 25.4 mm)

All test columns were tested under displacement control and were subjected to the cyclic pattern of loading shown in Figure 4.10.1. Displacements were applied at a constant rate of 0.005 in./s (0.13 mm/s) for three complete cycles at displacement levels of ± 0.33 , ± 0.67 and ± 1 times Δ_y , then increased to a constant rate of 0.01 in./s (0.26 mm/s) for three complete cycles at displacement levels of ± 1.5 , ± 2 , ± 3 , ± 4 , ± 5 , ± 6 , ± 8 , ± 10 , ± 12 , ± 14 , ± 16 , ± 18 and ± 20 times Δ_y , unless failure occurred first. Failure was defined as a 20% drop in peak lateral load for each specimen. Δ_y was theoretically determined from moment-curvature analyses of each test column.

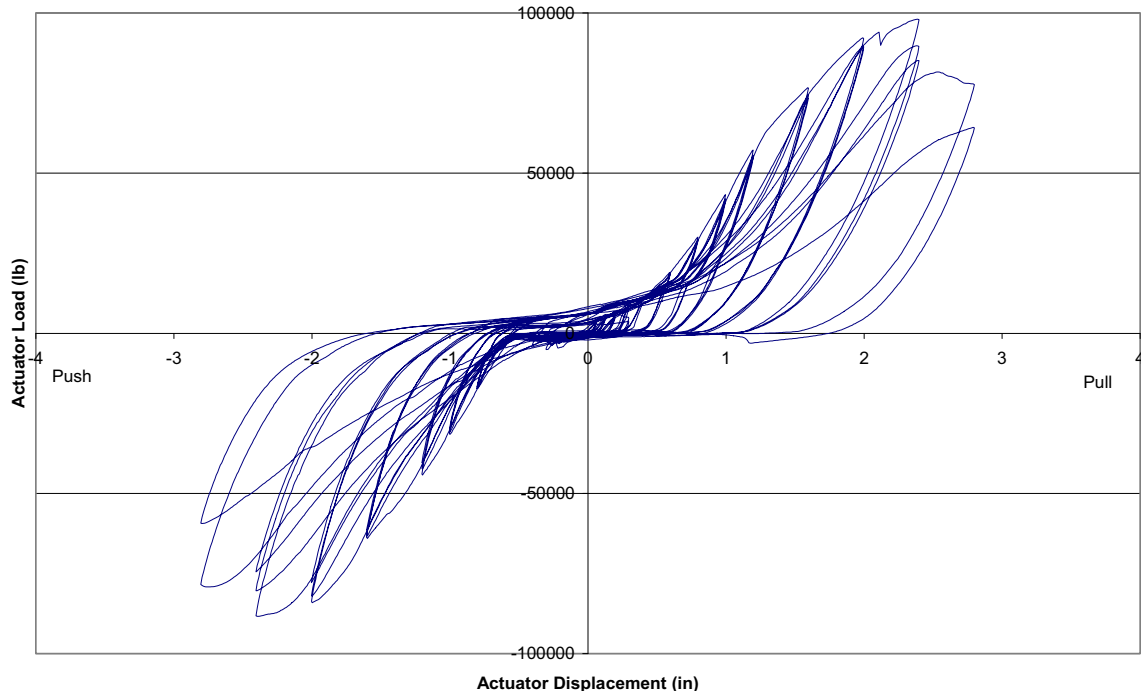
. Figure 5.2.1 – Column 1 Lateral Load vs. Displacement Hysteresis Curves (1 kip = 4.45 kN, 1 in. = 25.4 mm)

Figure 5.2.1 shows the overall hysteretic performance of Column 1 in terms of the lateral force vs. actuator displacement. The displacements shown in Figure 5.2.1 include unintentional displacements due to gaps between the steel pipes cast into the load stub and the steel loading rods used to connect the loading frame. These gaps were intended to provide construction tolerances for placing the loading rods, but also resulted in flat spots in the hysteresis curves. i.e., displacements under zero lateral force. These unintended displacements were later removed from the data for the purpose of comparing results with other tests. Shims between the steel pipes in the load stub and the loading pins were also installed in later tests to minimize these unintended displacements.

Column 1 exhibited moderate energy dissipation capacity but little ductility. The stiffness of the column showed minor degradation up to a displacement level of 1.2 in. (30 mm), with a loss in stiffness at later displacement levels up to the peak load. The peak lateral load achieved was 98 kips and occurred at a lateral displacement of 2.4 in. (61 mm). The column exhibited a significant decrease in lateral stiffness and strength at a displacement level of 2.8 in. (71 mm), and the applied load dropped below 80% of the peak load during the first cycle at this displacement. The test was stopped after the second cycle at a displacement level of 2.8 in. (71 mm).

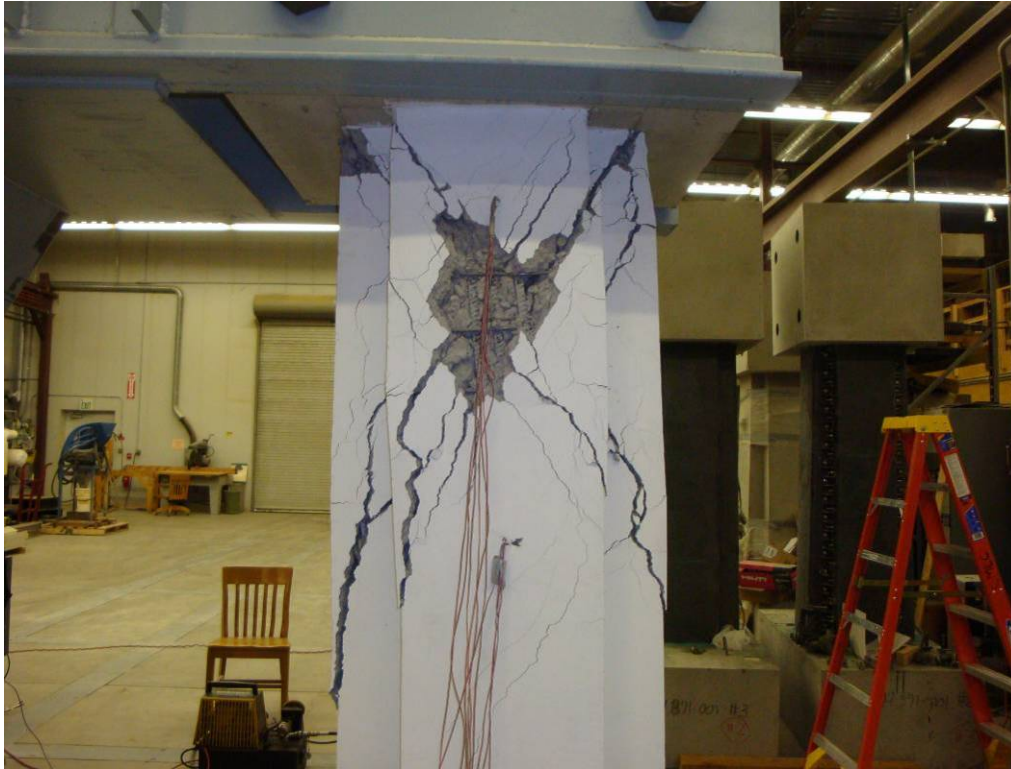
Figure 5.2.3 – Column 1 Shear Cracking Near the End of Testing.

Figure 5.2.2 shows Column 1 at the beginning of the test. Yielding of the longitudinal bars first occurred at lateral force level of 27 kips (120 kN) followed by flexural cracking at the top and bottom of the column. Early shear cracks formed at a lateral force level of about 65 kips (290 kN). Yielding of the transverse reinforcement first occurred at a lateral force level of 88 kips (390 kN) followed by the opening of large shear cracks near the end of the test. The final failure mode for the column was a shear failure. Figure 5.2.3 shows the large shear cracks present near the end of testing.

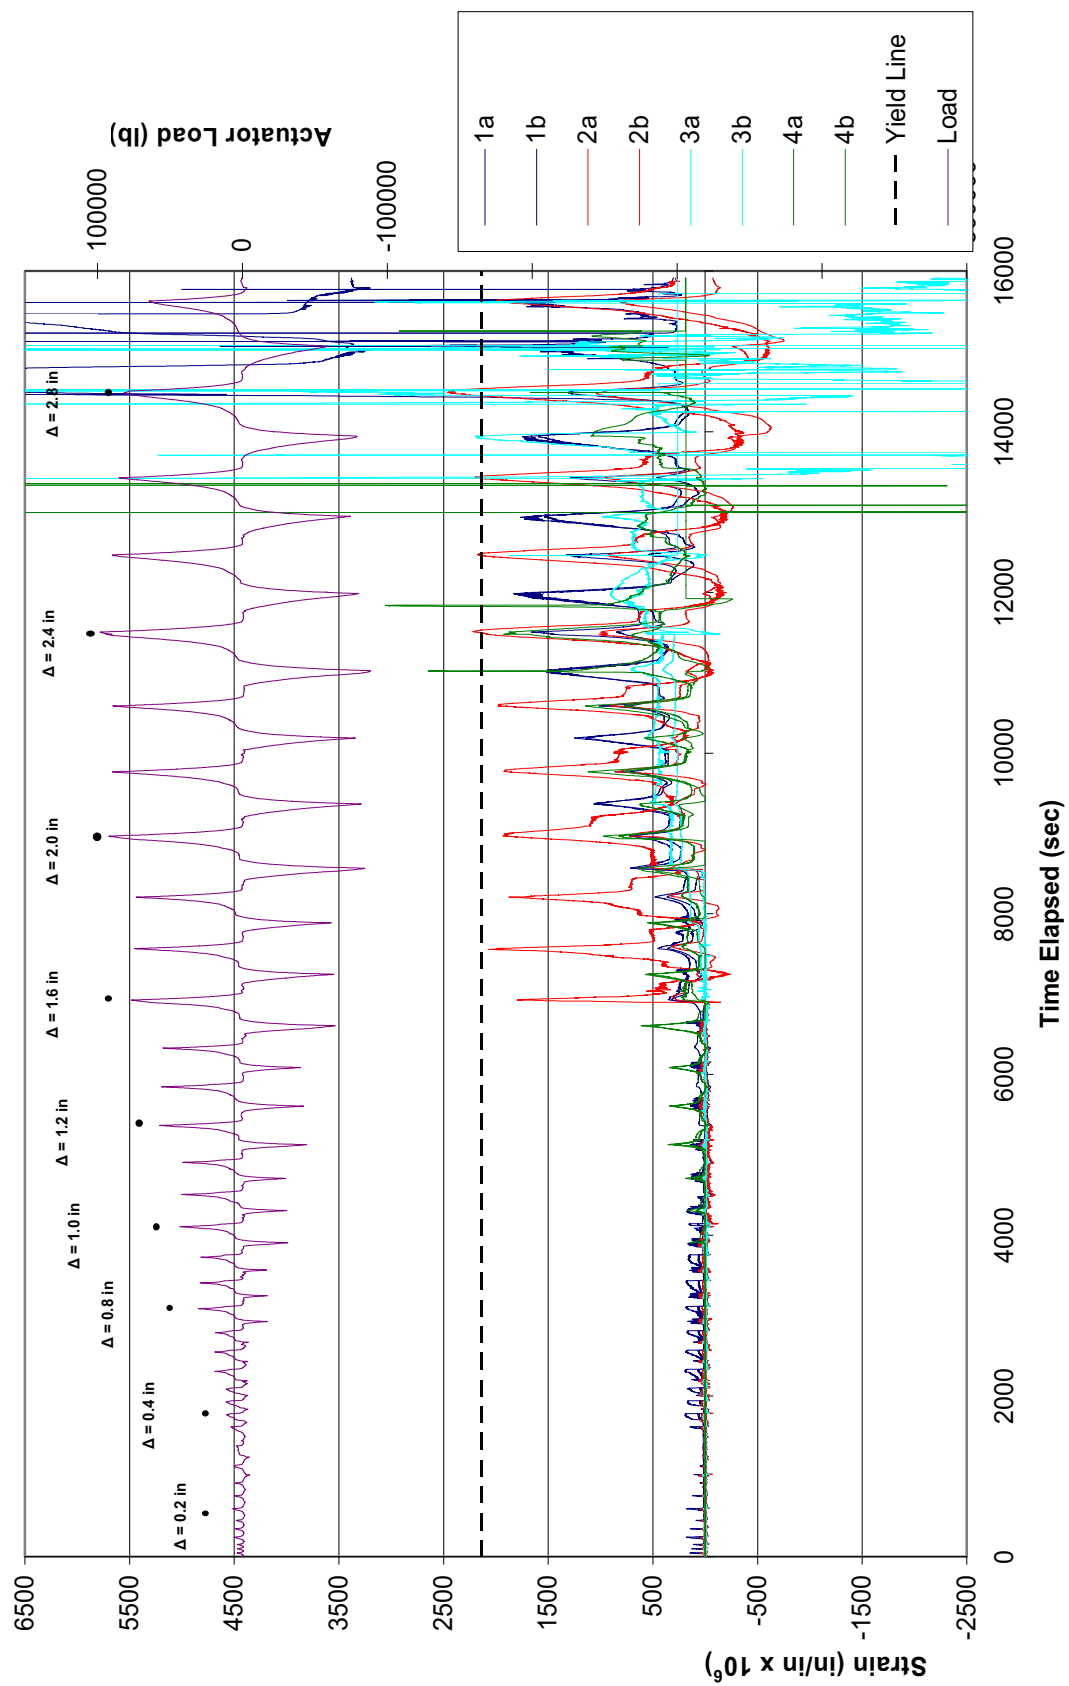
Figure 5.2.4 – Column 1 Transverse Strain Gage Data (1 kip = 4.45 kN, 1 in. = 25.4 mm)

Figure 5.2.4 shows transverse hoop strains with time alongside a plot of the column load with time. Very small hoop strains were observed up to a displacement level of 1.6 in. (41 mm). During the first cycle at a displacement level of 1.6 in. (41 mm), the peak lateral force achieved was 65 kips (290 kN) and the first shear cracks appeared in the column. Strain gage 2, located slightly above the column mid-height, recorded strain values near yielding, while small strains were observed in all other strain gages. Hoop strains increased linearly in strain gages 1 and 4, located near the top and bottom of the column, respectively, up to the yield point at a displacement level of 2.4 in. (61 mm). Very large hoop strains were observed beyond the third cycle at a displacement of 2.4 in. (61 mm), corresponding to the opening of large shear cracks in the column.

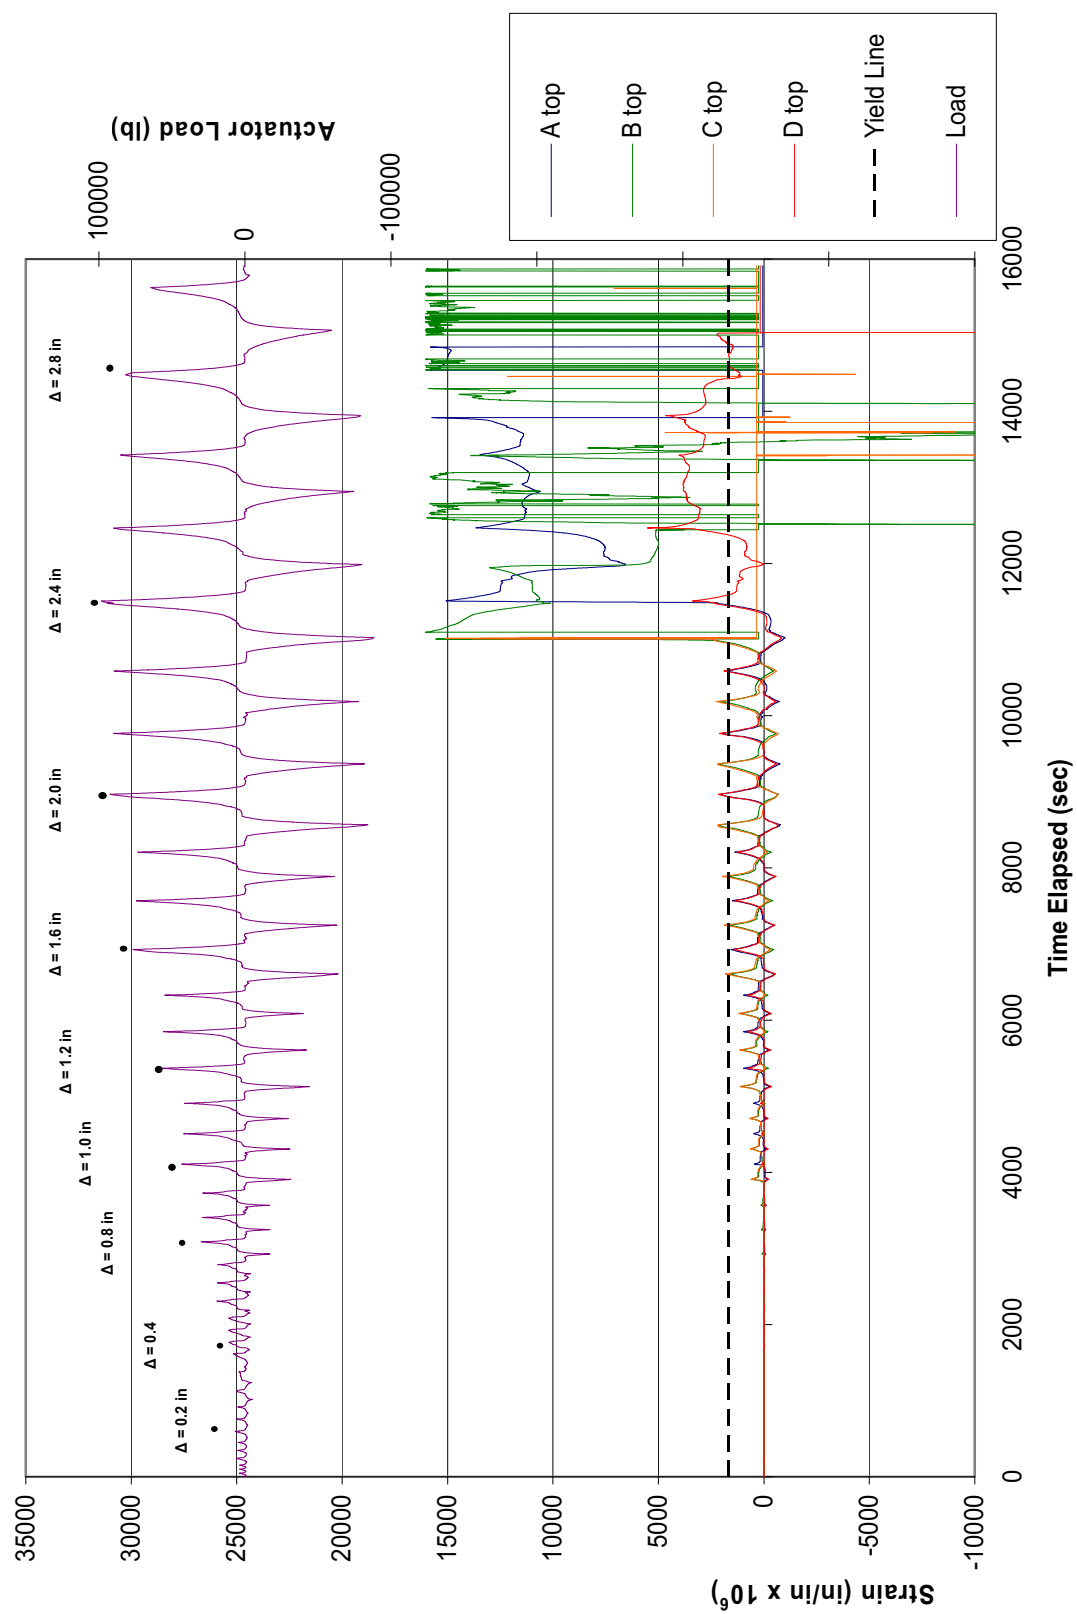
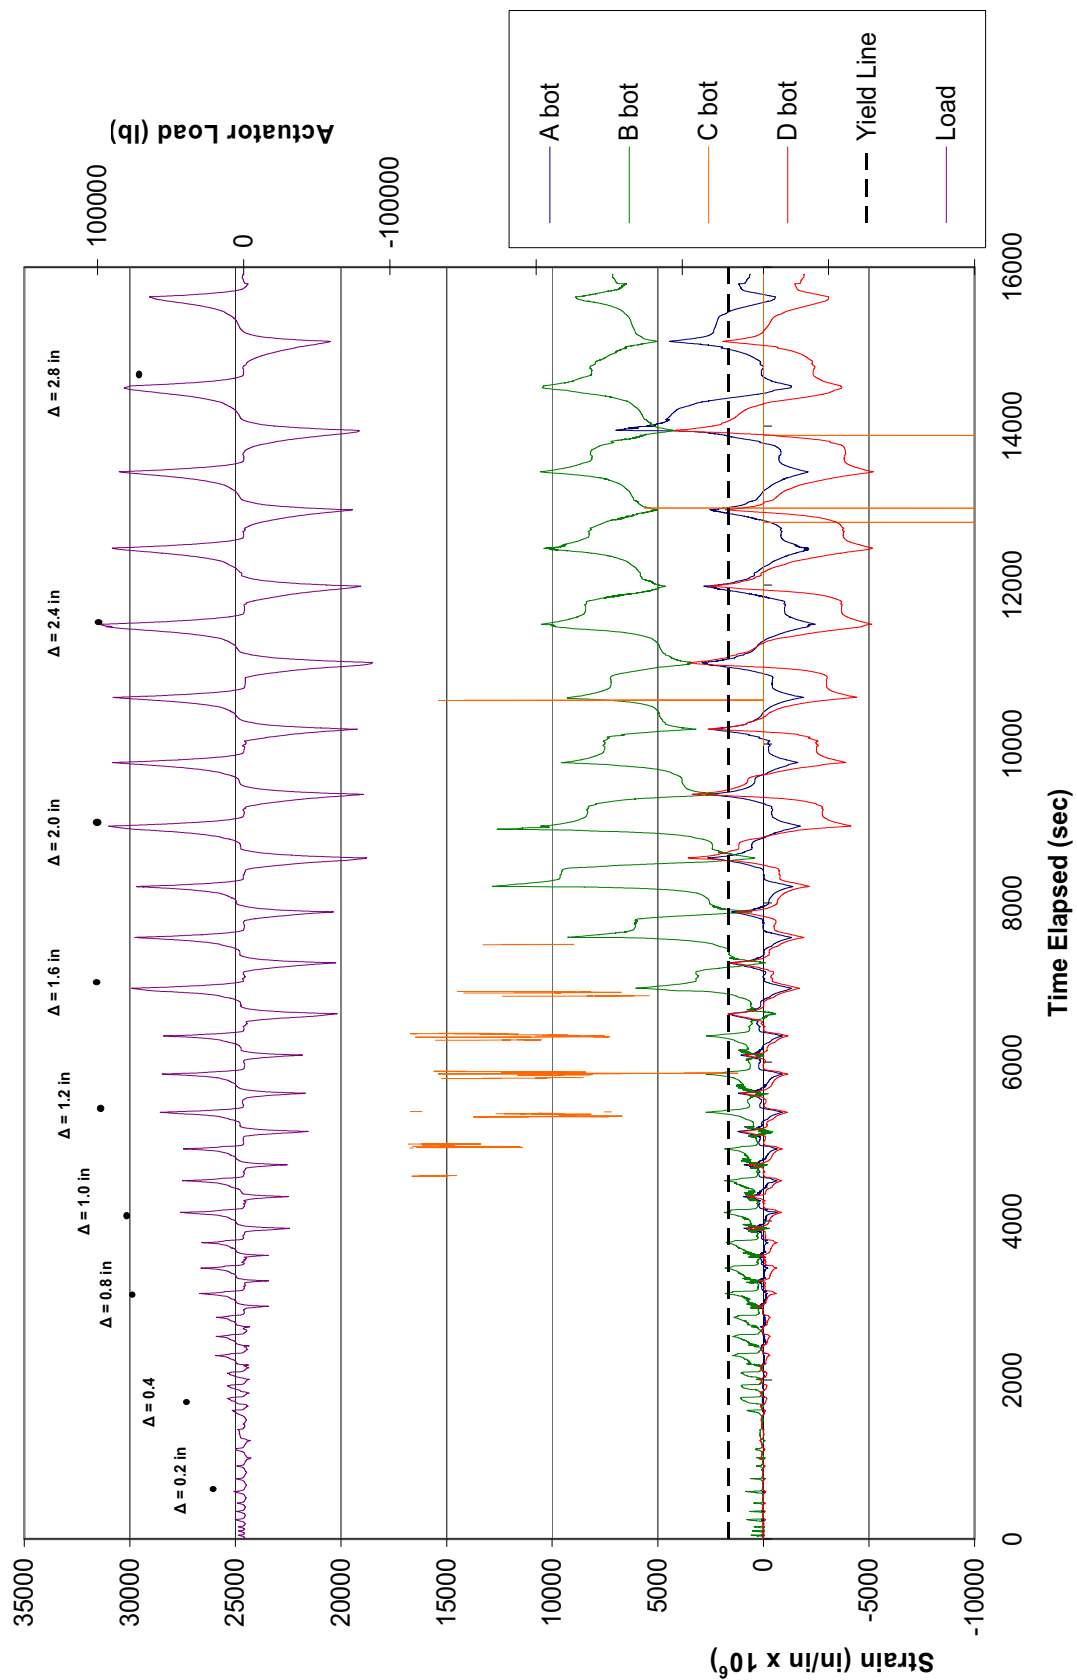
Figures 5.2.5 and 5.2.6 show the strains in the longitudinal bars at the top and bottom of the column, respectively. Approximately a linear strain profile was observed in the top strain gages up to the first yield at a displacement level of 1.6 in. (41 mm). After yielding, strains stayed nearly constant until the first cycle at a displacement level of 2.4 in. (61 mm), after which very large strains in excess of 15,000 $\mu\epsilon$ were observed. Strains in the bottom strain gages reached first yield at a displacement level of about 0.8 in. (20 mm), much earlier than the top strain gages. Strains stayed nearly constant up to a displacement level of 1.6 in. (41 mm) and then increased rapidly to strains in excess of 5,000 $\mu\epsilon$ for the remainder of the test.

Figure 5.2.5 – Column 1 Longitudinal Bar Strain Gage Data at the Top of the Column (1 kip = 4.45 kN, 1 in. = 25.4 mm)

Figure 5.2.6 – Column 1 Longitudinal Bar Strain Gage Data at the Bottom of the Column (1 kip = 4.45 kN, 1 in. = 25.4 mm)

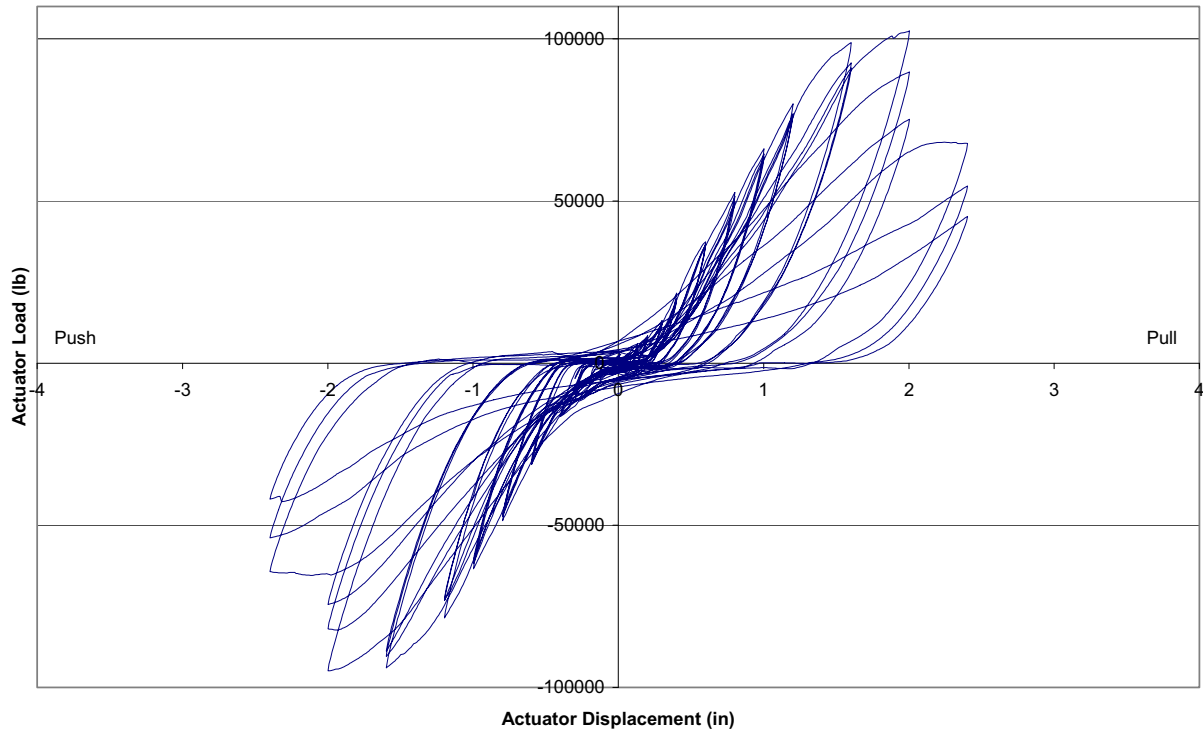
Figure 5.3.1 – Column 5 Lateral Load vs. Displacement Hysteresis Curves

Figure 5.3.1 shows the overall hysteretic performance of Column 5 in terms of the lateral force vs. actuator displacement. The column exhibited moderate energy dissipation capacity but little ductility. The stiffness of the column showed minor degradation up to a displacement level of 1.2 in. (30 mm), followed by a loss in stiffness at later displacement levels up to the peak load. The peak lateral load achieved was 102 kips (453 kN) and occurred at a lateral displacement of 2.0 in. (51 mm). The column exhibited a significant decrease in lateral stiffness and strength at a displacement level of 2.0 in. (51 mm), and the applied load dropped below 80% of the peak load during the third cycle at this displacement. The test was stopped after the third cycle at a displacement level of 2.4 in. (61 mm).

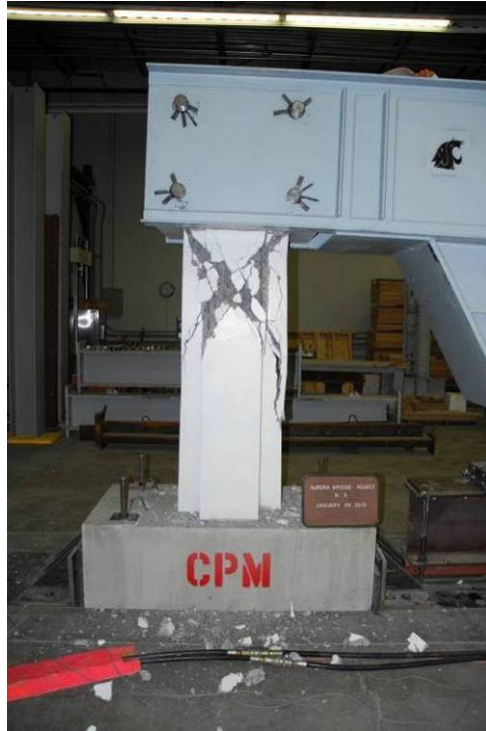
Figure 5.3.3 – Column 5 Shear Cracking Near the End of Testing.

Figure 5.3.2 shows Column 5 in the test setup at the beginning of the test. Yielding of the longitudinal bars first occurred at a lateral force level of 49 kips (218 kN) followed by flexural cracking at the top and bottom of the column. Early shear cracks formed at a lateral force level of about 73 kips (325 kN). Yielding of the transverse reinforcement first occurred at a lateral force level of 93 kips (414 kN) followed by the opening of large shear cracks near the end of the test. The final failure mode for the column was a shear failure. Figure 5.3.3 shows the large shear cracks present near the end of testing.
