**SEISMIC RETROFIT OF CRUCIFORM-SHAPED COLUMNS
IN THE AURORA AVENUE BRIDGE USING FRP WRAPPING**

A thesis submitted in partial fulfillment of
the requirements for the degree of

WASHINGTON STATE UNIVERSITY
Department of Civil and Environmental Engineering

MAY 2010

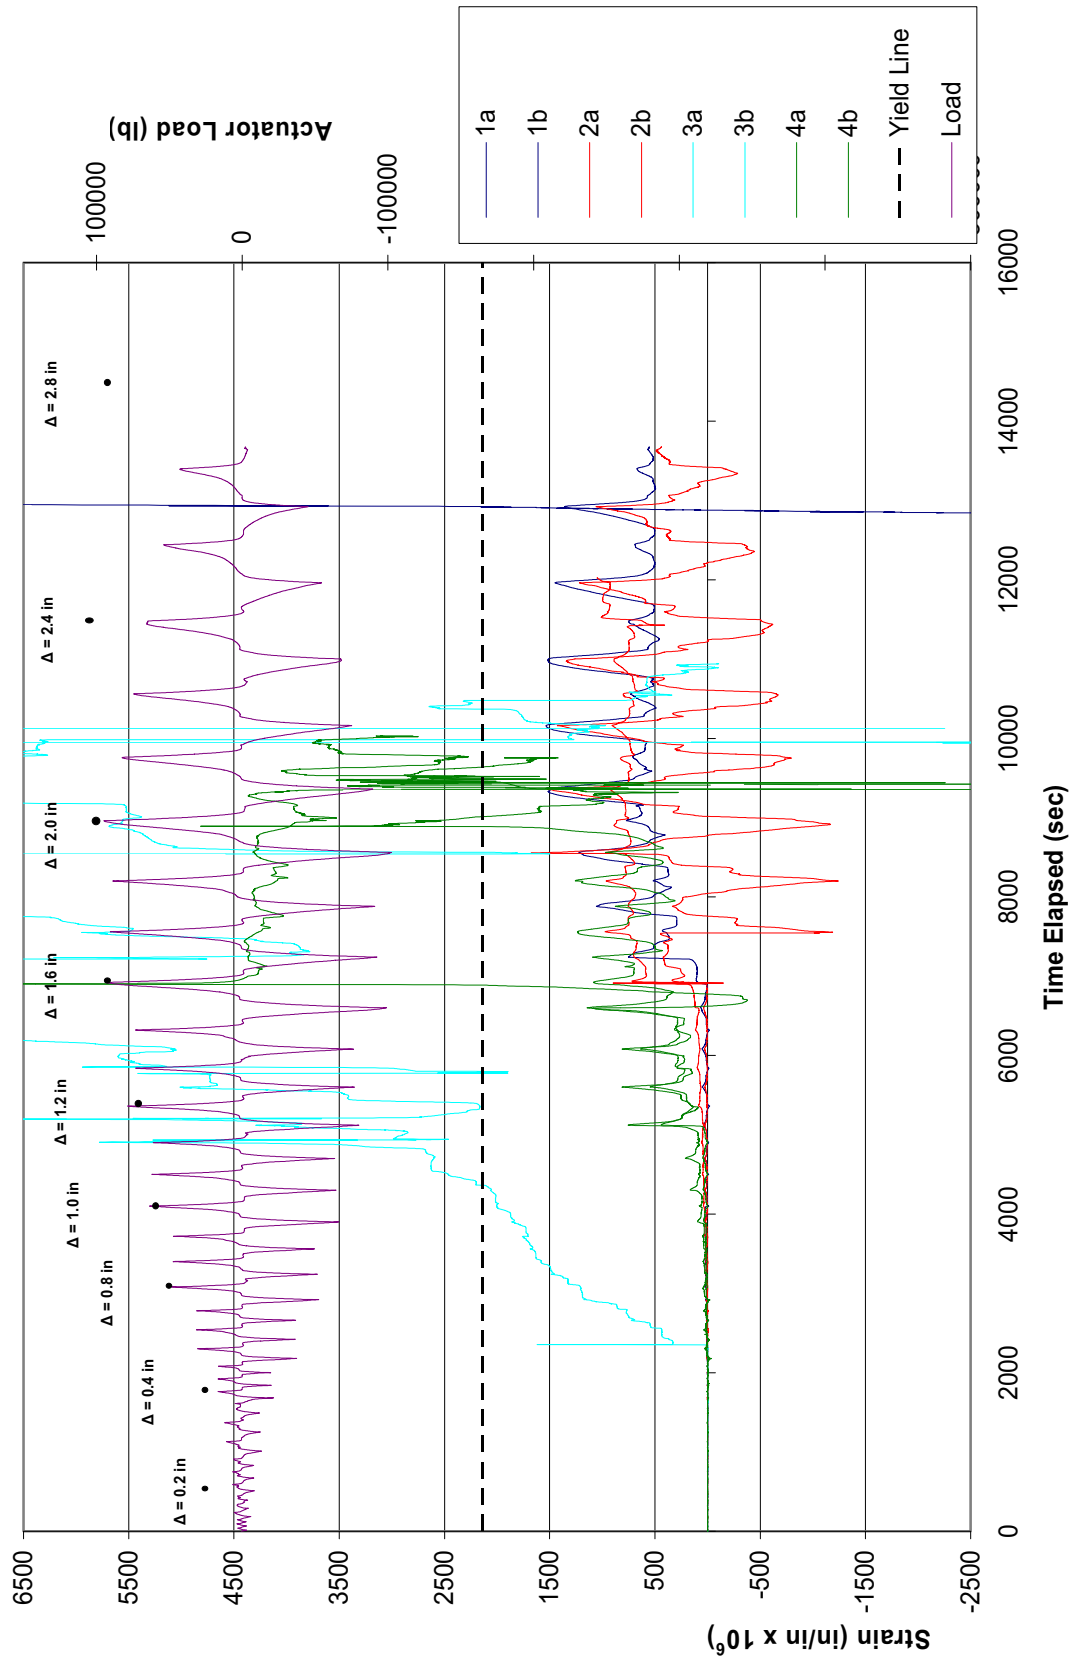
(Figure 5.3.4 – Column 5 Transverse Strain Gage Data (1 kip = 4.45 kN, 1 in. = 25.4 mm))

Figure 5.3.4 shows transverse hoop strains with time alongside a plot of the column load with time. Almost negligible hoop strains were observed up to a displacement level of 1.2 in. (30 mm). Hoop strains increased linearly up to the yield point at a displacement level of 2.0 in. (51 mm) and then decreased linearly until the end of the test.

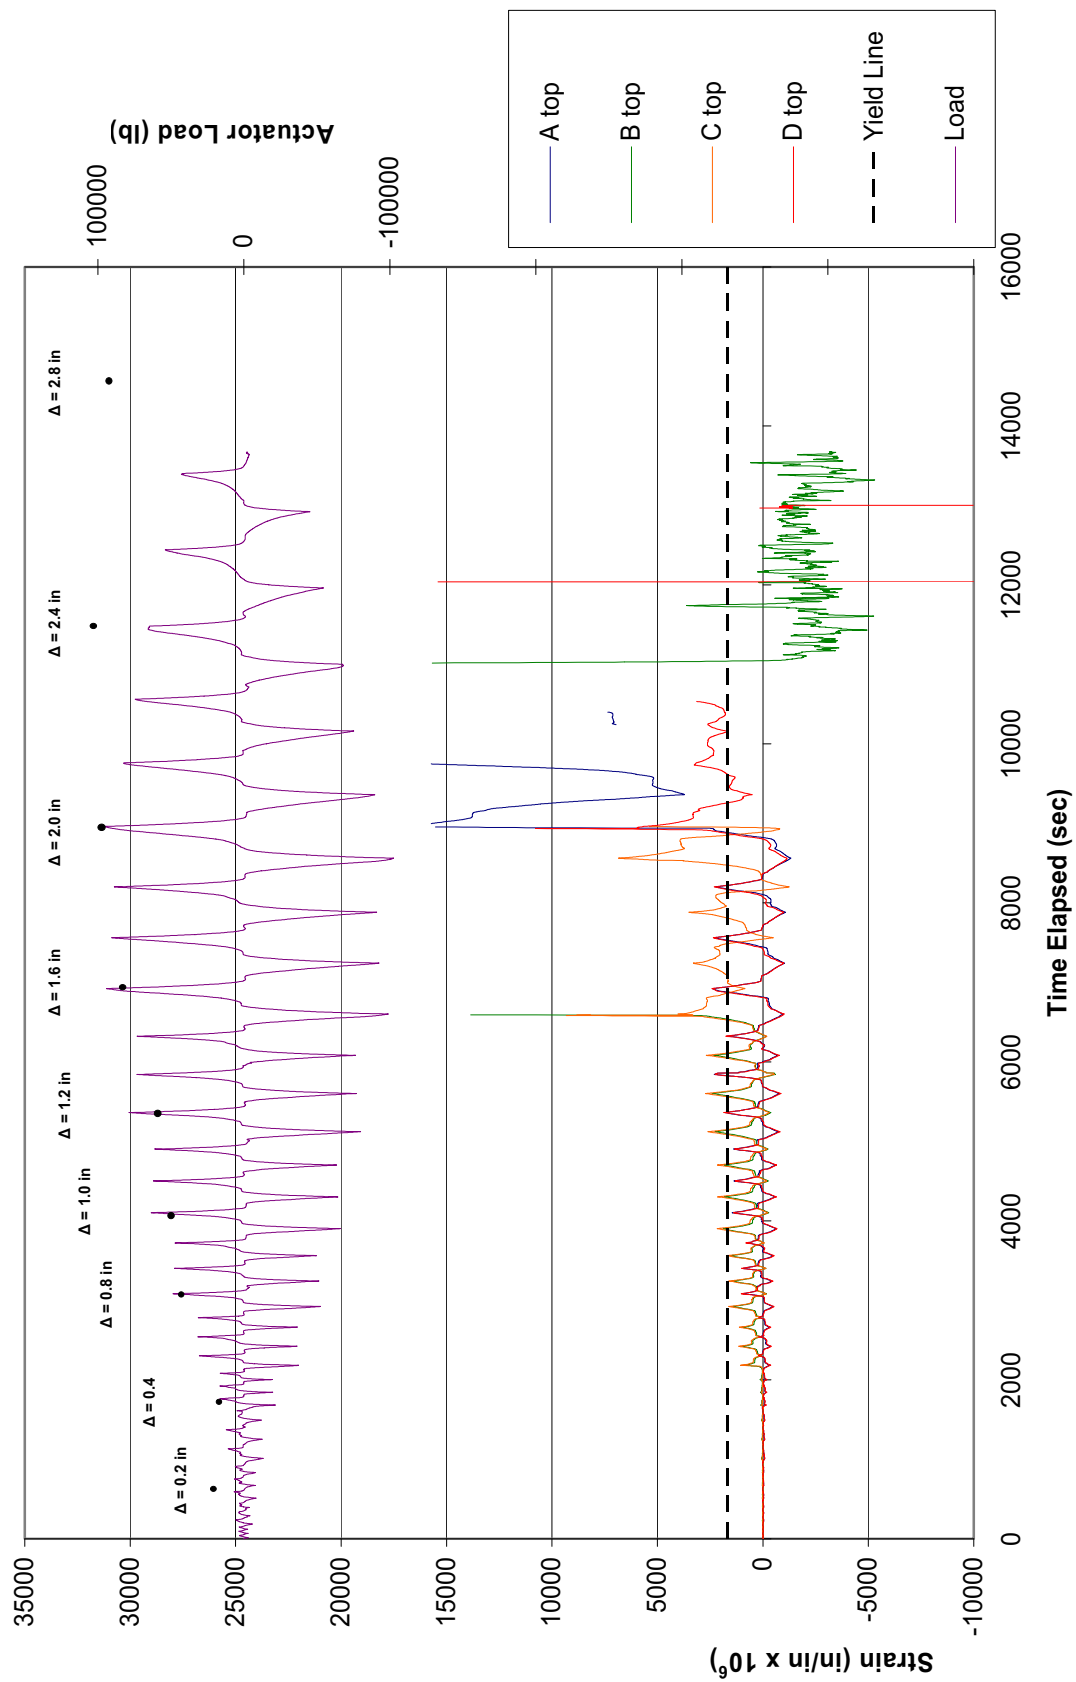
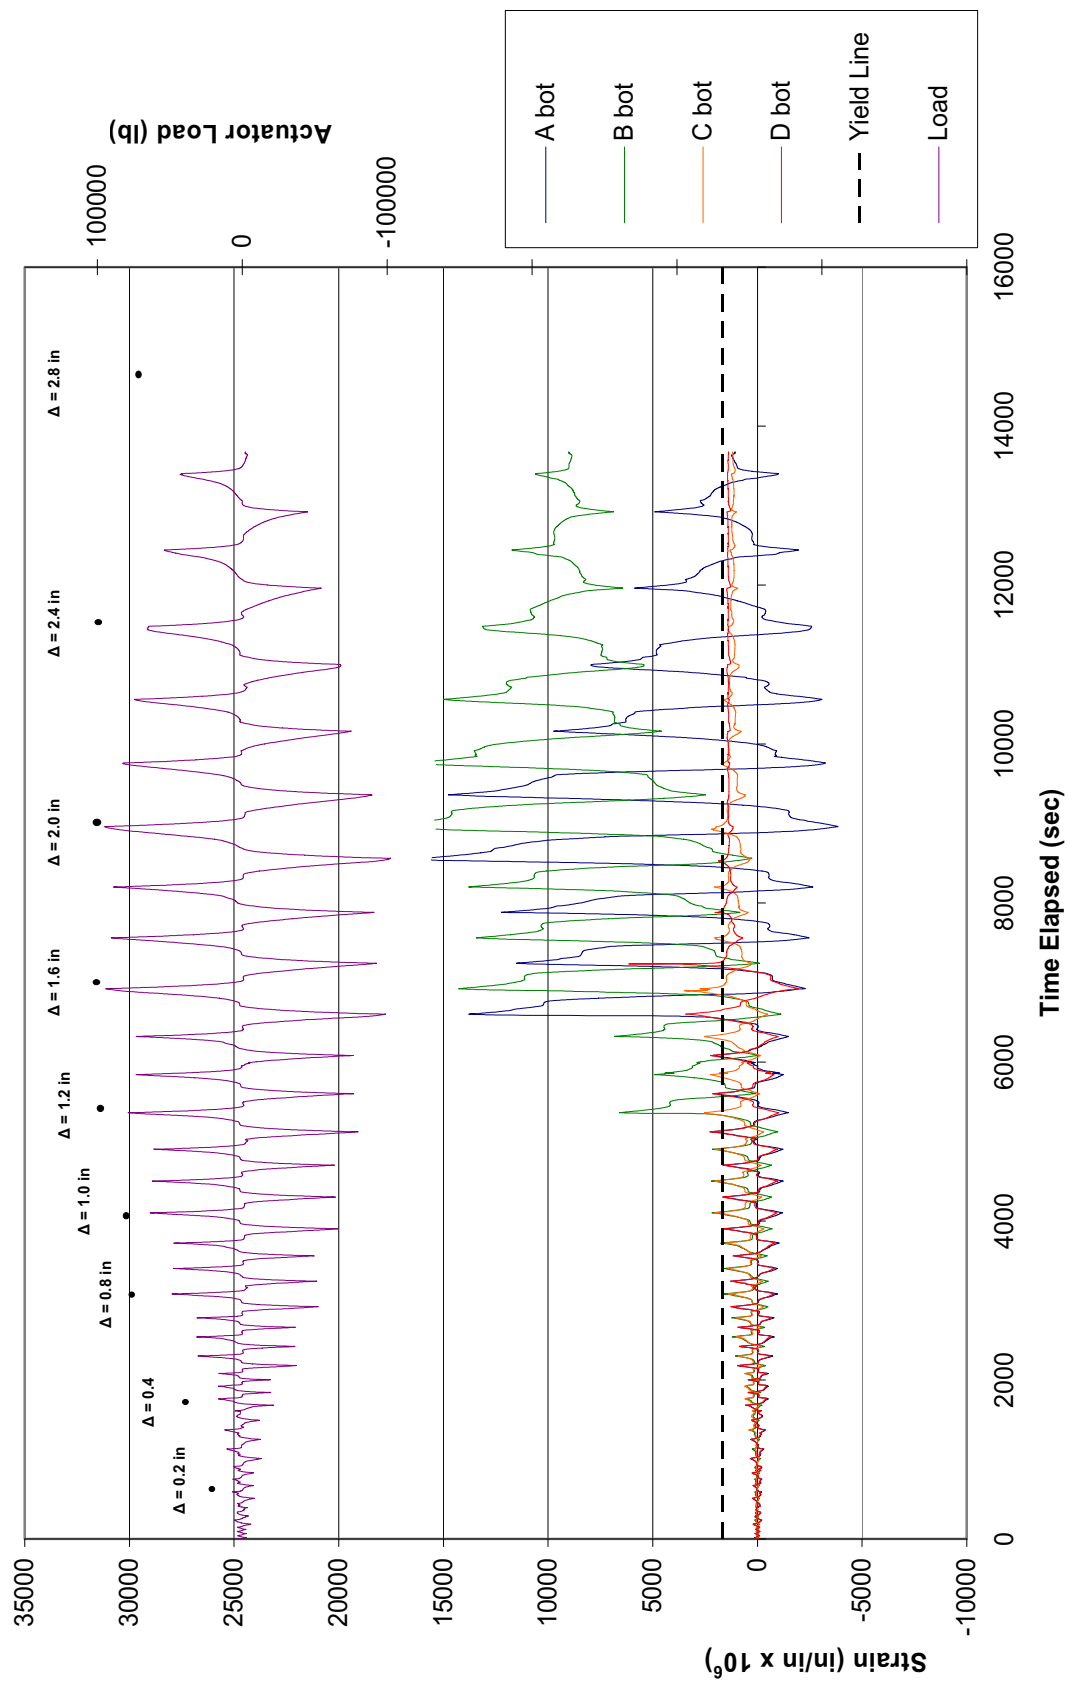
Figures 5.3.5 and 5.3.6 show the strains in the longitudinal bars at the top and bottom of the column, respectively. A linear strain profile was observed in the top strain gages up to the first yield at a displacement level of 1.0 in. (25 mm). After yielding, strains stayed nearly constant until the first cycle at a displacement level of 1.6 in. (41 mm), after which very large strains in excess of 15,000 $\mu\epsilon$ were observed. Strains in the bottom strain gages reached first

Figure 5.3.5 – Column 5 Longitudinal Bar Strain Gage Data at the Top of the Column (1 kip = 4.45 kN, 1 in. = 25.4 mm)

Figure 5.3.6 – Column 5 Longitudinal Bar Strain Gage Data at the Bottom of the Column (1 kip = 4.45 kN, 1 in. = 25.4 mm)

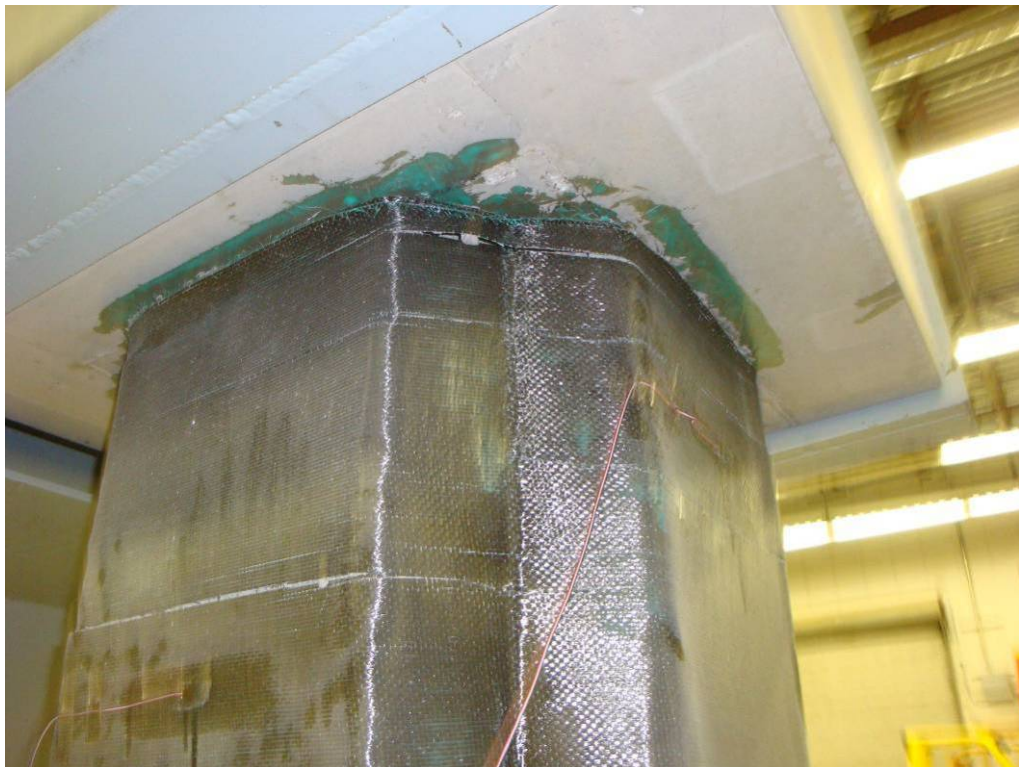
Figure 5.4.3 – Column 2 Pullout of FRP Jacket from Reentrant Corners

Figure 5.4.3 shows the pullout of the FRP jacket from the reentrant corners. Yielding of the transverse reinforcement first occurred at a lateral force level of 88 kips (390 kN) during the second cycle at a displacement level of 2.0 in. (51 mm), followed by a shear crack forming under the FRP wrap. After removing the FRP jacket at the end of testing, it is evident that the final failure mode for the column was a shear failure. Figure 5.4.4 shows the large shear cracks present at the end of testing. Further inspection also showed that the pullout of FRP from the reentrant corners was likely due to spalling of the cover concrete from flexural hinging rather than debonding of the FRP jacket from the concrete.

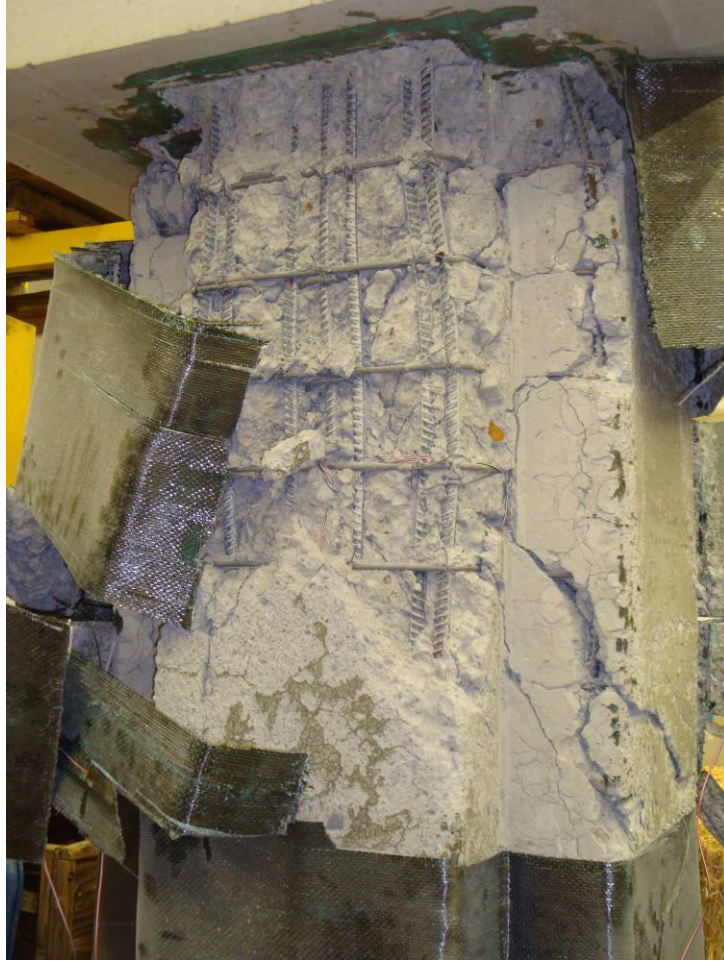
Figure 5.4.4 – Column 2 Large Shear Cracks under FRP Jacket at the End of Testing

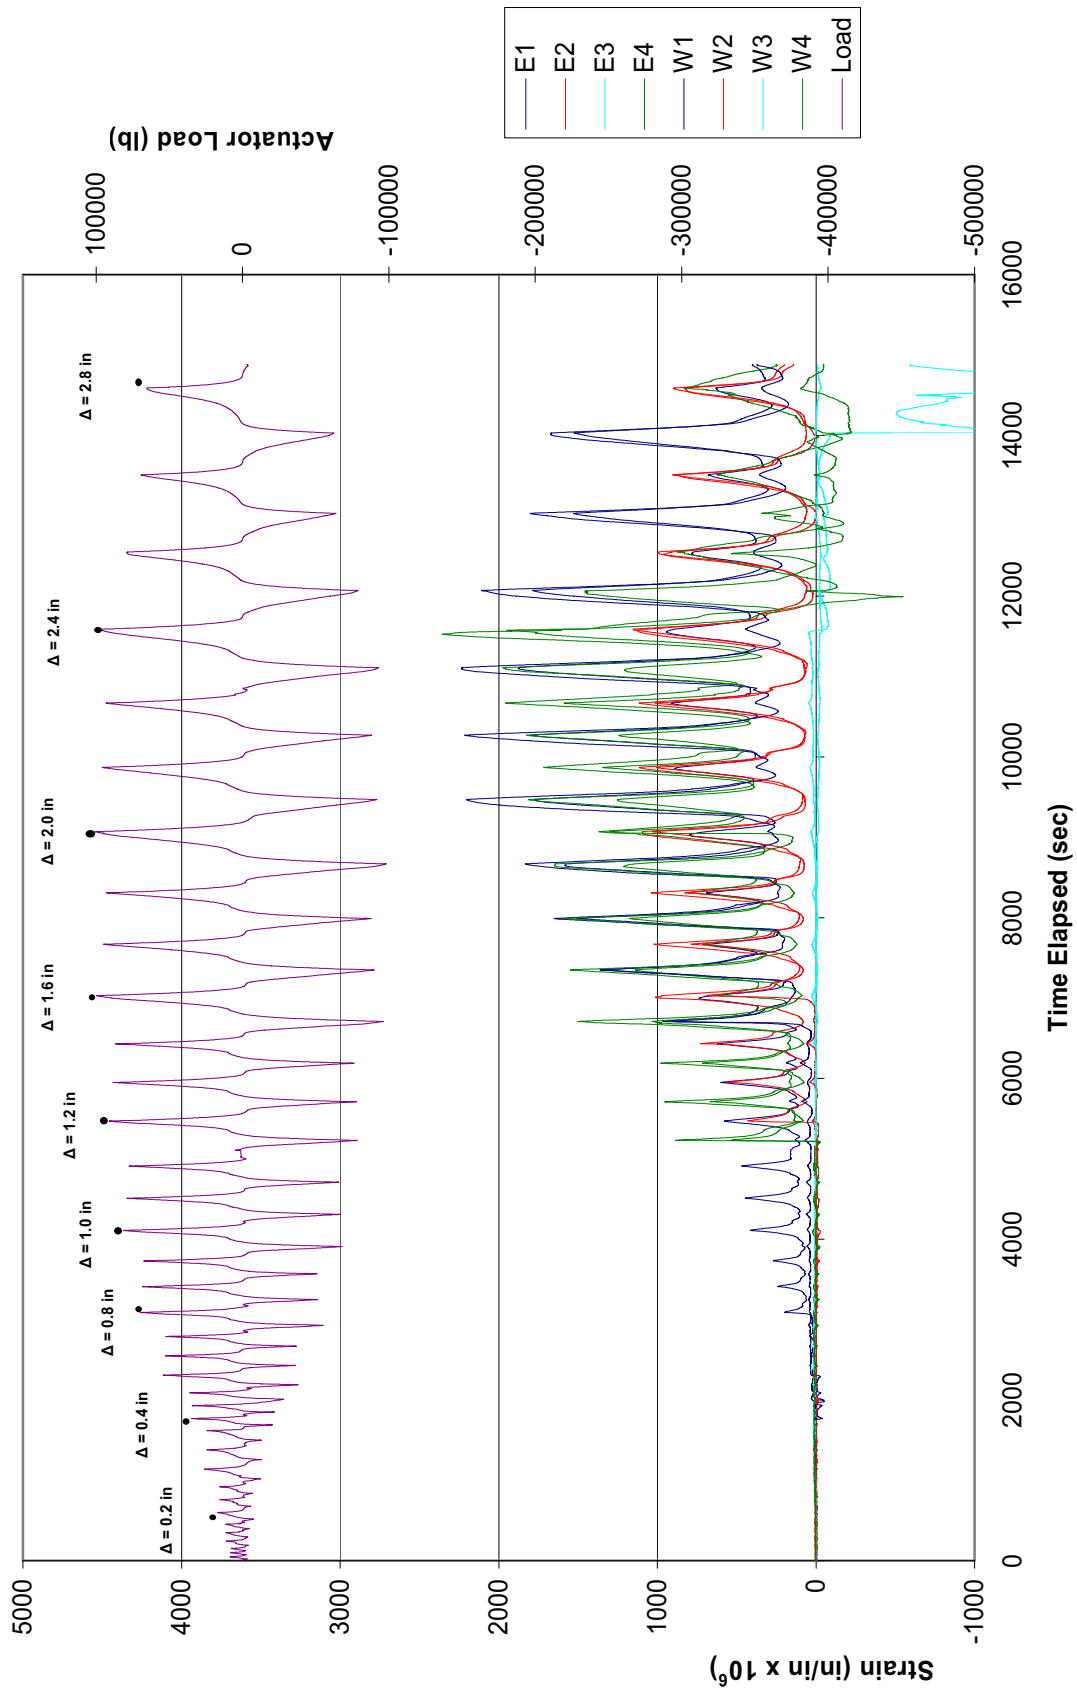
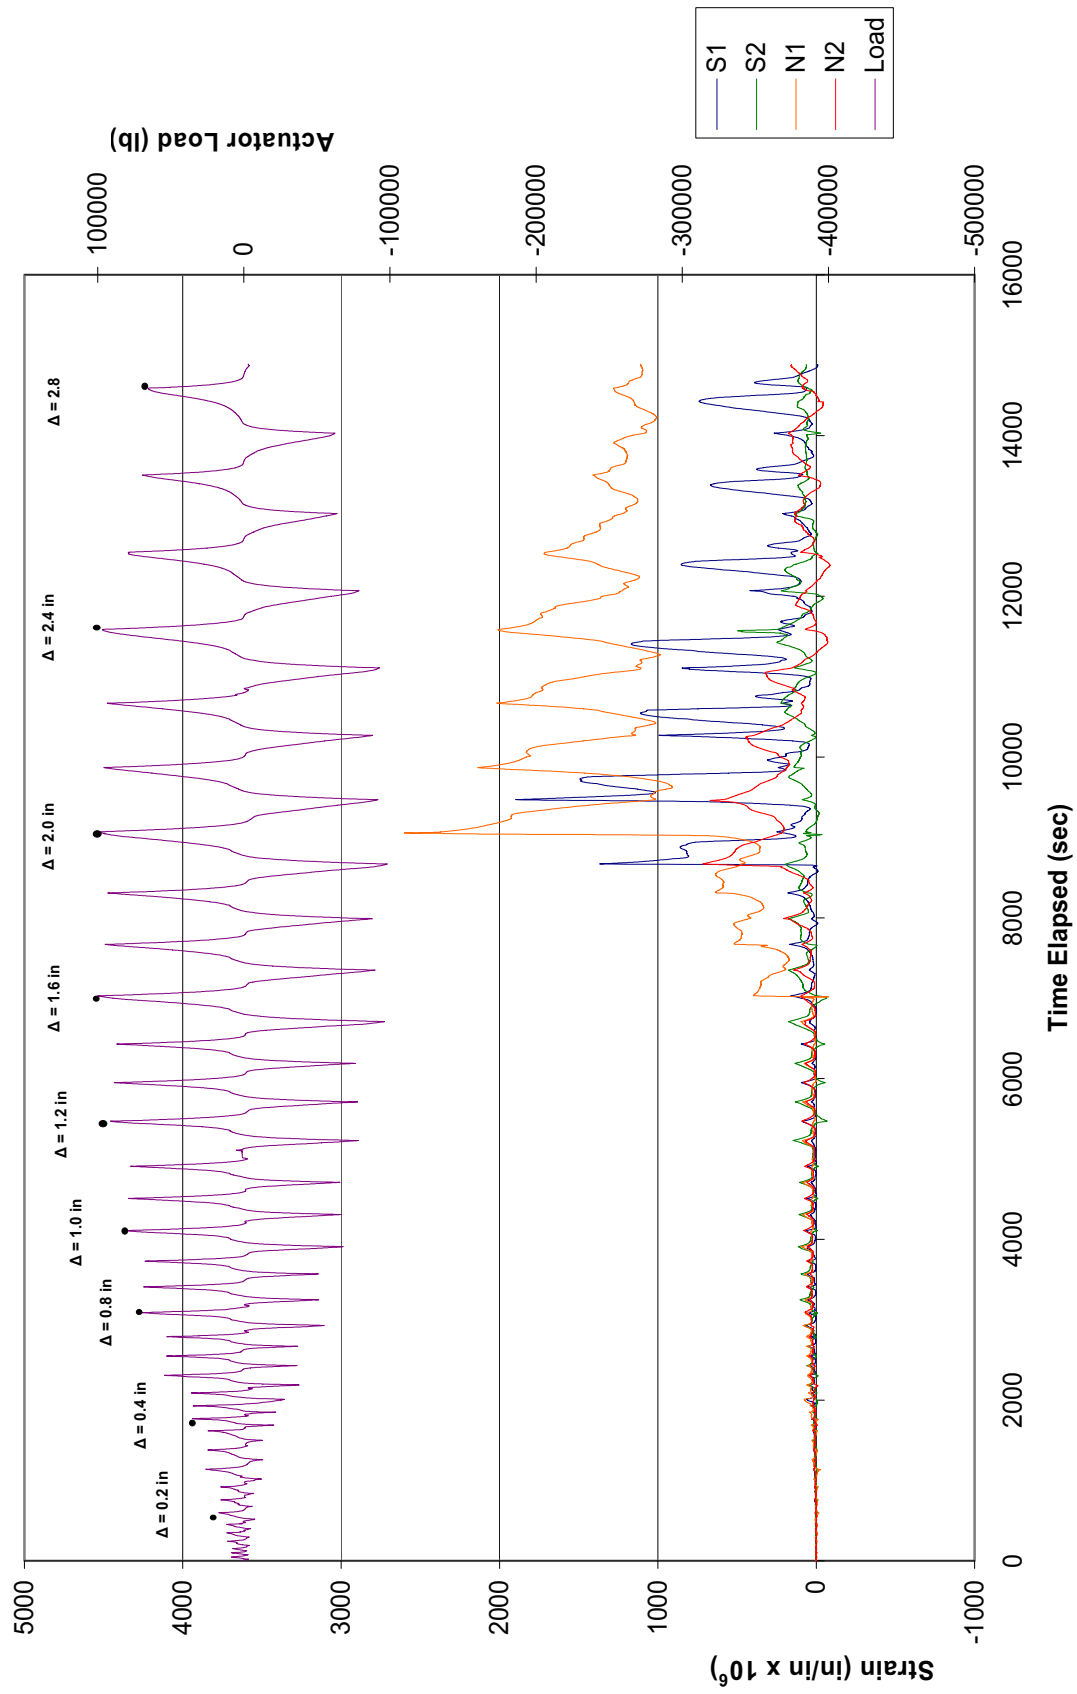
Figures 5.4.8 and 5.4.9 show the strains with time for the FRP jacket strain gages parallel and perpendicular to the applied load, respectively. Almost negligible strains were observed in the parallel FRP strain gages up to a displacement level of 0.8 in. (20 mm). A linear strain profile was then observed up to the peak strain value of 2300 $\mu\epsilon$ during the first cycle at a displacement level of 2.4 in. (61 mm). Afterwards, strains decreased rapidly as the FRP jacket pulled away from the reentrant corners. All measured strains were well below the FRP jacket ultimate strain capacity of around 19,000 $\mu\epsilon$.

Negligible strains were observed in the perpendicular FRP gages near the top and bottom of the column up to a displacement level of 2.0 in. (51 mm). Strain readings spiked sharply during the first cycle at a displacement level of 2.0 in. (51 mm) at a peak strain of 2600 $\mu\epsilon$ corresponding with the beginning of pullout of the FRP jacket from the reentrant corners. Strains decreased with further testing.

Figure 5.4.8 – Column 2 Parallel FRP Jacket Strain Gage Data (1 kip = 4.45 kN, 1 in. = 25.4 mm)

Figure 5.4.9 – Column 2 Perpendicular FRP Jacket Strain Gage Data (1 kip = 4.45 kN, 1 in. = 25.4 mm)

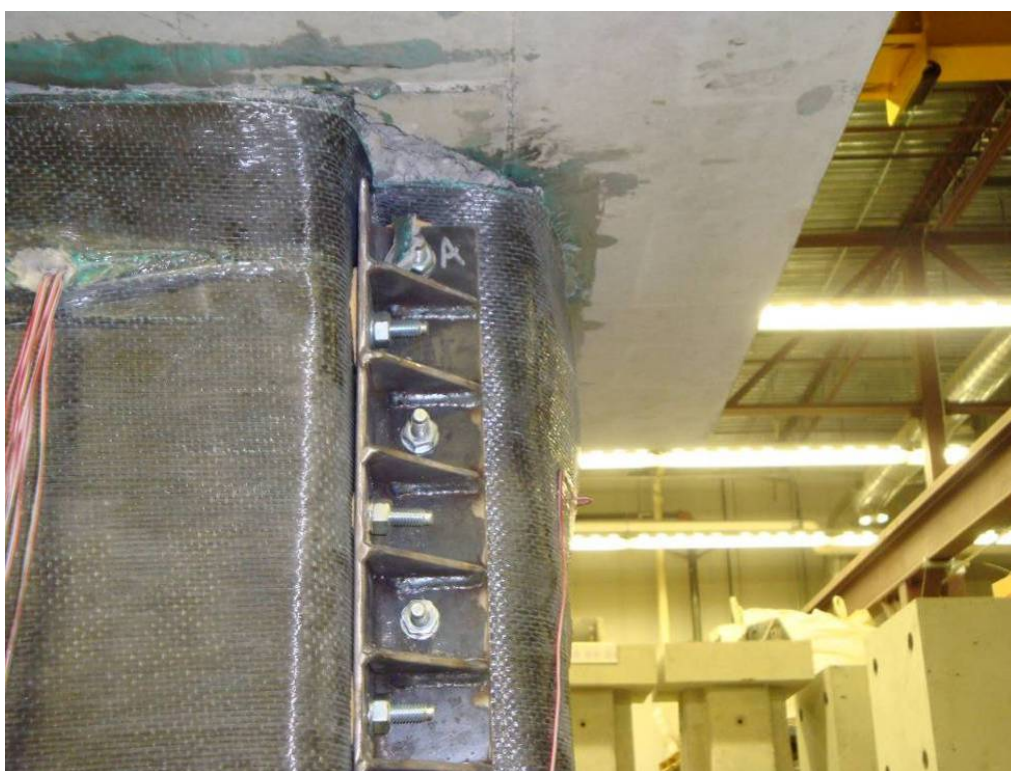
Figure 5.5.3 – Column 3 Bulging of FRP Jacket at the Top of the Column

Figure 5.5.3 shows the bulging of the FRP jacket at the top of the column. During the first cycle at a displacement level of 3.2 in. (81 mm) the epoxy anchors at the top of the column failed and the load displacement curve peaked before reaching a lateral displacement of 3.2 in. (81 mm), indicating the failure of the column. No shear distress was observed in the column throughout the test, and the final failure mechanism was development of plastic hinges at the top and bottom of the column. The failure of the epoxy anchors at the top of the column near the end of testing was likely due to crushing and degradation of the concrete under the FRP jacket in the plastic hinge region. Figure 5.5.4 shows the failure of the reentrant corner anchorage near the end of testing.

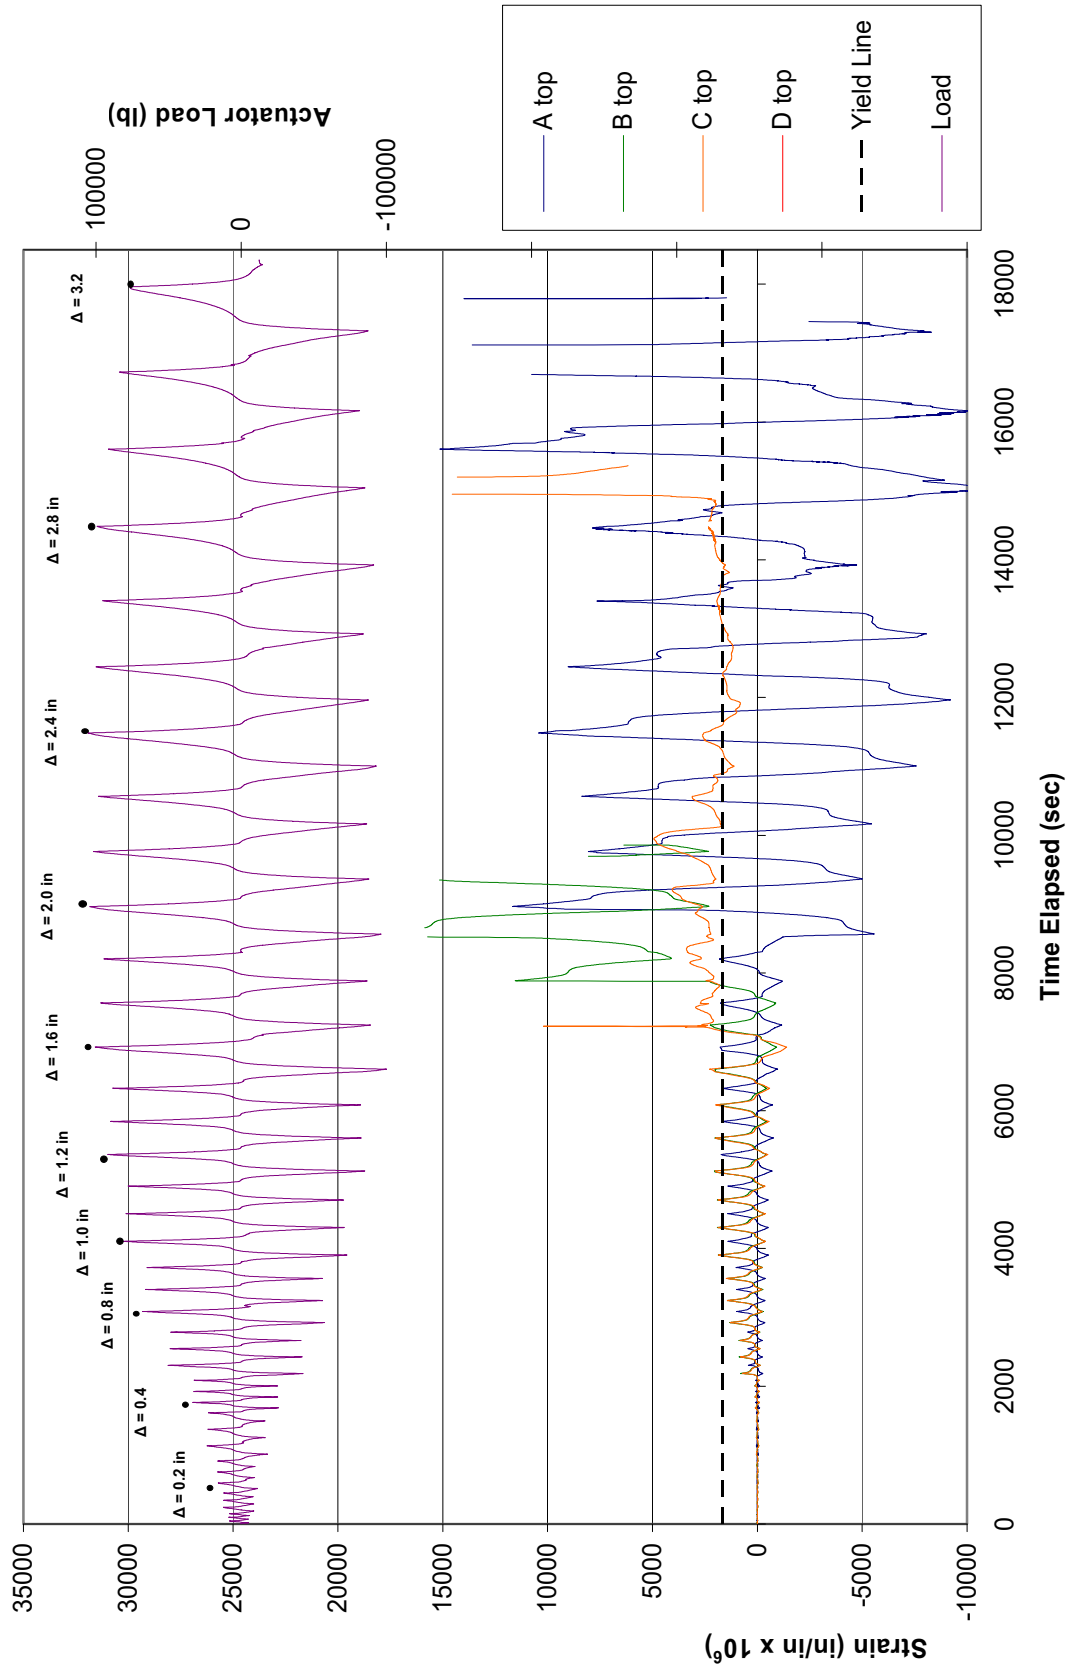
Figure 5.5.6 – Column 3 Longitudinal Bar Strain Gage Data at the Top of the Column (1 kip = 4.45 kN, 1 in. = 25.4 mm)

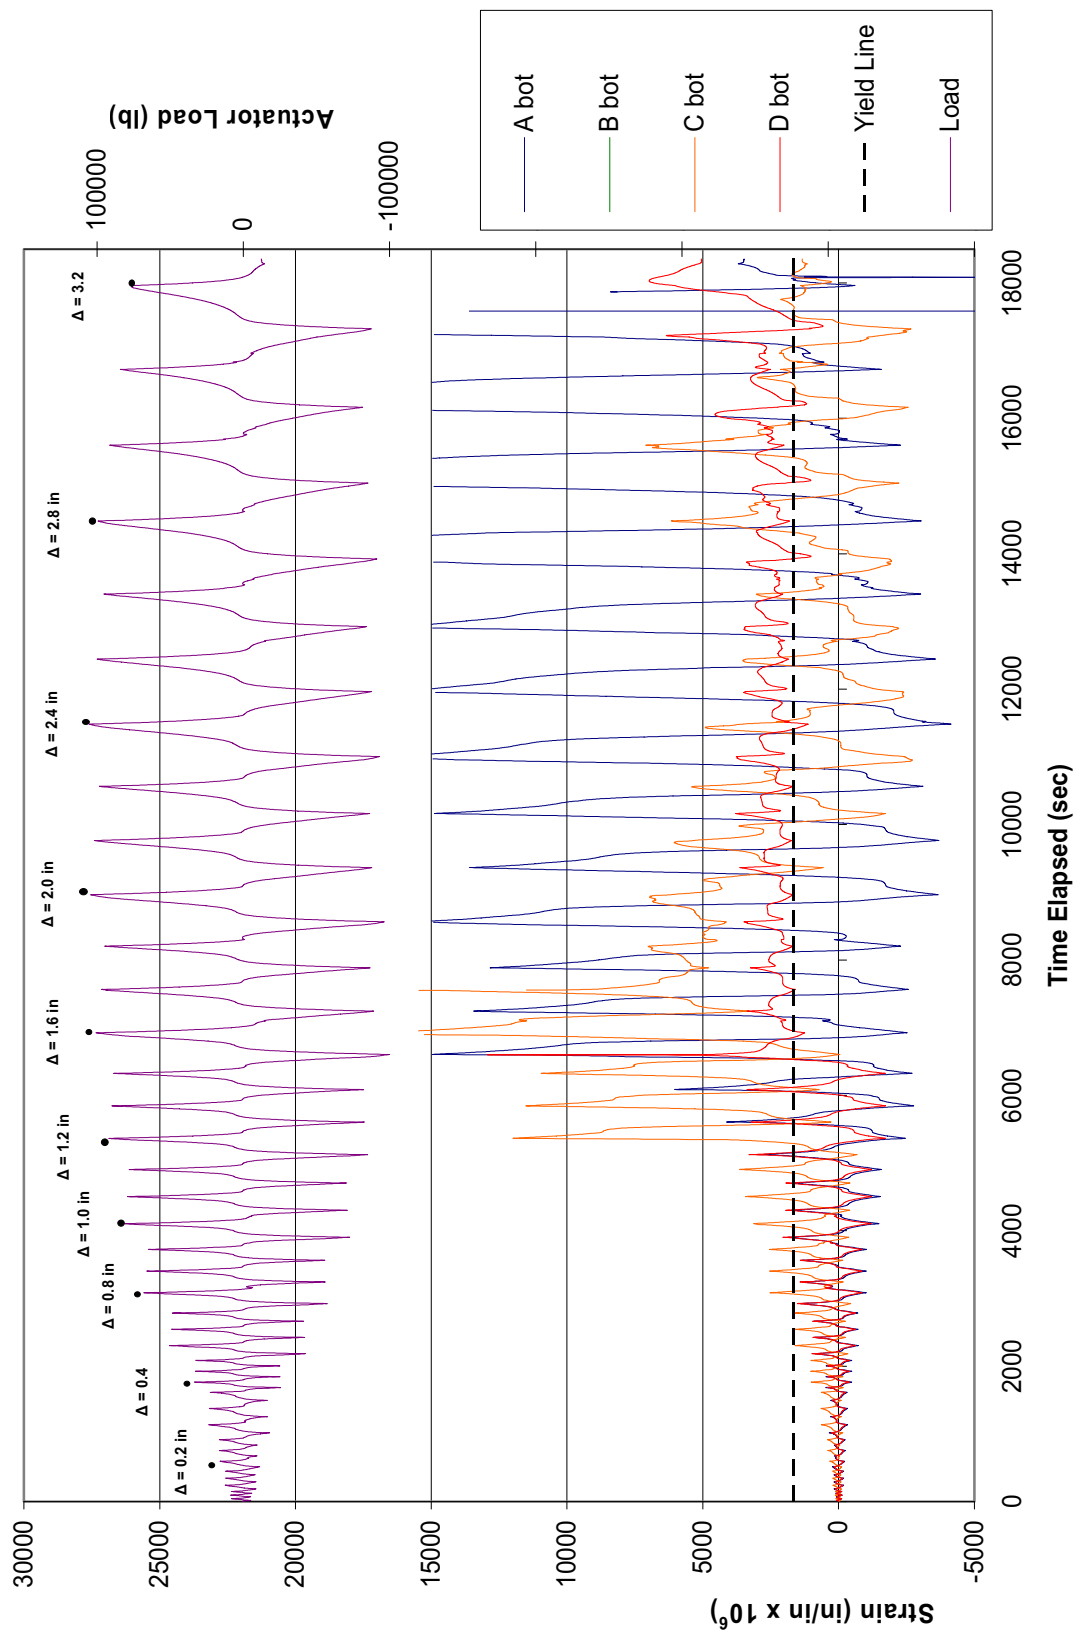
Figure 5.5.7 – Column 3 Longitudinal Bar Strain Gage Data at the Bottom of the Column (1 kip = 4.45 kN, 1 in. = 25.4 mm)

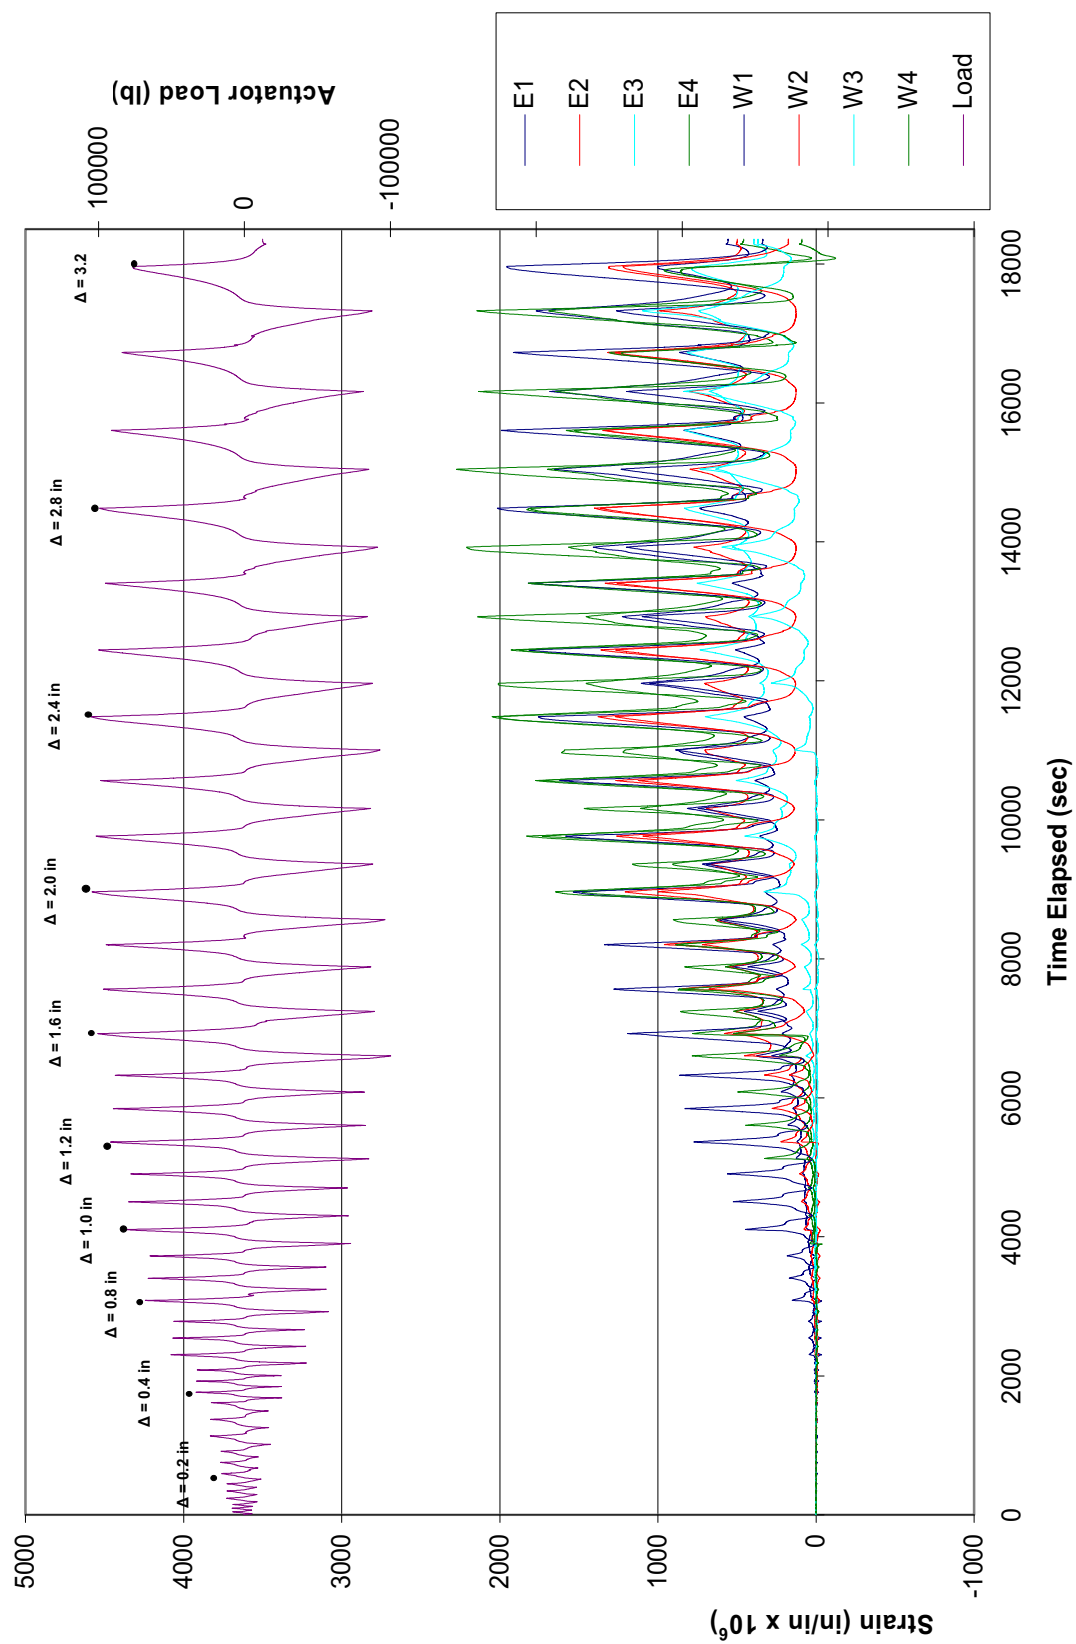
Figure 5.5.8 – Column 3 Parallel FRP Jacket Strain Gage Data (1 kip = 4.45 kN, 1 in. = 25.4 mm)

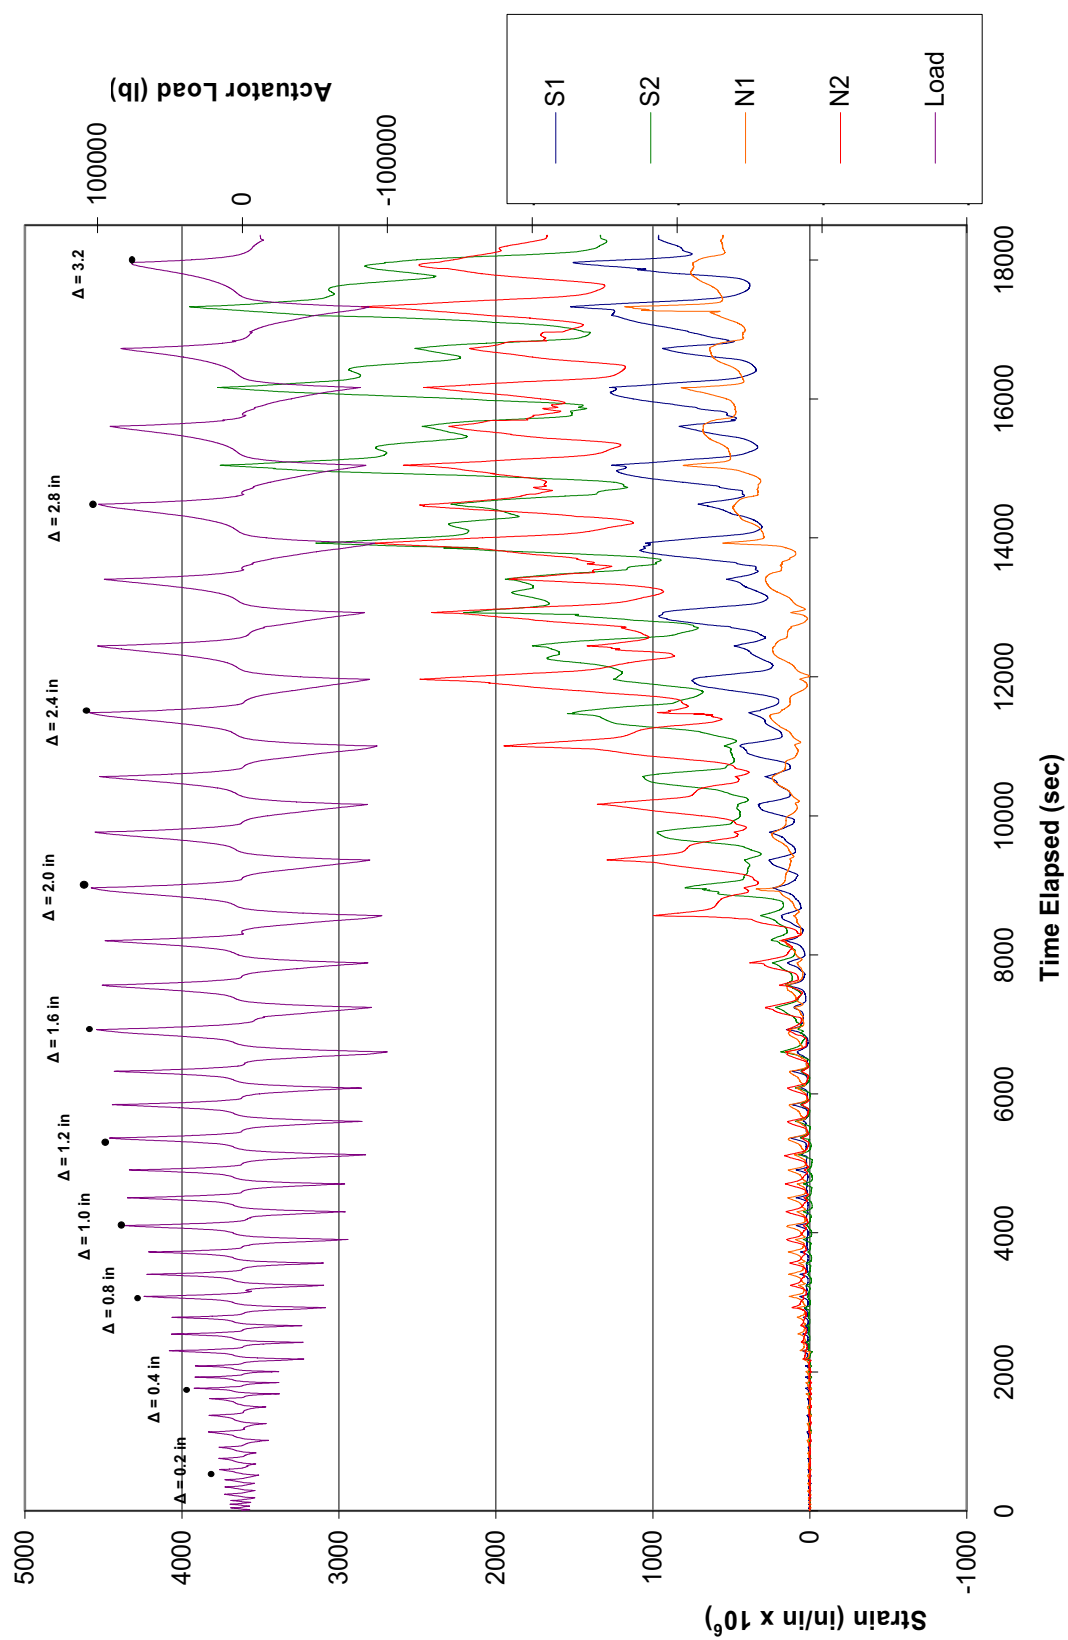
Figure 5.5.9 – Column 3 Perpendicular FRP Jacket Strain Gage Data (1 kip = 4.45 kN, 1 in. = 25.4 mm)

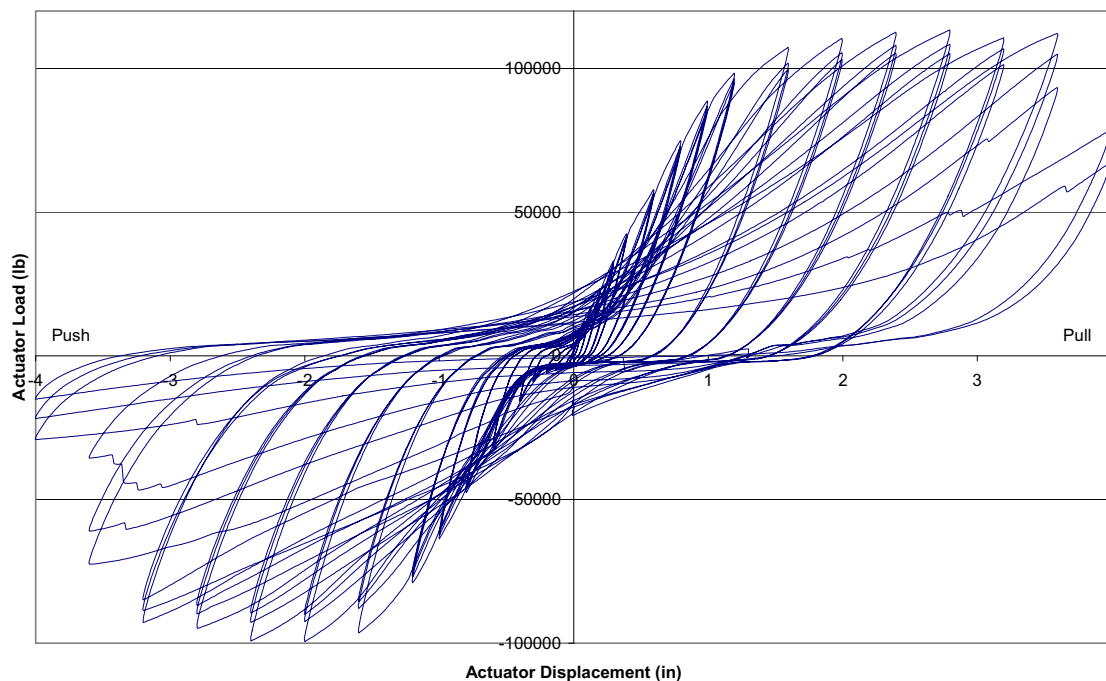
Figure 5.6.1 – Column 4 Lateral Load vs. Displacement Hysteresis Curves

(1 kip = 4.45 kN, 1 in. = 25.4 mm)

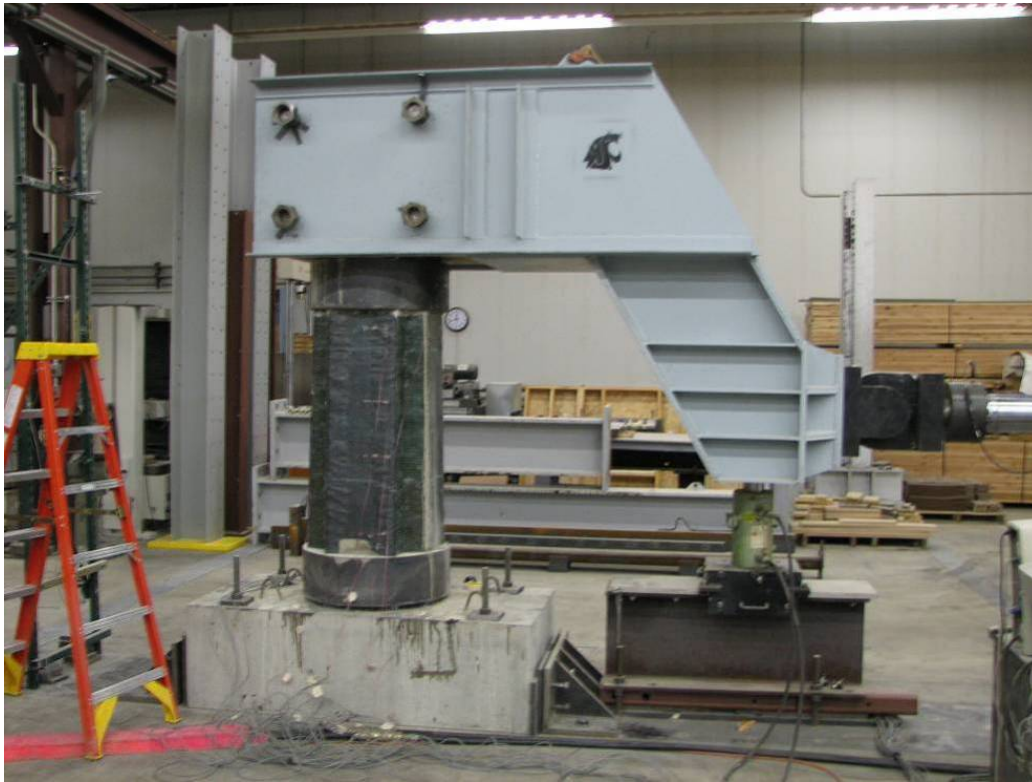
Figure 5.6.2 – Column 4 Test Setup

Figure 5.6.2 shows Column 4 at the beginning of the test. The flexural response of the column was nearly identical to that of Column 2 through the early part of testing with yielding of the longitudinal bars first occurring at a lateral force level of 55 kips (245 kN) followed by

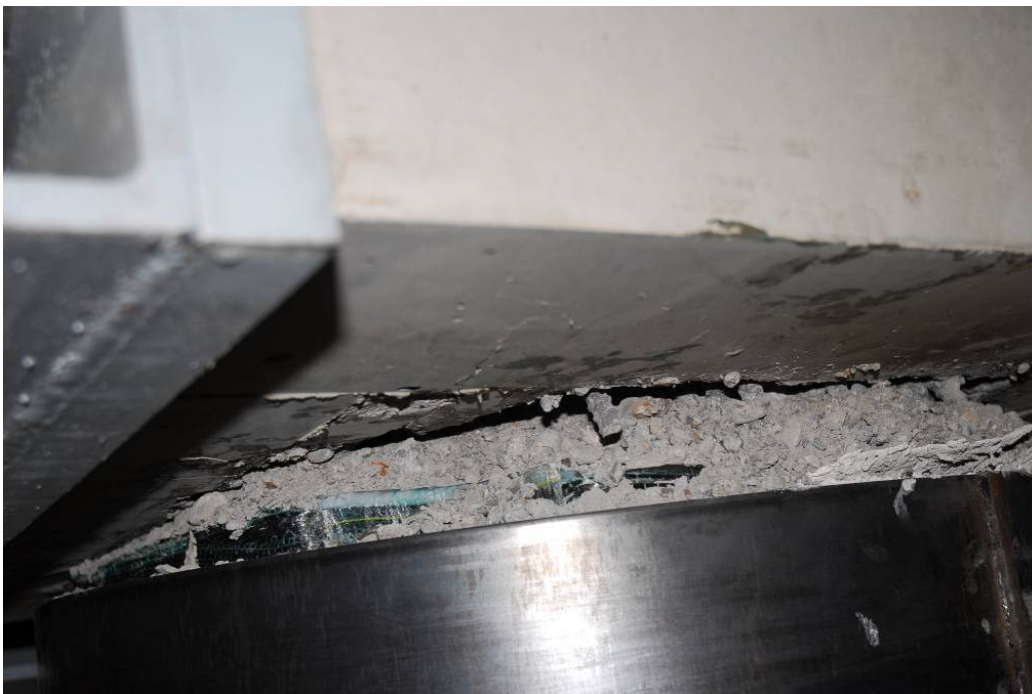
5.6.3 – Column 4 Longitudinal Rebar Fracture

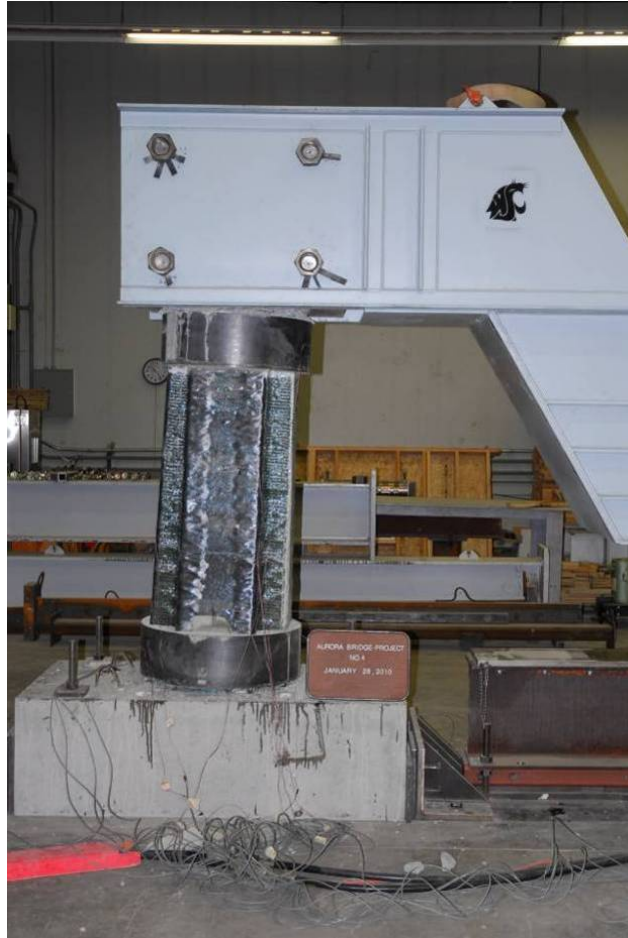
Figure 5.6.4 – Column 4 Near the End of Testing

flexural cracking at the top and bottom of the column. Strains in the transverse reinforcement were small throughout the test and did not come close to the yield strain. FRP jacket strains were slightly lower than those for Column 3 parallel to the applied load, and strains on the steel collar were almost negligible throughout the test. The applied lateral load remained nearly constant even after development of plastic hinges at the top and bottom of the column up to a displacement level of 3.6 in. (91 mm). While cycling at a displacement level of 3.6 in. (91 mm), several of the vertical rebar fractured, resulting in significant decrease in the lateral stiffness and strength. Figure 5.6.3 shows the fractured longitudinal steel which was caused by low-cycle fatigue due to the stress reversals in the plastic hinge region. The final failure mode for the column was flexural hinging leading to fracture of the longitudinal rebar with no distress observed in the FRP jacket and steel collar at the end of testing. Figure 5.6.4 shows the column at the end of testing and illustrates the significant rotation of the plastic hinge regions.
