**SEISMIC RETROFIT OF CRUCIFORM-SHAPED COLUMNS
IN THE AURORA AVENUE BRIDGE USING FRP WRAPPING**

A thesis submitted in partial fulfillment of
the requirements for the degree of

WASHINGTON STATE UNIVERSITY
Department of Civil and Environmental Engineering

MAY 2010

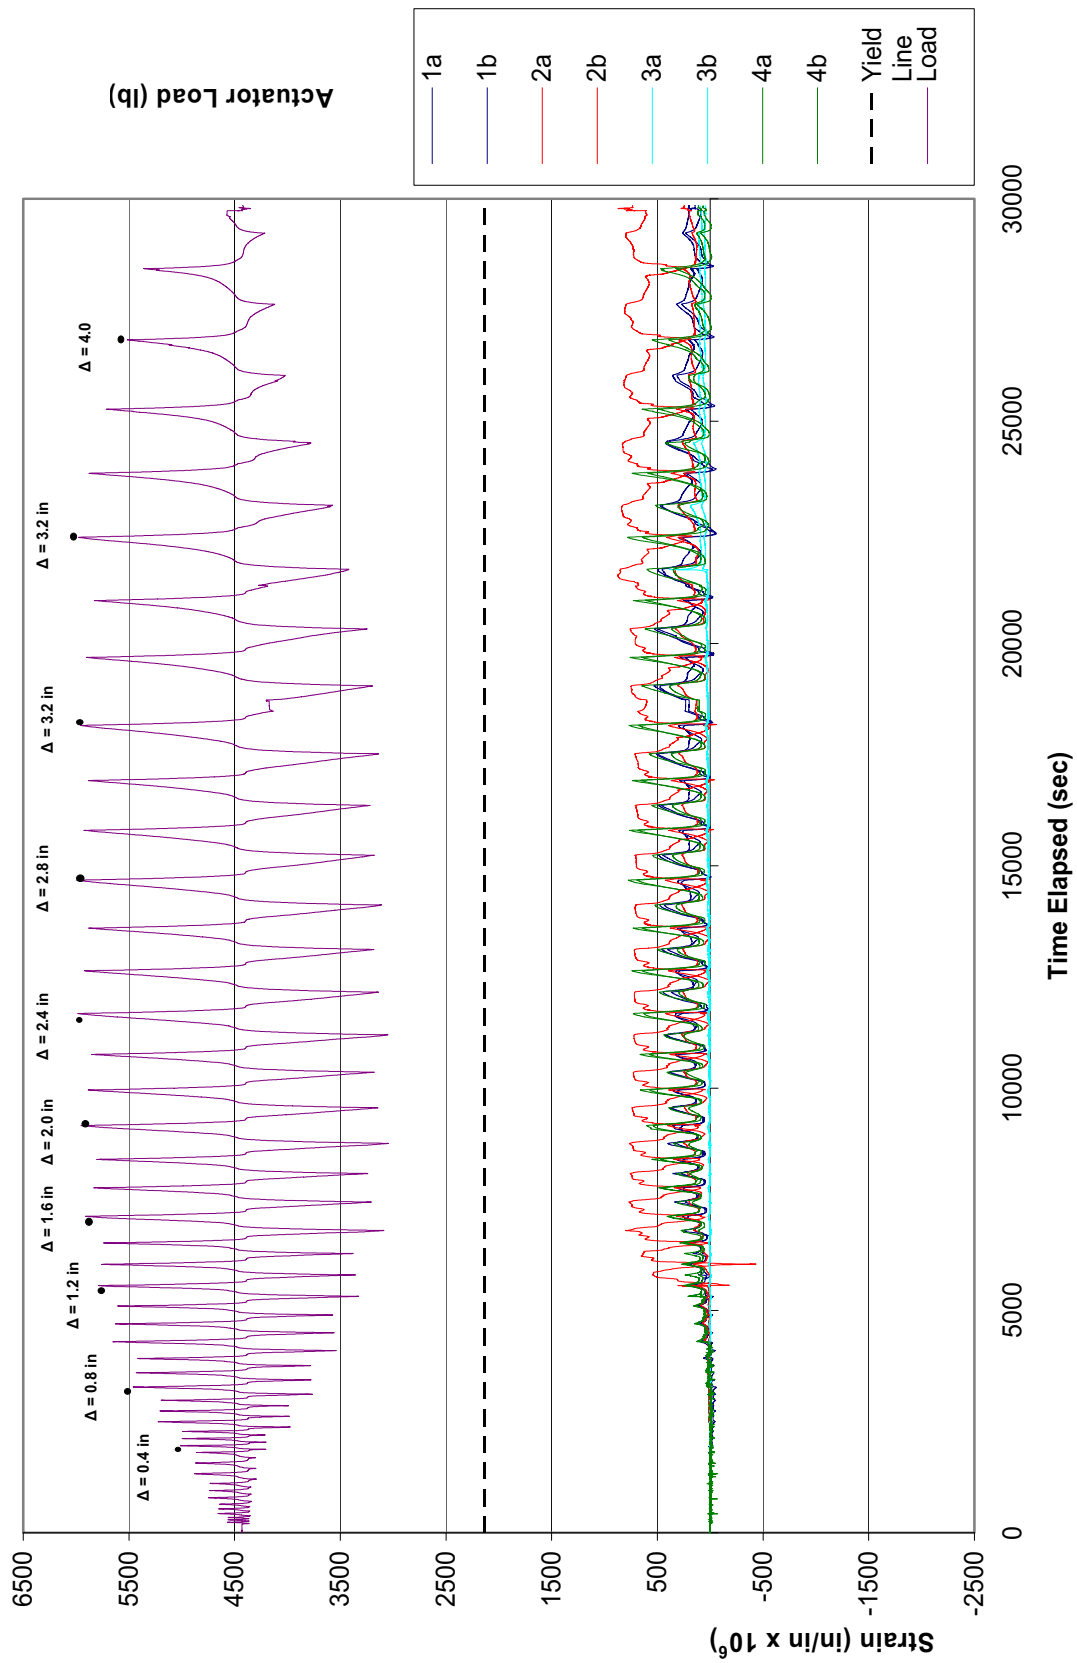
Figure 5.6.5 – Column 4 Transverse Strain Gage Data (1 kip = 4.45 kN, 1 in. = 25.4 mm)

Figure 5.6.5 shows a plot of the transverse hoop strains with time. Almost negligible hoop strains were observed up to a displacement level of 1.2 in. (30 mm). A linear strain profile was then observed up to peak strain of about $700 \mu\epsilon$ at a displacement level of 1.6 in. (41 mm). The observed hoop strains were nearly constant for the remainder of the test. The peak strain observed for the transverse hoops was far below the yield strain.

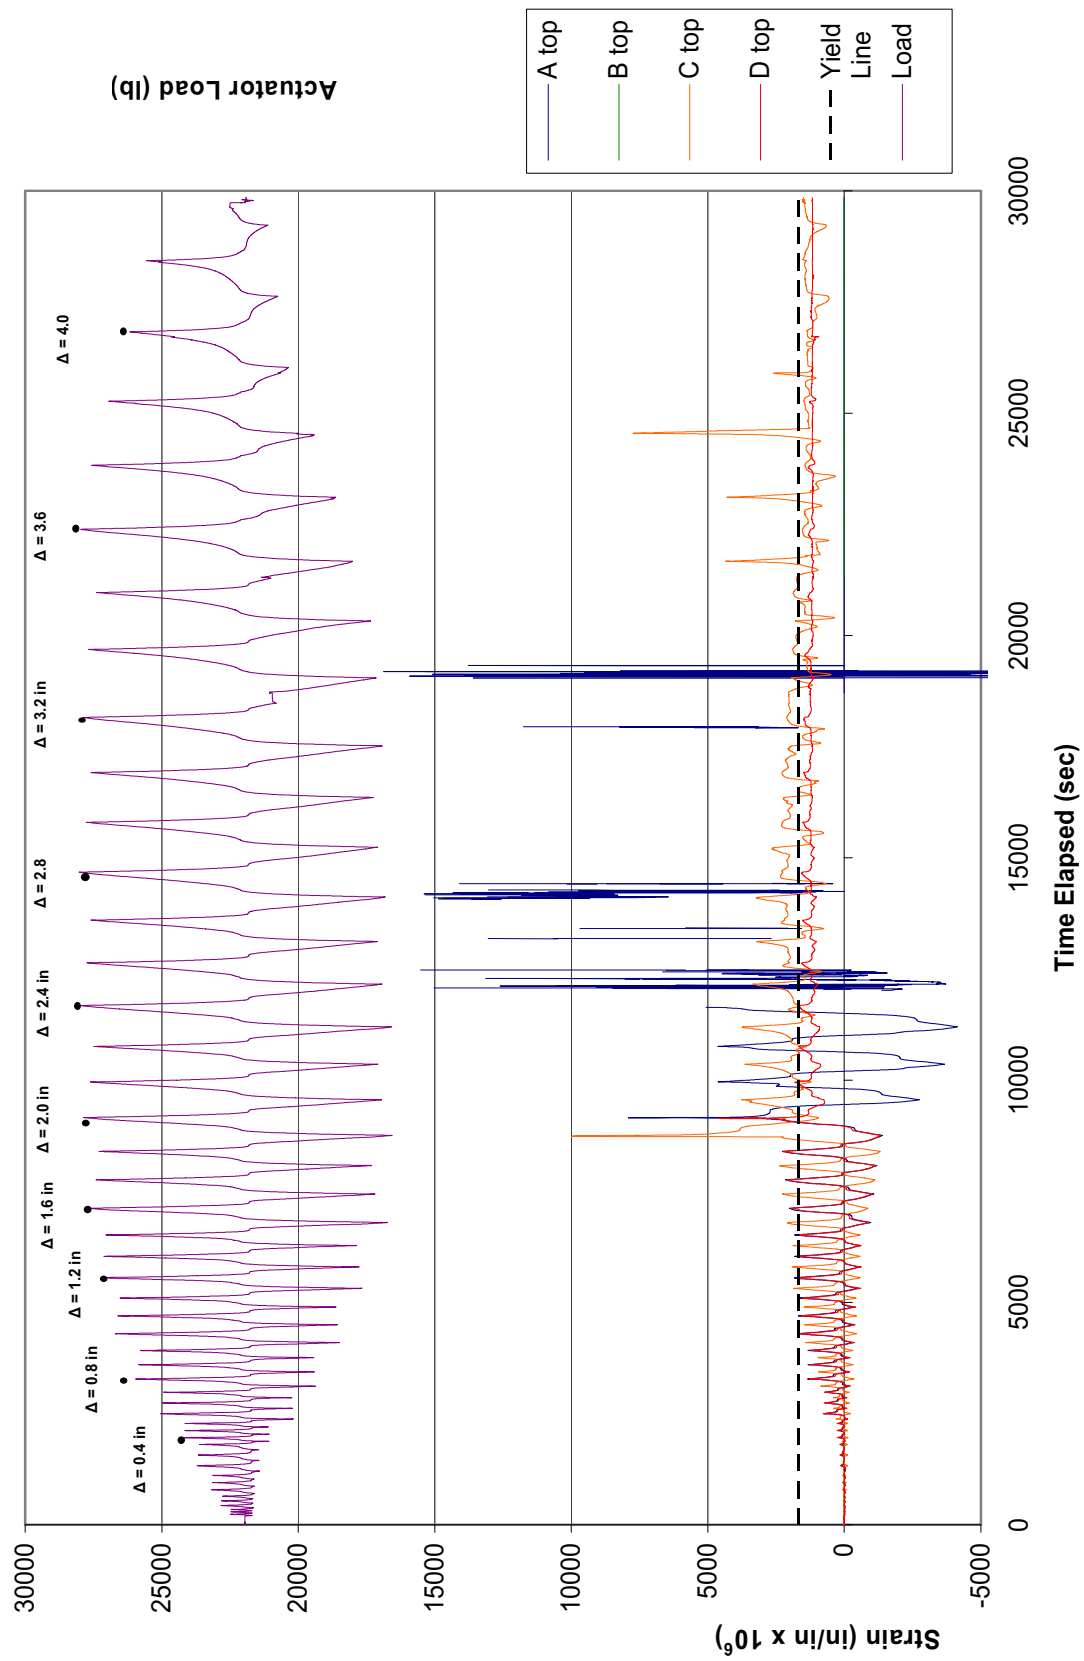
Figure 5.6.6 – Column 4 Longitudinal Bar Strain Gage Data at the Top of the Column (1 kip = 4.45 kN, 1 in. = 25.4 mm)

Figures 5.6.6 and 5.6.7 show the strains in the longitudinal bars at the top and bottom of the column, respectively. A linear strain profile was observed in the top strain gages up to the first yield at a displacement level of 1.0 in. (25 mm). After yielding, strains stayed nearly constant until the first cycle at a displacement level of 2.0 in. (51 mm). Very large strains in excess of 10,000 $\mu\epsilon$ were observed until a displacement level of 2.8 in. (71 mm), after which strains near the yield strain were observed for the remainder of the test.

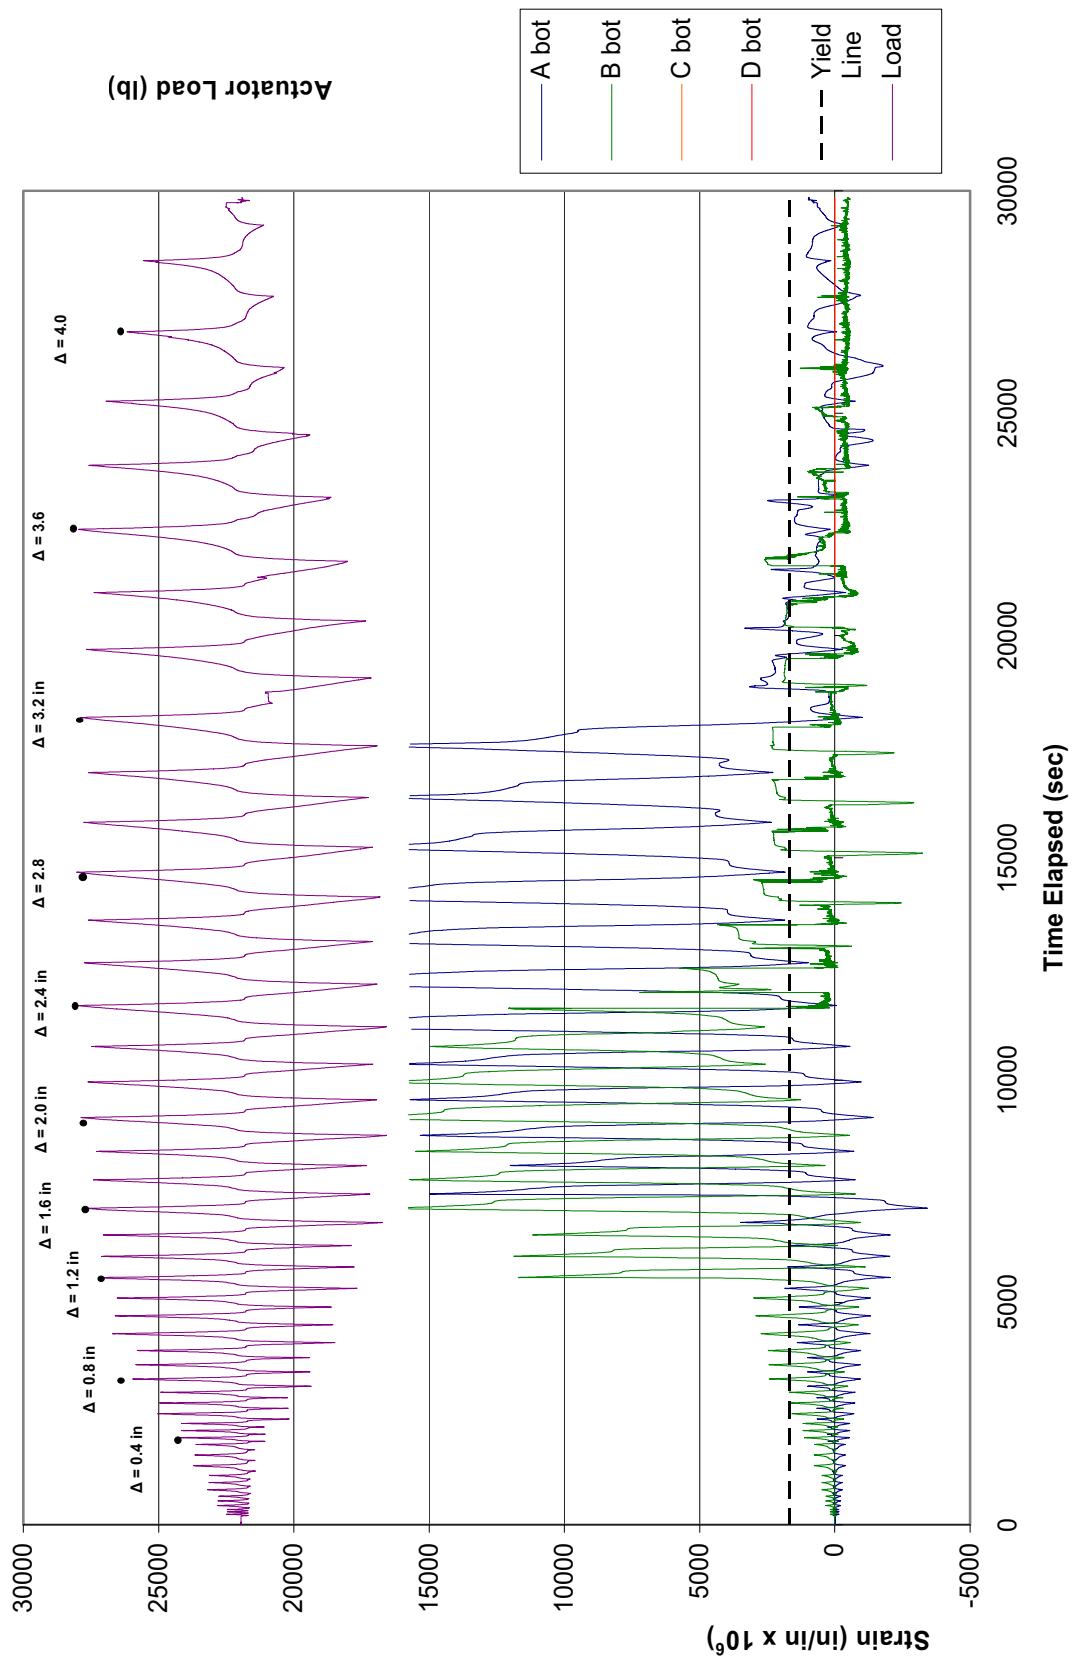
Figure 5.6.7 – Column 4 Longitudinal Bar Strain Gage Data at the Bottom of the Column (1 kip = 4.45 kN, 1 in. = 25.4 mm)

Strains in the bottom strain gages reached first yield at a displacement level of about 0.8 in. Strains increased linearly up to a displacement level of 1.2 in. (30 mm) and then increased rapidly to strains in excess of 10,000 $\mu\epsilon$. Very large strains were observed up to a displacement level of 3.2 in. (81 mm), after which strains near the yield strain were observed for the remainder of the test.

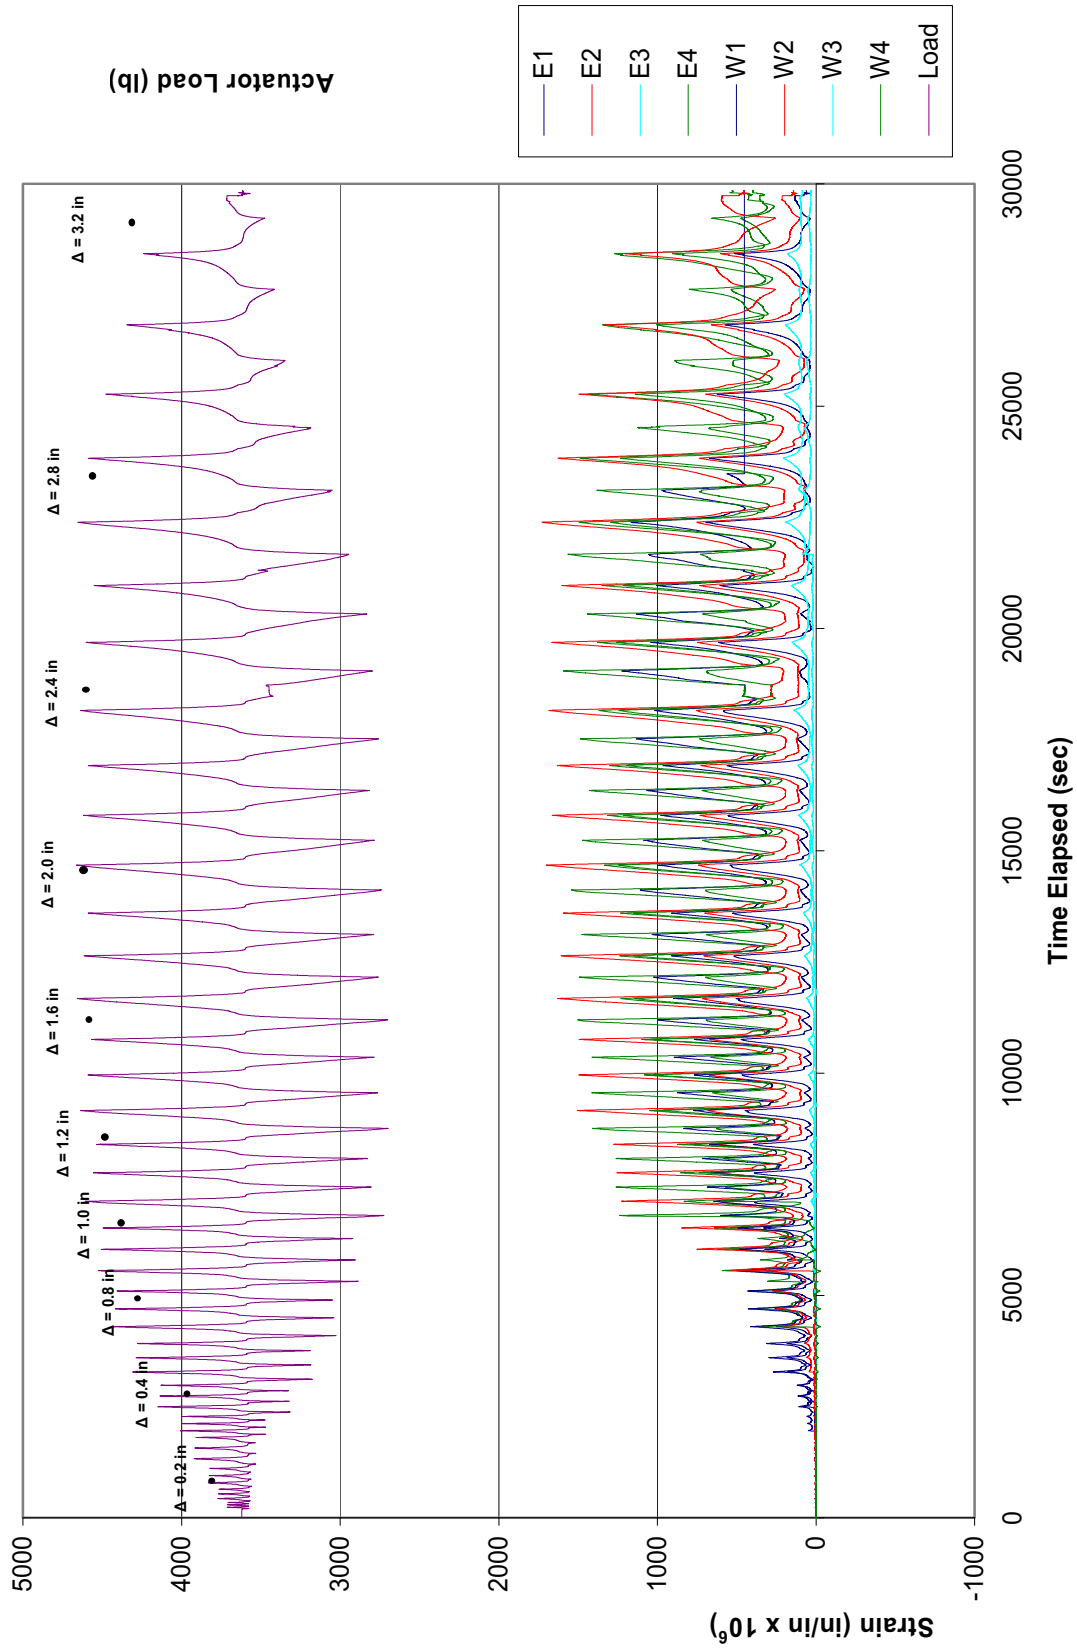
Figure 5.6.8 – Column 4 Parallel FRP Jacket Strain Gage Data (1 kip = 4.45 kN, 1 in. = 25.4 mm)

Figures 5.6.8 and 5.6.9 show the strains in the FRP jacket for strain gages parallel to the applied load and in the steel collar for strain gages perpendicular to the applied load. Almost negligible strains were observed in the parallel FRP strain gages up to a displacement level of 0.6 in. (15 mm). A linear strain profile was then observed up to the peak strain value of 2200 $\mu\epsilon$ at a displacement level of 2.4 in. (61 mm). Afterwards, strains remained nearly constant up to a displacement level of 3.6 in. (91 mm) and then decreased linearly for the remainder of the test. All measured strains were well below the FRP jacket ultimate strain capacity of around 19,000 $\mu\epsilon$.

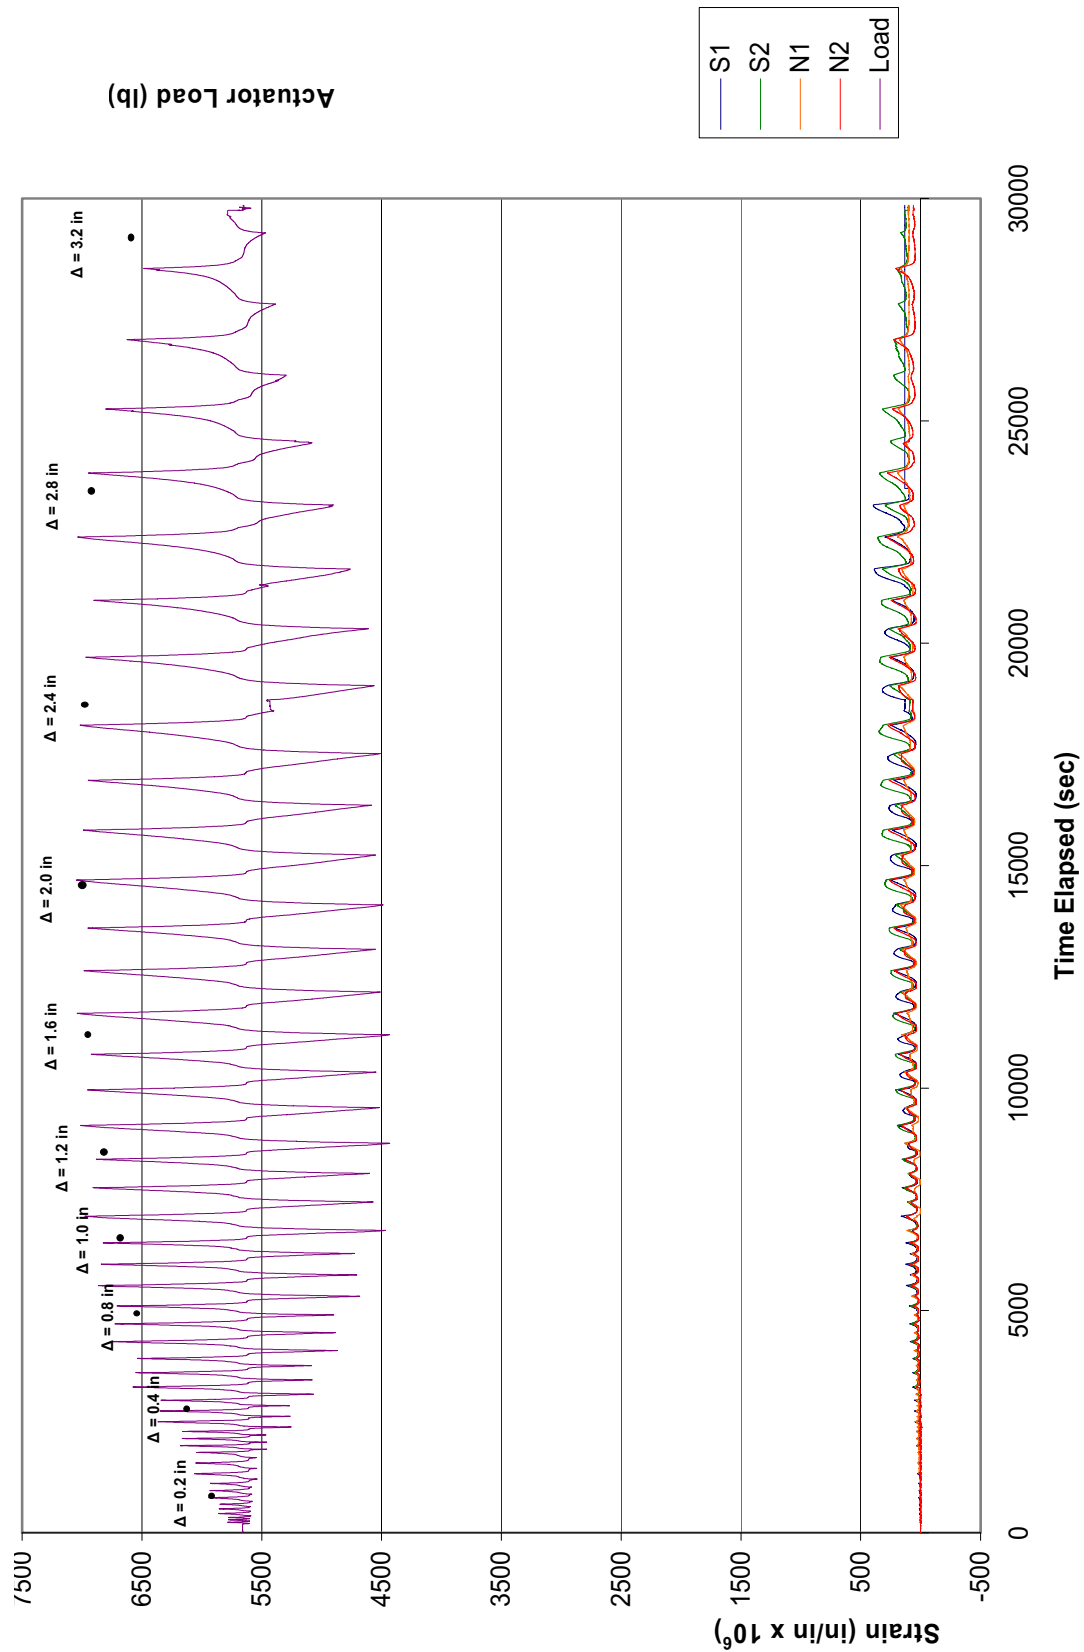
Figure 5.6.9 – Column 4 Perpendicular Steel Collar Strain Gage Data (1 kip = 4.45 kN, 1 in. = 25.4 mm)

Very small strains were observed in the steel collar strain gages placed perpendicular to the loading direction throughout the test and were well below the steel collar yield strain of 1300 $\mu\epsilon$.

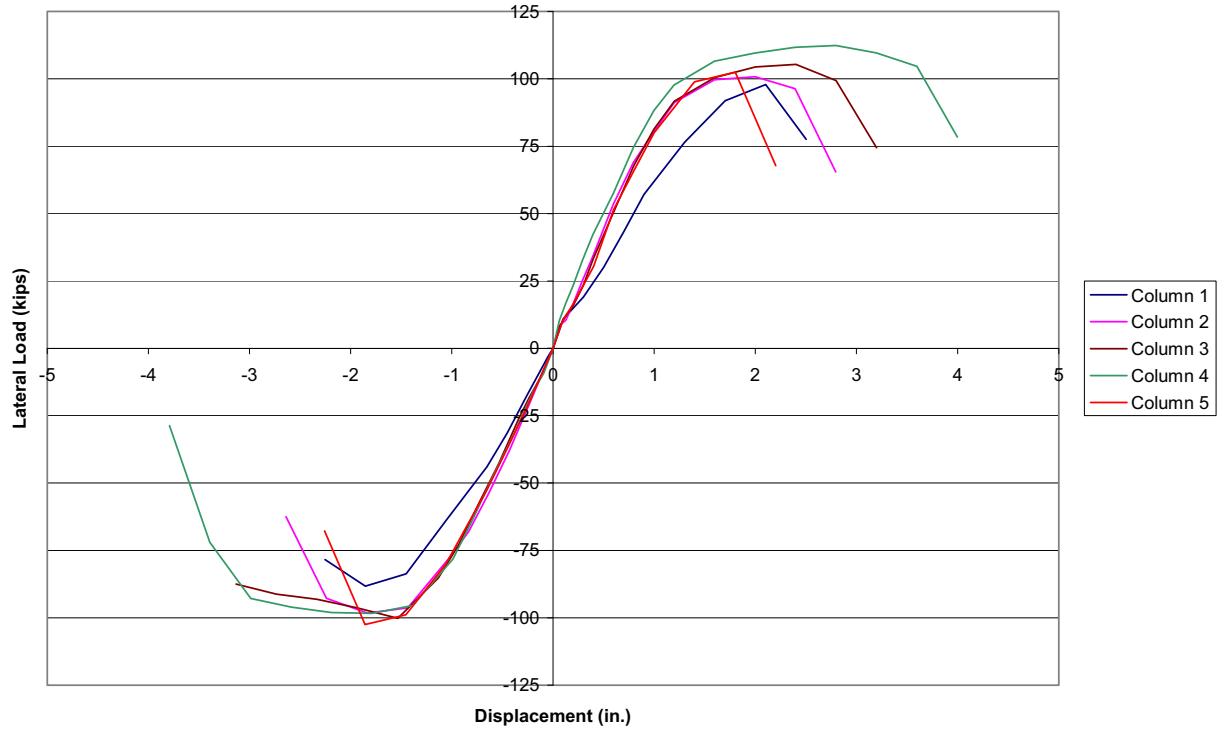
Figure 5.7.1 – Envelope Lateral Load vs. Displacement Hysteresis Curves

(1 kip = 4.45 kN, 1 in. = 25.4 mm)

A summary of relevant characteristics of the test specimens is presented in Table 5.7.1. Listed characteristics include the effective secant stiffness and shear force corresponding to the first yield of the longitudinal reinforcement, the maximum observed column shear strength, the maximum displacement ductility and drift ratio attained at the maximum response, and the total amount of energy dissipated throughout the test. Figure 5.7.1 shows the envelope lateral load vs. actuator displacement curves for Columns 1-5.

The as-built Columns 1 and 5 attained their theoretical ideal flexural capacity at a displacement level of about 1.3 in. (33 mm), and then failed in a brittle manner at a displacement level of about 2.0 in. (61 mm). Column 2, with a full-height FRP jacket and no reentrant corner anchorage, also failed in a brittle manner but at a slightly higher displacement level of 2.4 in. (71

mm). Stable and ductile hysteretic responses were obtained for both Columns 3 and 4. Column 3 developed plastic hinges at the top and bottom of the column at a displacement level of 3.2 in. (81 mm), while Column 4 achieved a displacement level of 3.6 in. (91 mm) without any signs of physical, strength or stiffness degradation. Column 4 failed at a displacement level of 4.0 in. (0.1 m) due to fracture of the longitudinal reinforcement in the plastic hinge zones.

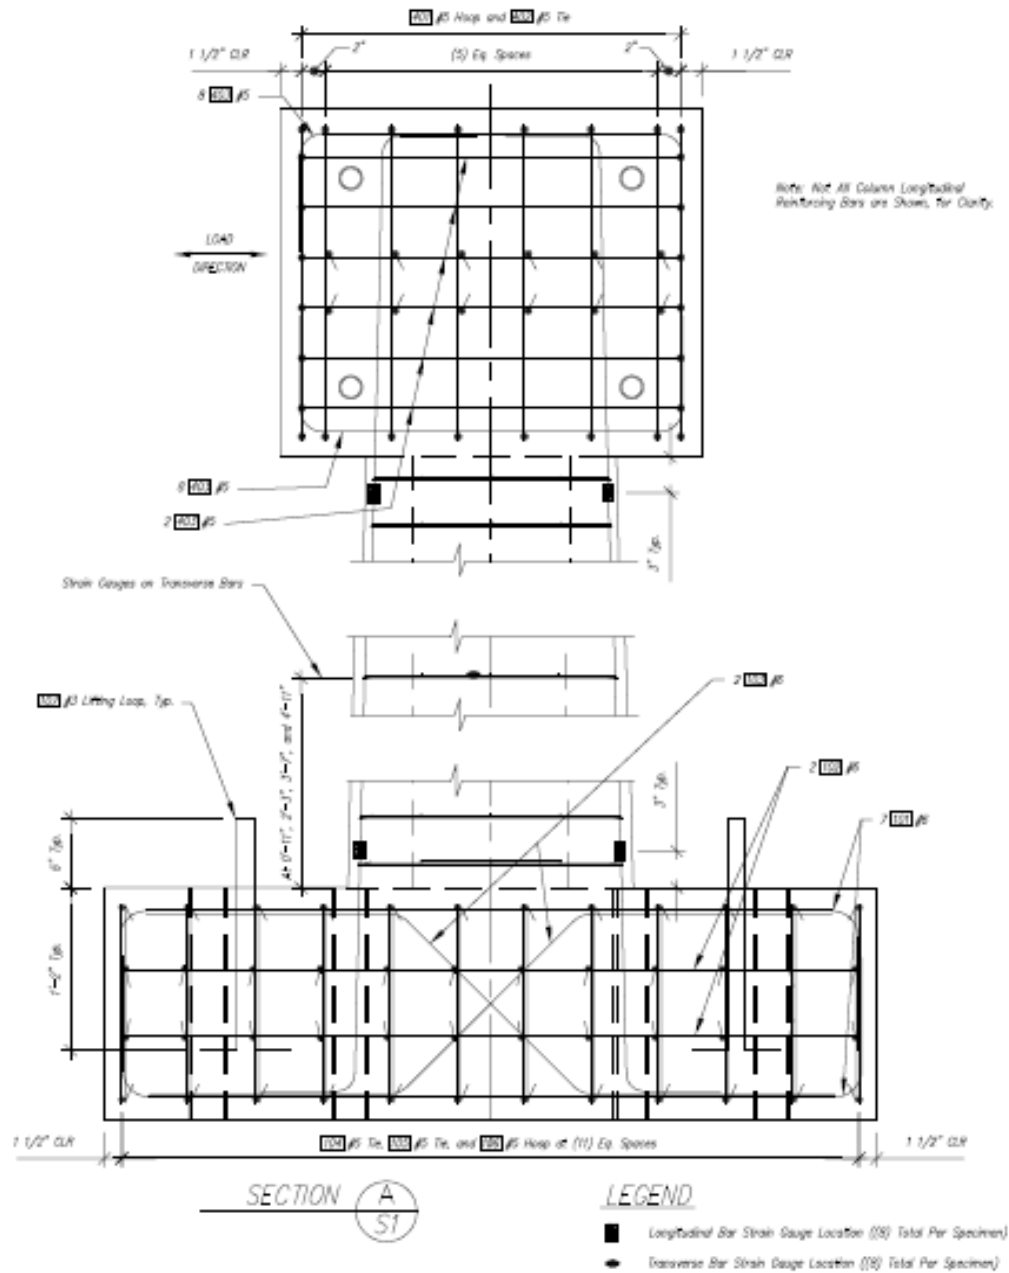
Figure A-1 – Strain Gage Locations Inside All Specimens (1 in. = 25.4 mm)

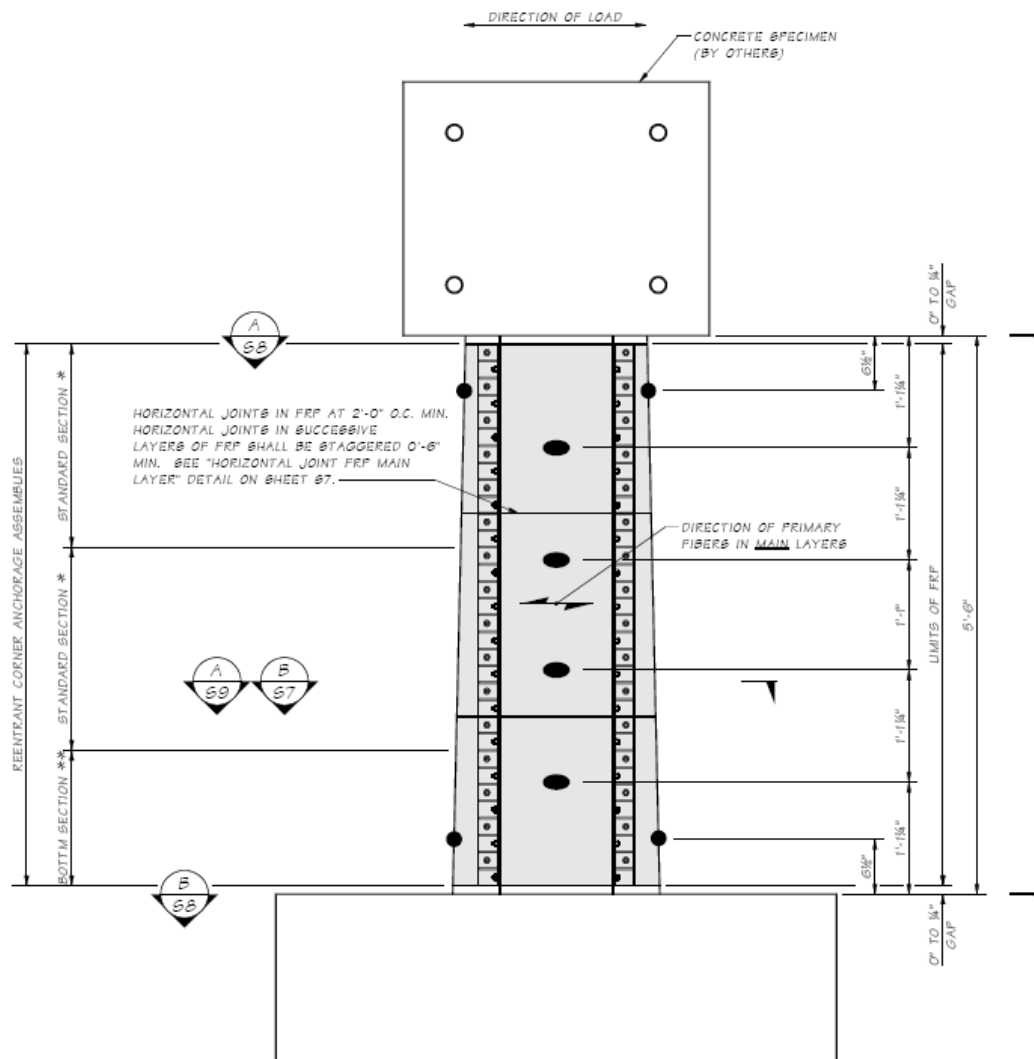
Figure A-2 – Strain Gage Locations on Retrofitted Specimens (1 in. = 25.4 mm)

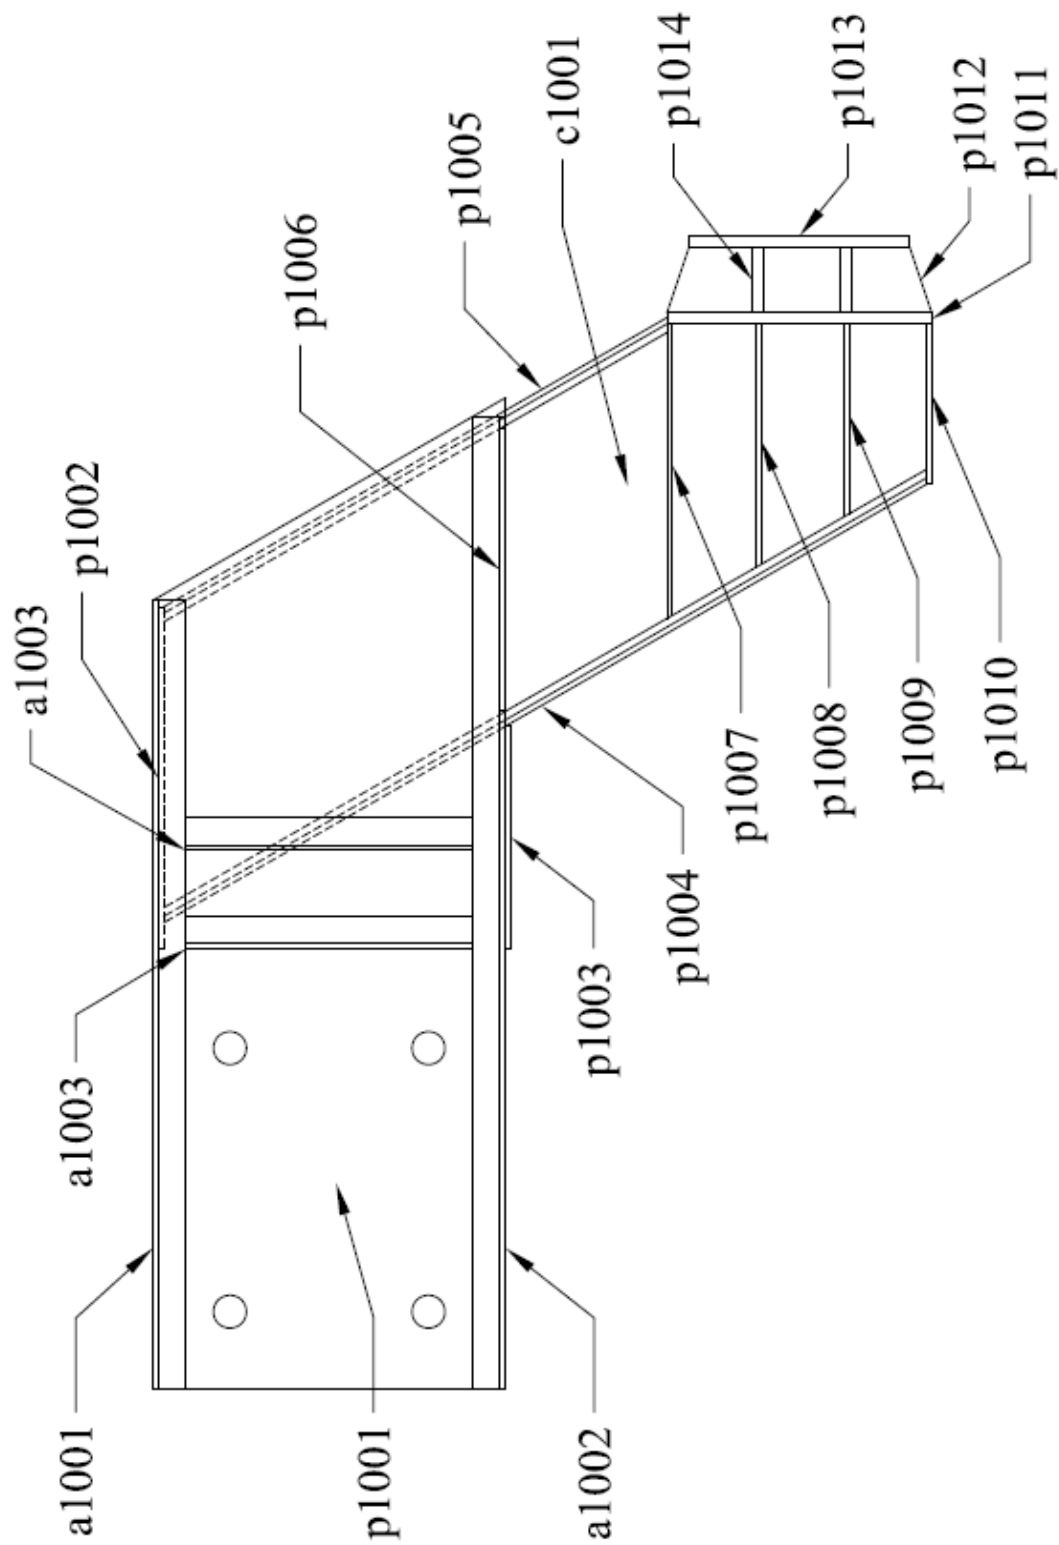
Figure A-3 Loading Frame Assembly Diagram

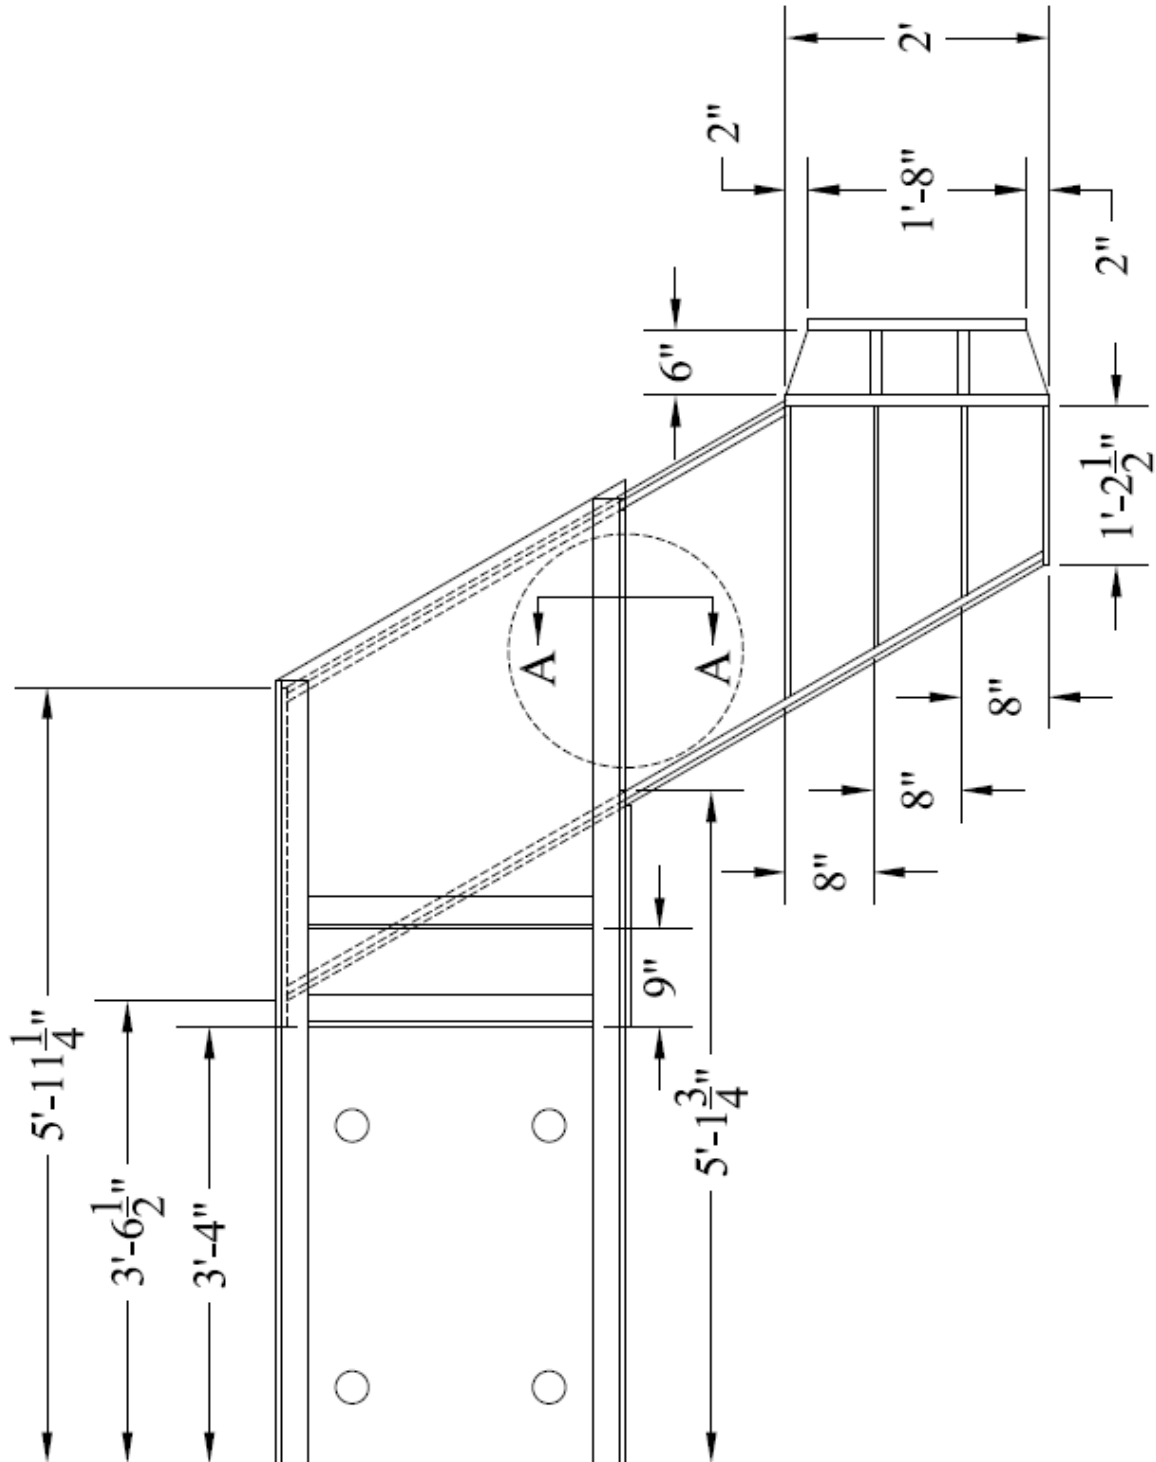
Figure A-4 – Loading Frame Front View (1 in. = 25.4 mm)

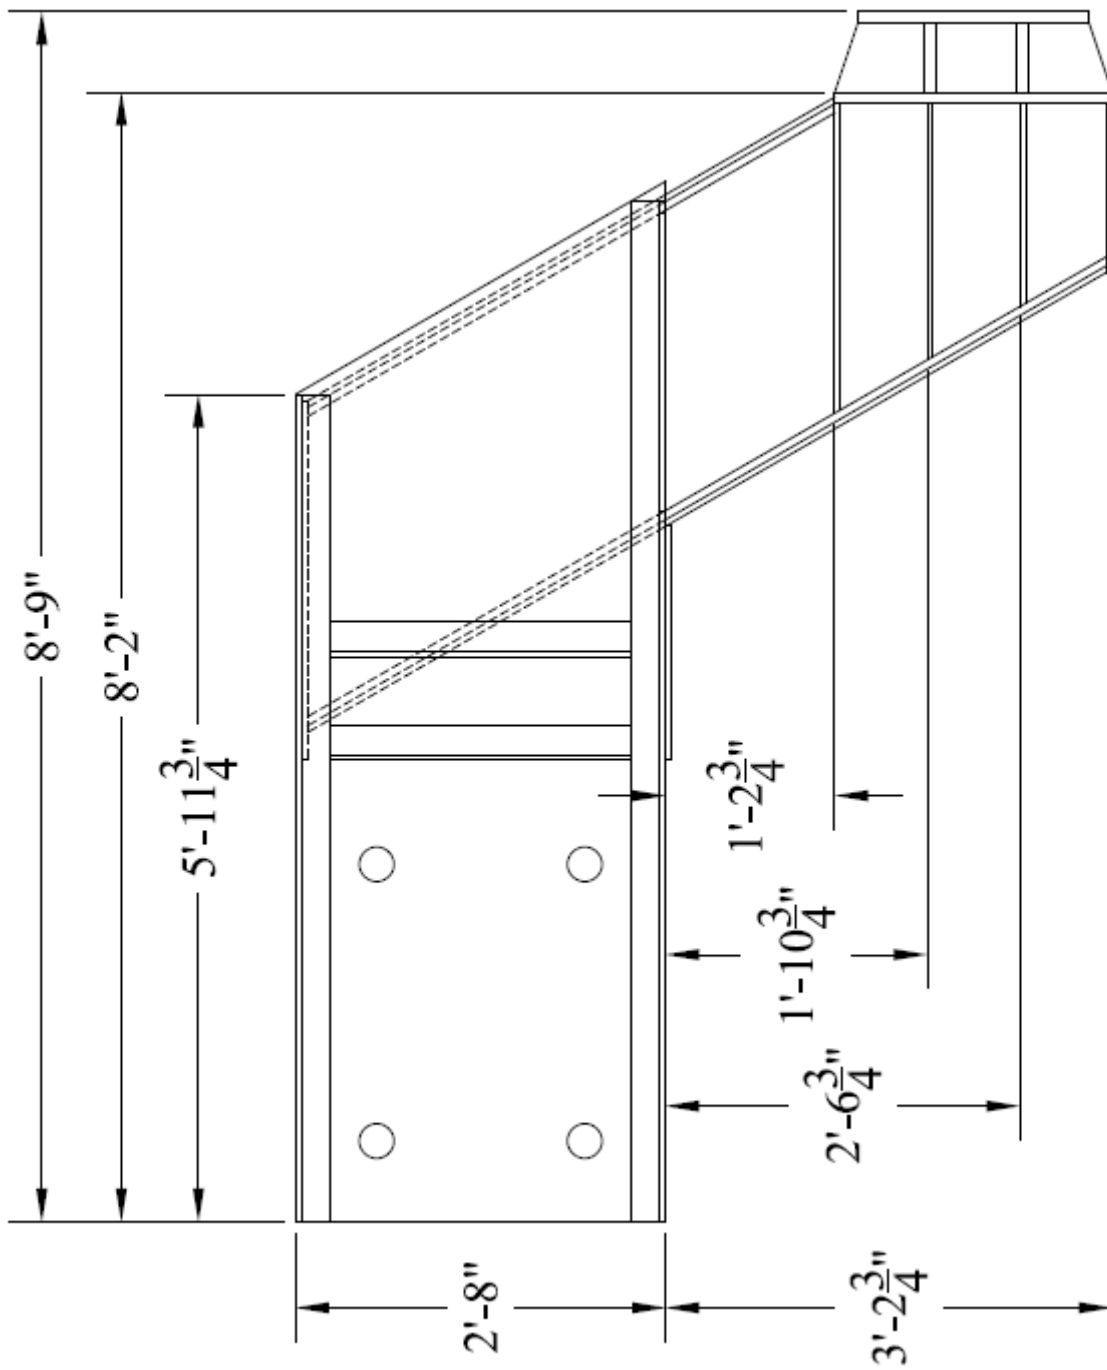
Figure A-5 - Loading Frame Front View (2) (1 in. = 25.4 mm)

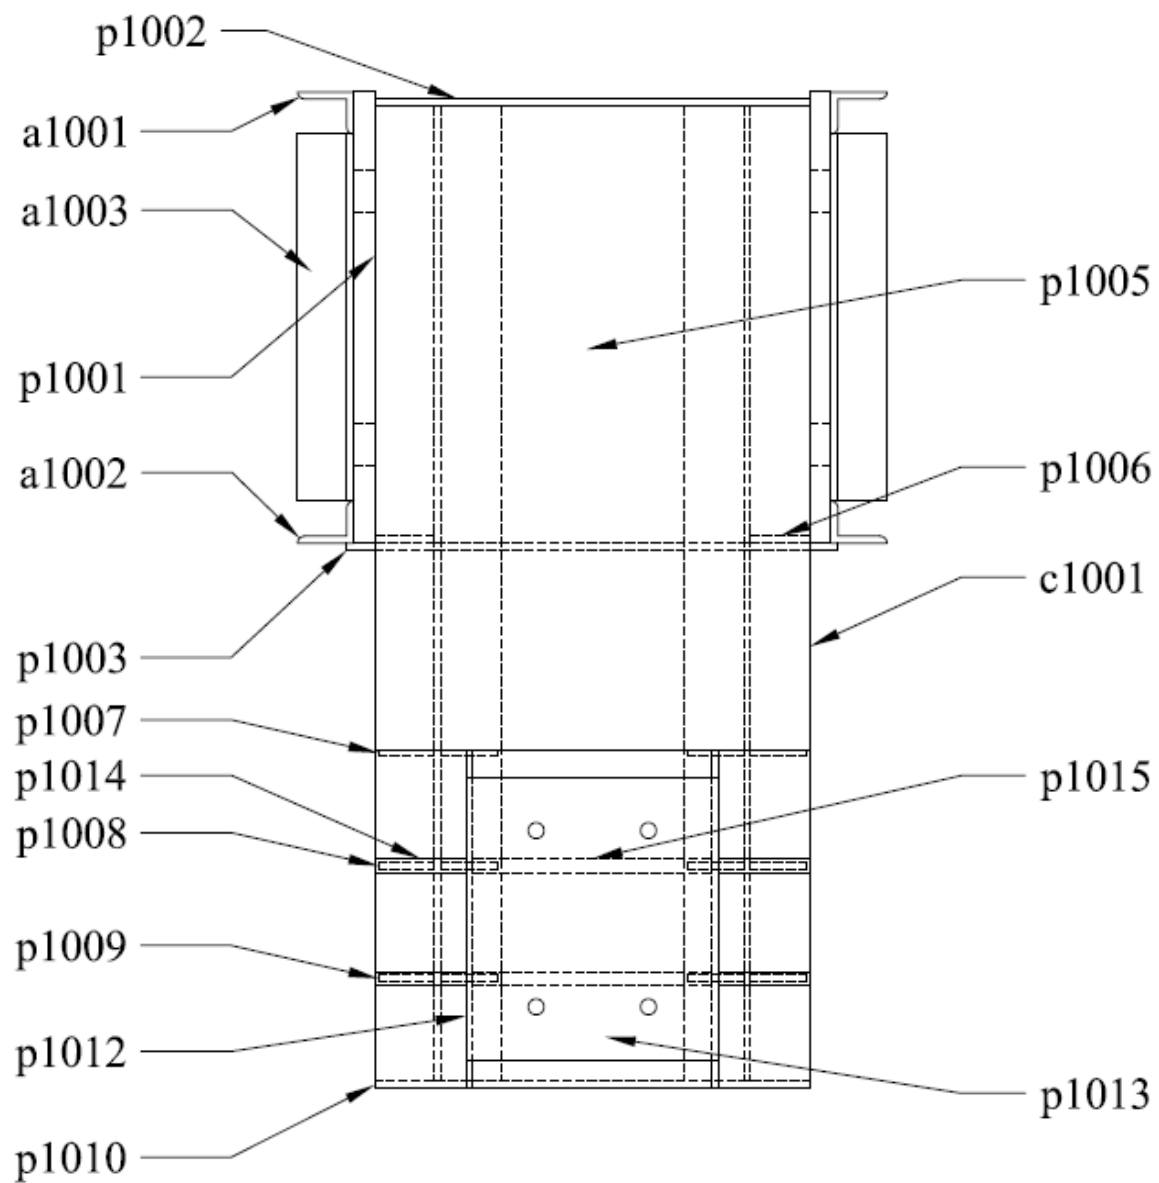
Figure A-6 – Loading Frame Side View

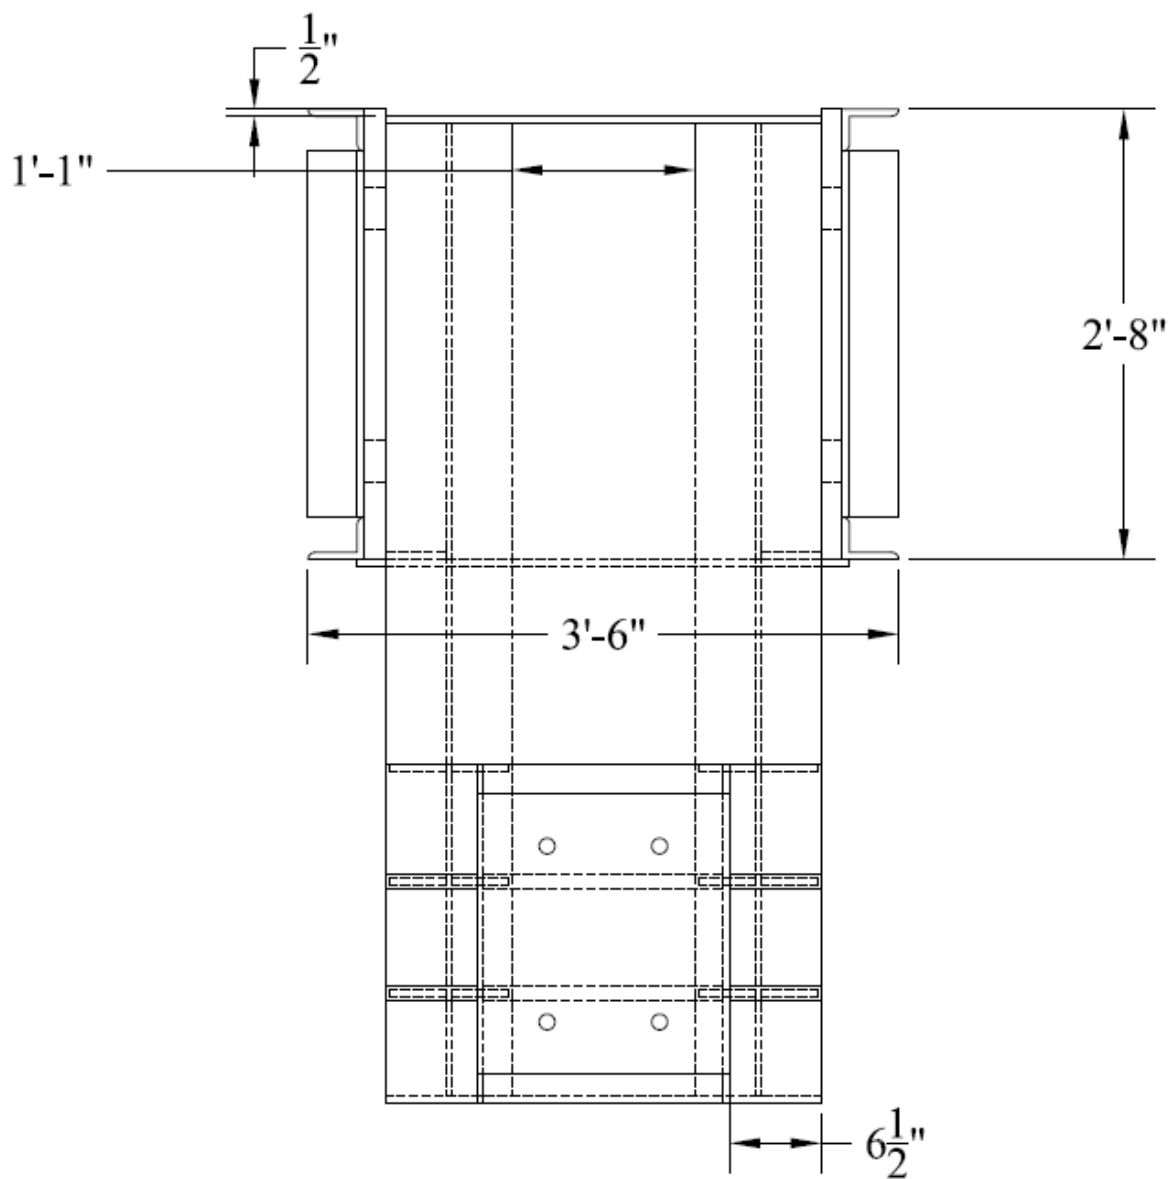
Figure A-7 – Loading Frame Side View (2) (1 in. = 25.4 mm)

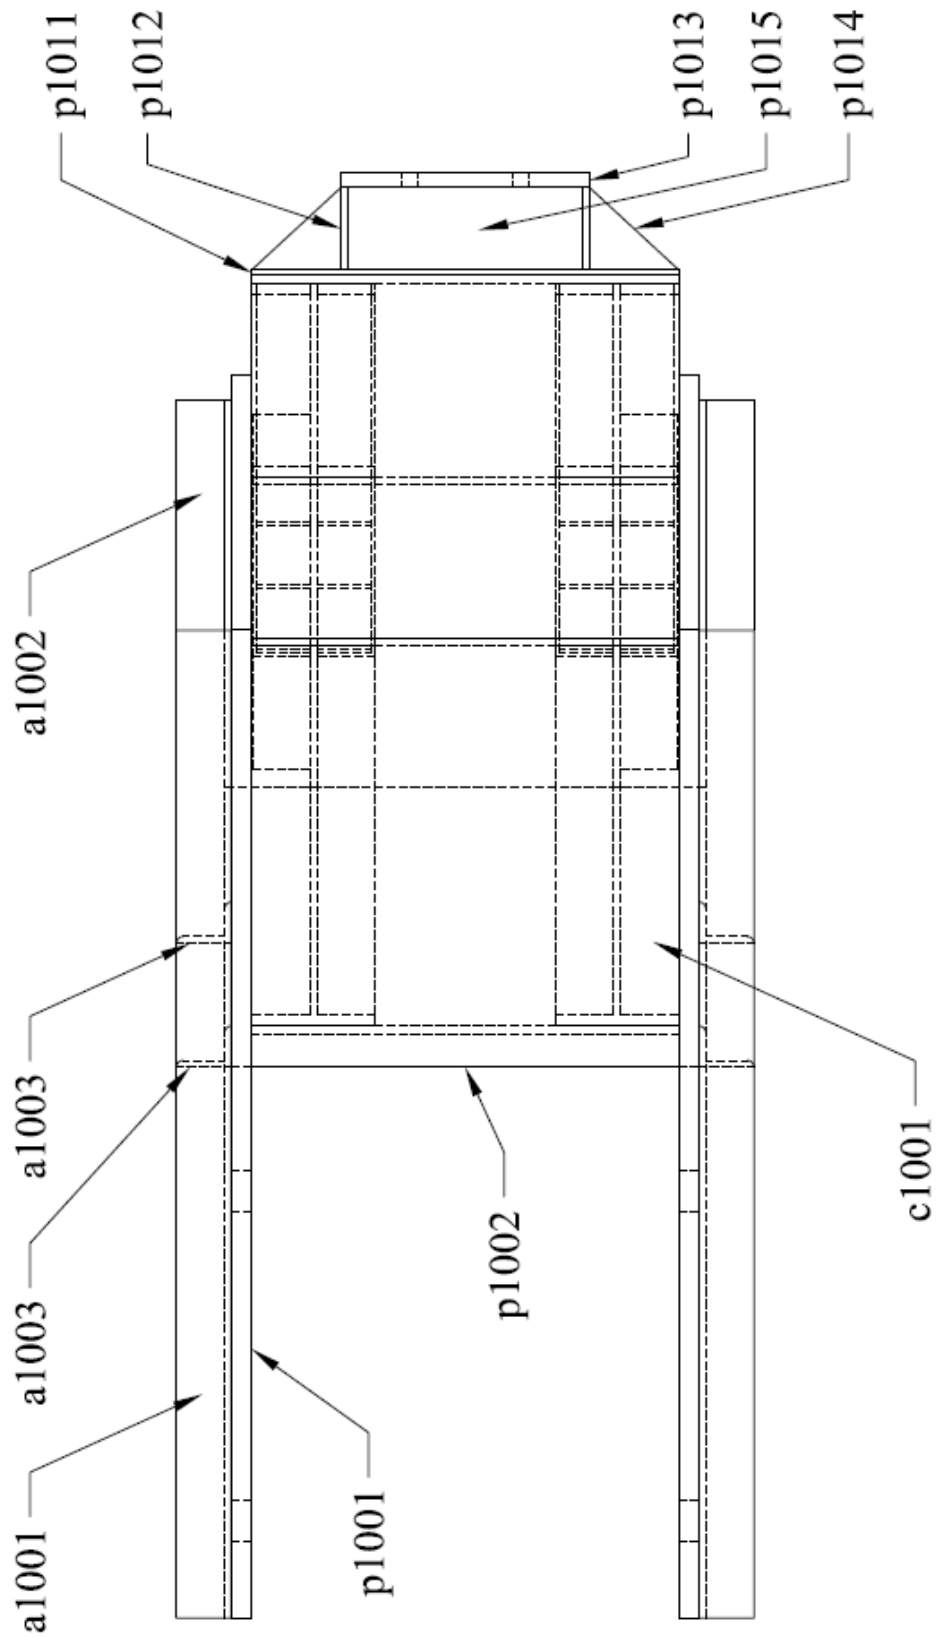
Figure A-8 – Loading Frame Top View
