**SEISMIC RETROFIT OF CRUCIFORM-SHAPED COLUMNS
IN THE AURORA AVENUE BRIDGE USING FRP WRAPPING**

A thesis submitted in partial fulfillment of
the requirements for the degree of

WASHINGTON STATE UNIVERSITY
Department of Civil and Environmental Engineering

MAY 2010

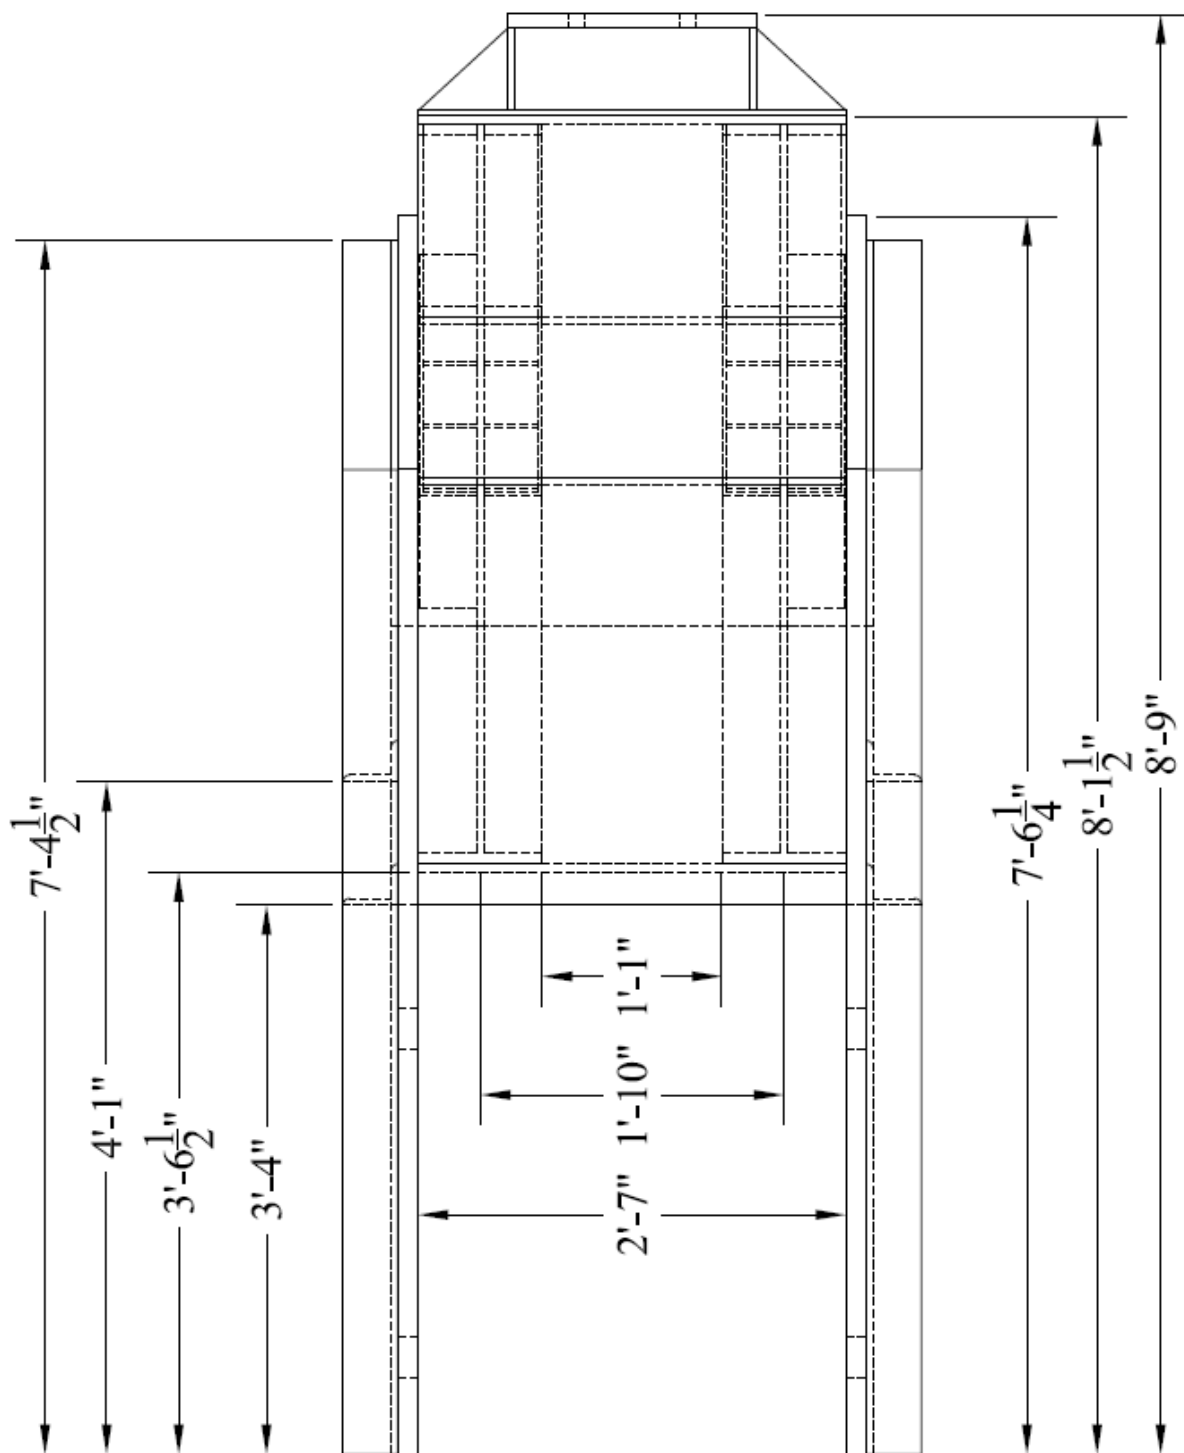
Figure A-9 – Loading Frame Top View (2) (1 in. = 25.4 mm)

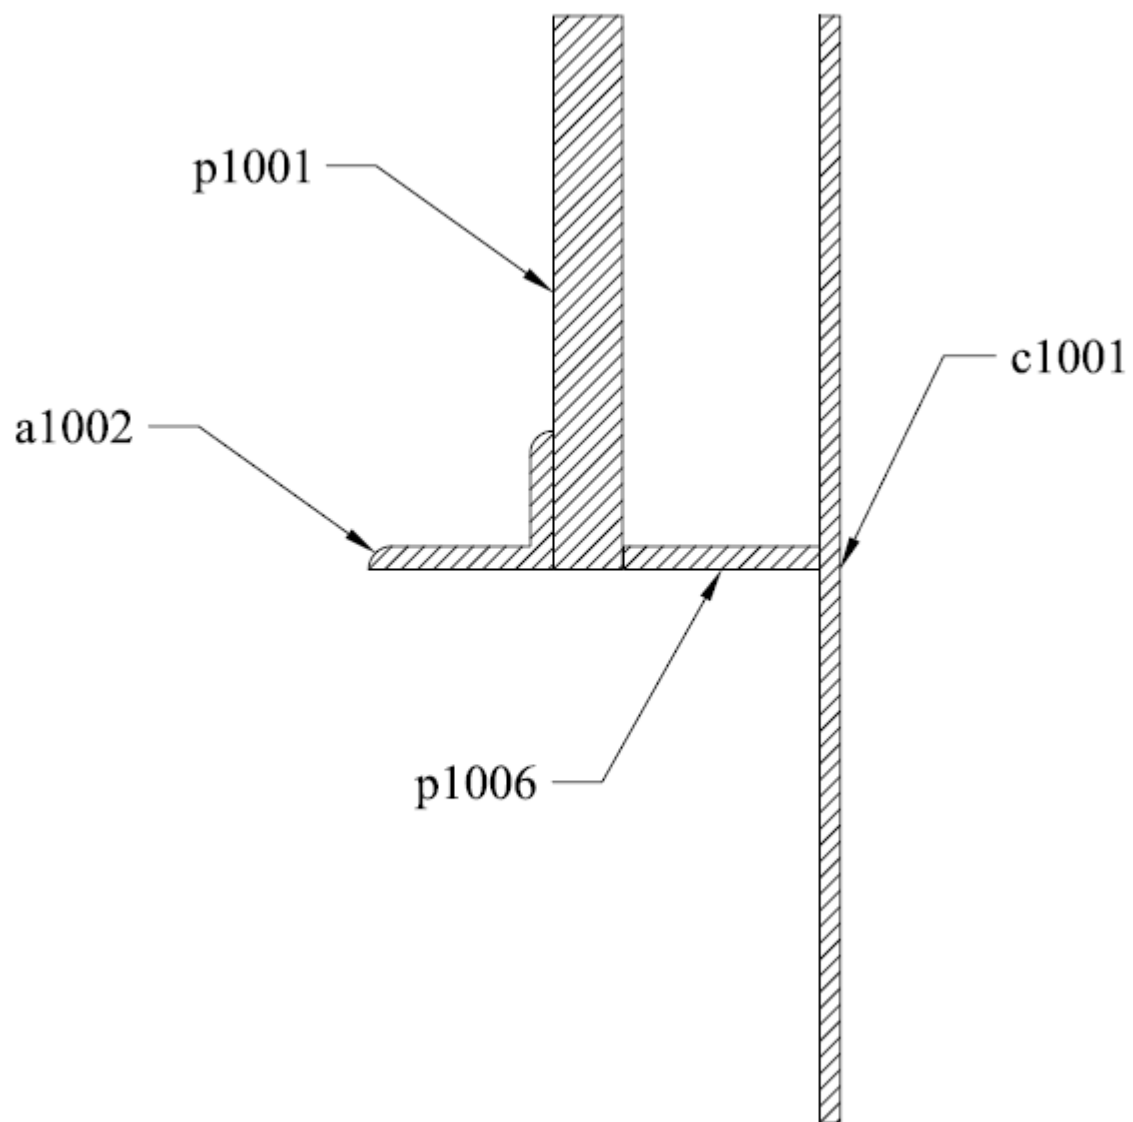
Figure A-10 – Loading Frame Section A-A

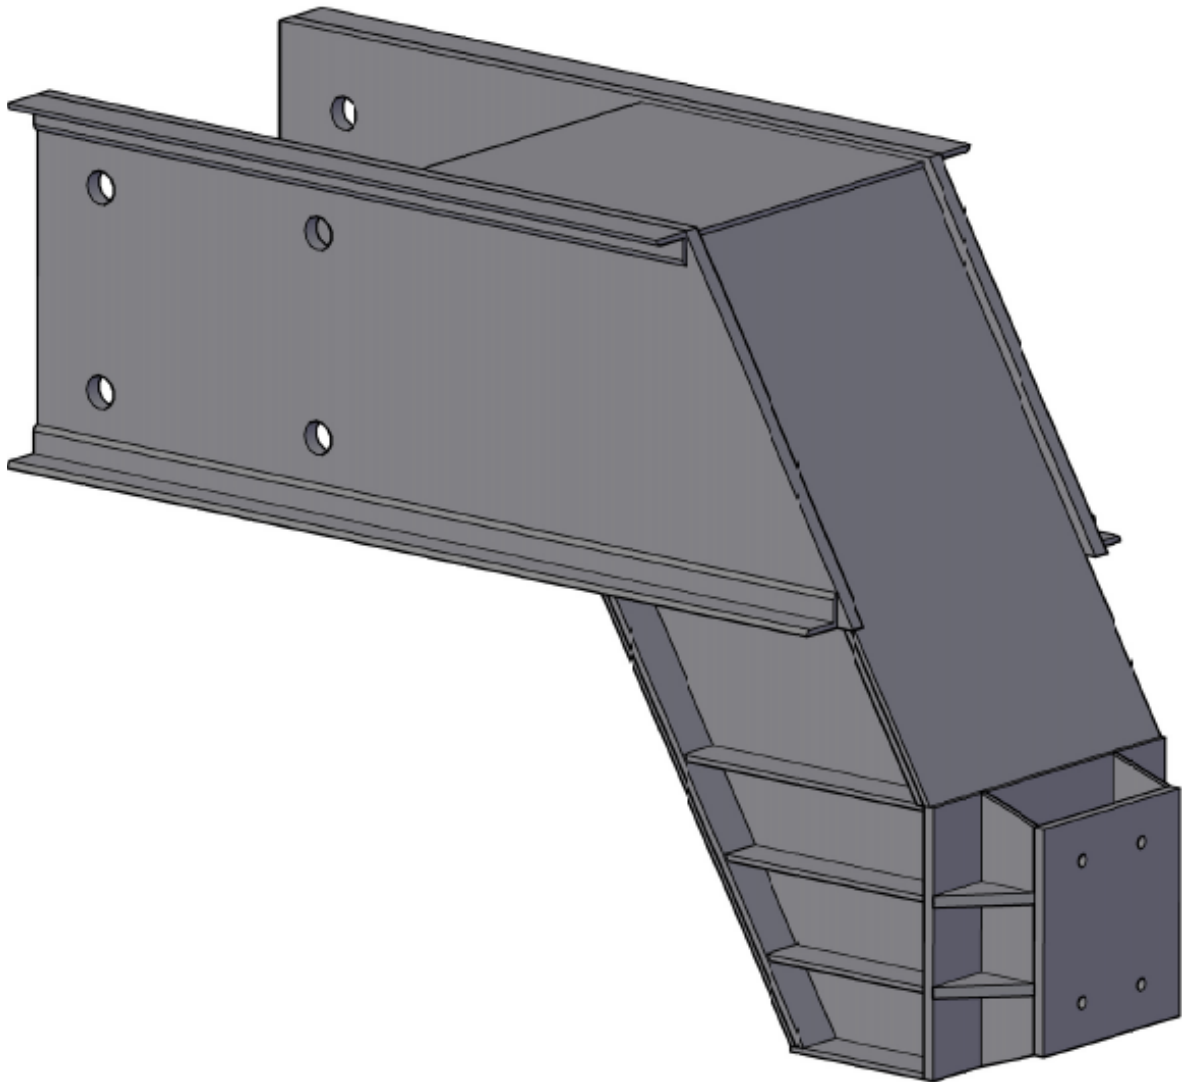
Figure A-11 – Loading Frame Isometric View

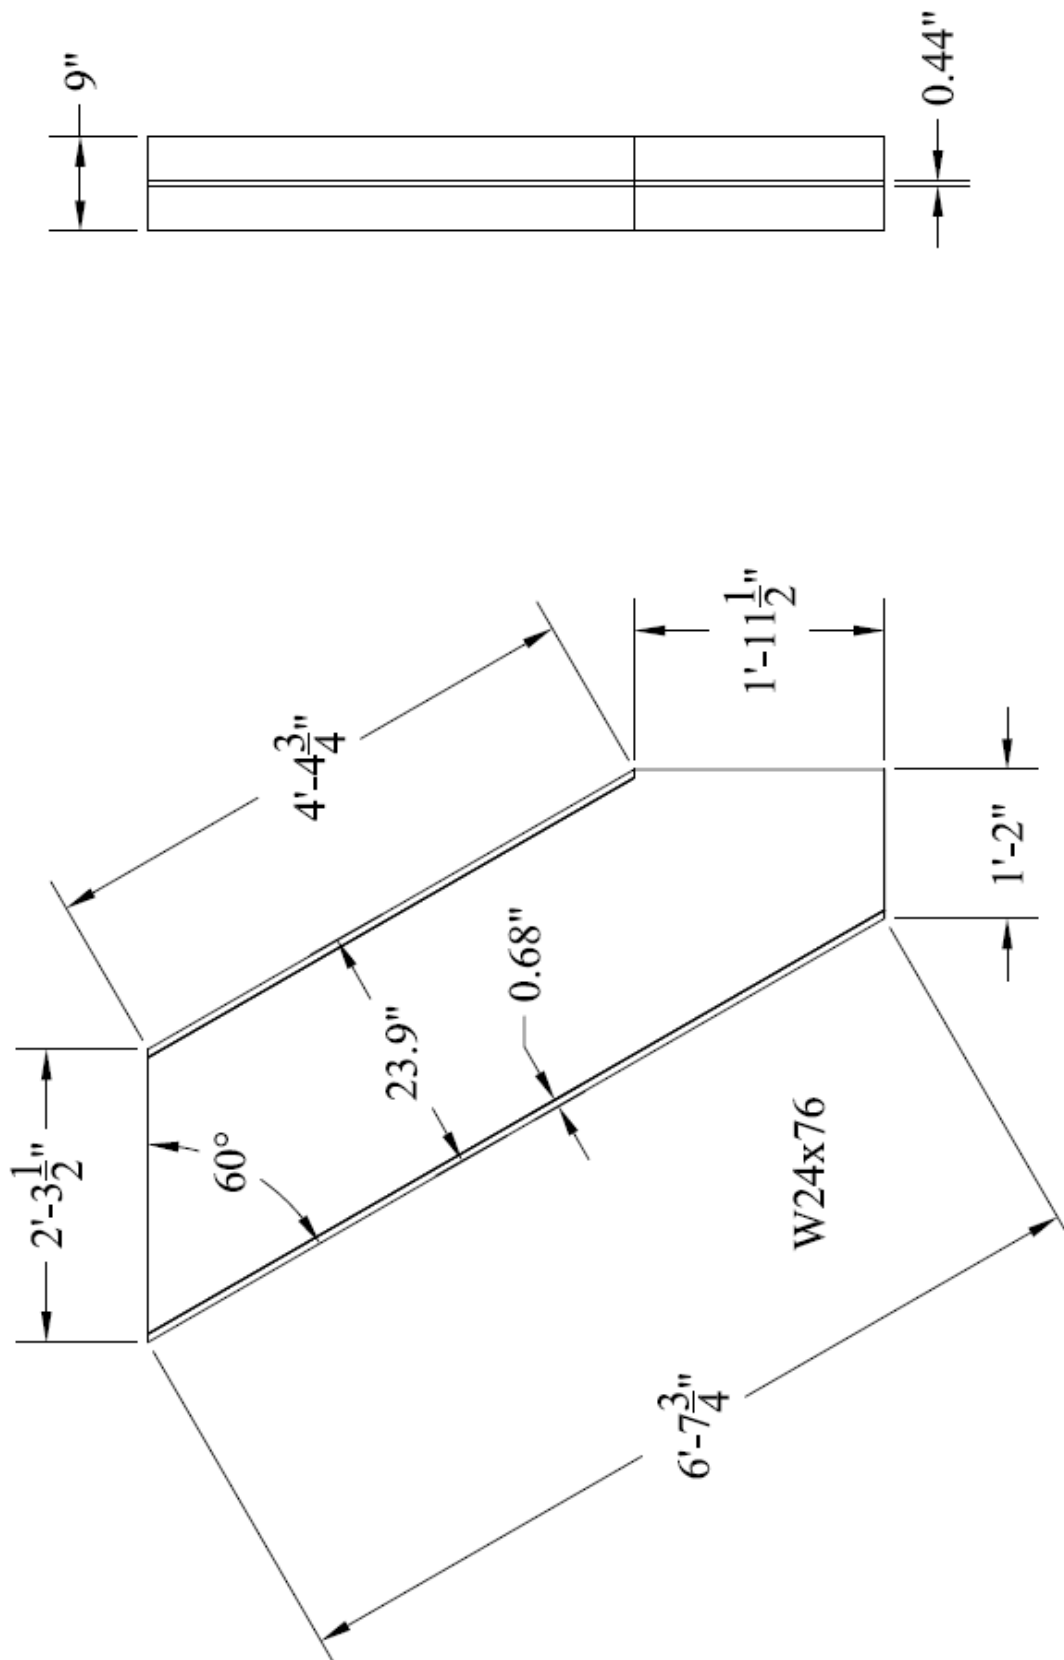
Figure A-12 – Loading Frame c1001 (1 in. = 25.4 mm)

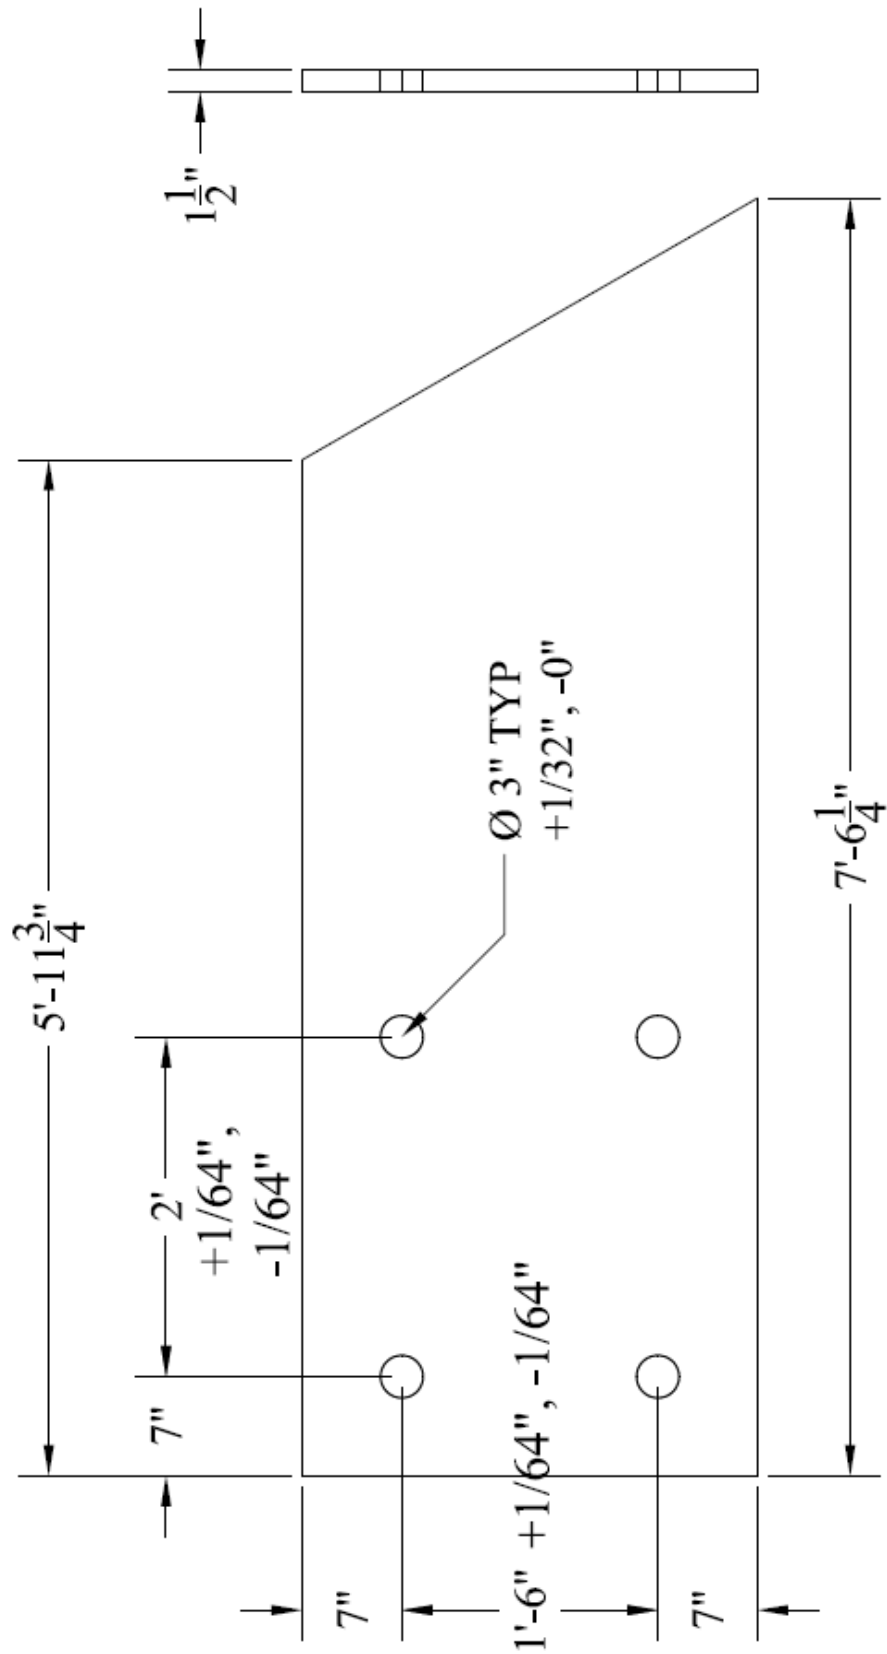
Figure A-13 – Loading Frame p1001 (1 in. = 25.4 mm)
